ENVIRONMENTAL PERFORMANCE REPORT AND MANAGEMENT PLAN (EPRMP)

CEMENT FINISHING PLANT PROJECT

BARANGAY LOWER IRASAN, MUNICIPALITY OF PRES. MANUEL A. ROXAS

JULY 2018

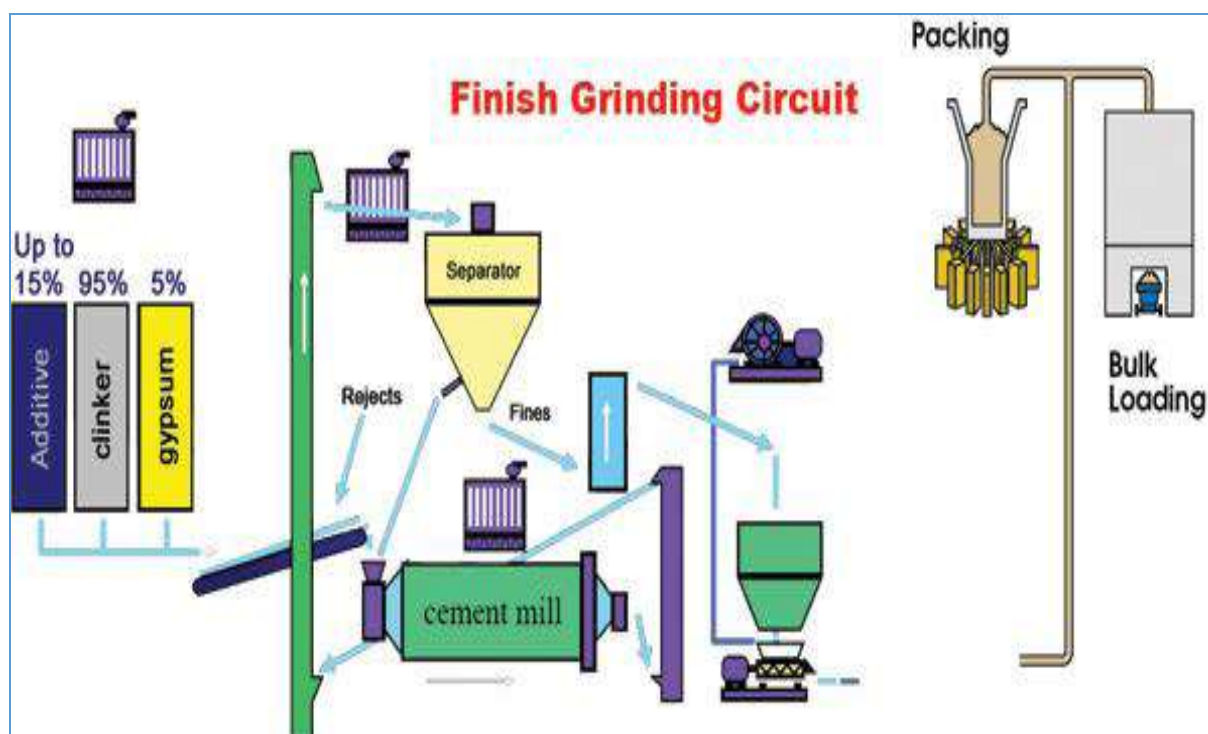
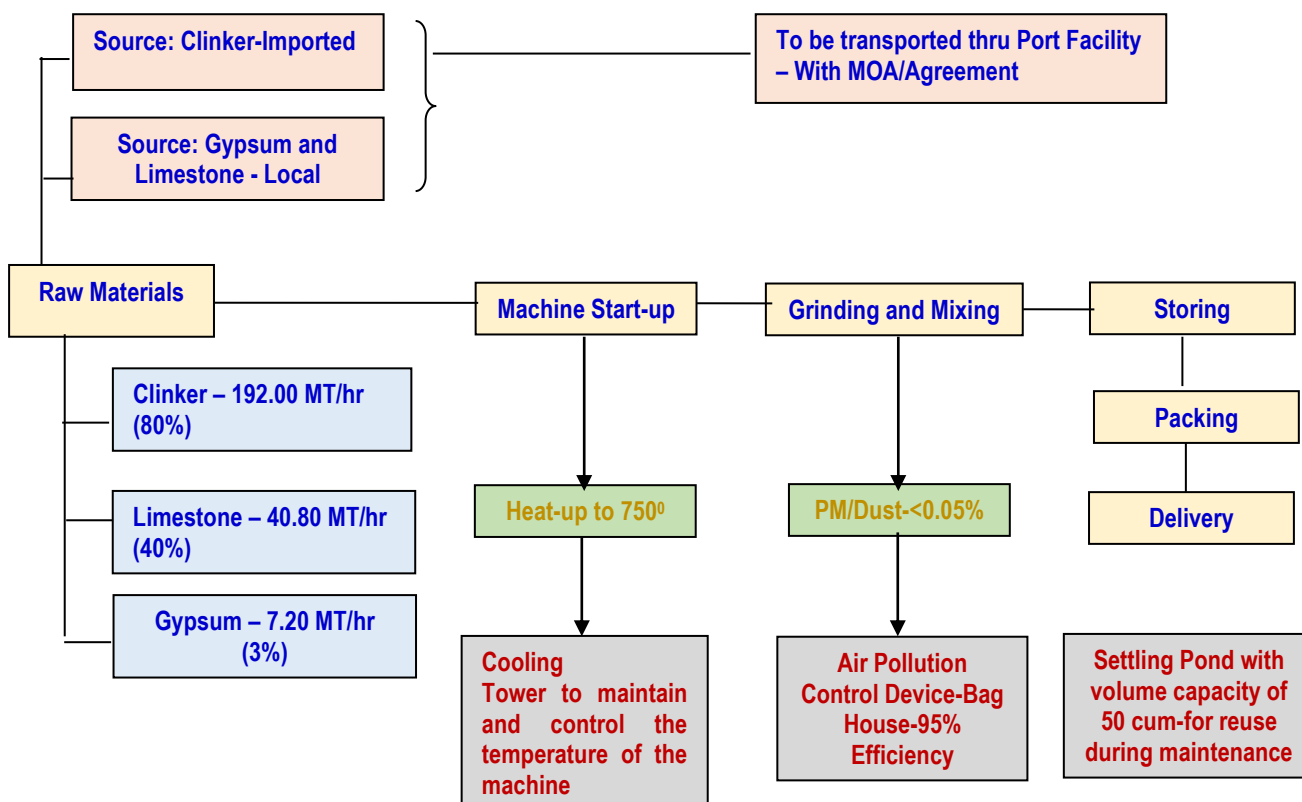
Plant Process Flow Diagram 1

Type	Capacity/Volume, MT per day
Raw Materials	Clinker Limestone Gypsum	80%=192.00 MT/hr 17%= 40.80 MT/hr 3%= 7.20 MT/hr 240 MT/hr
Total Land Area = 52,727 square meters

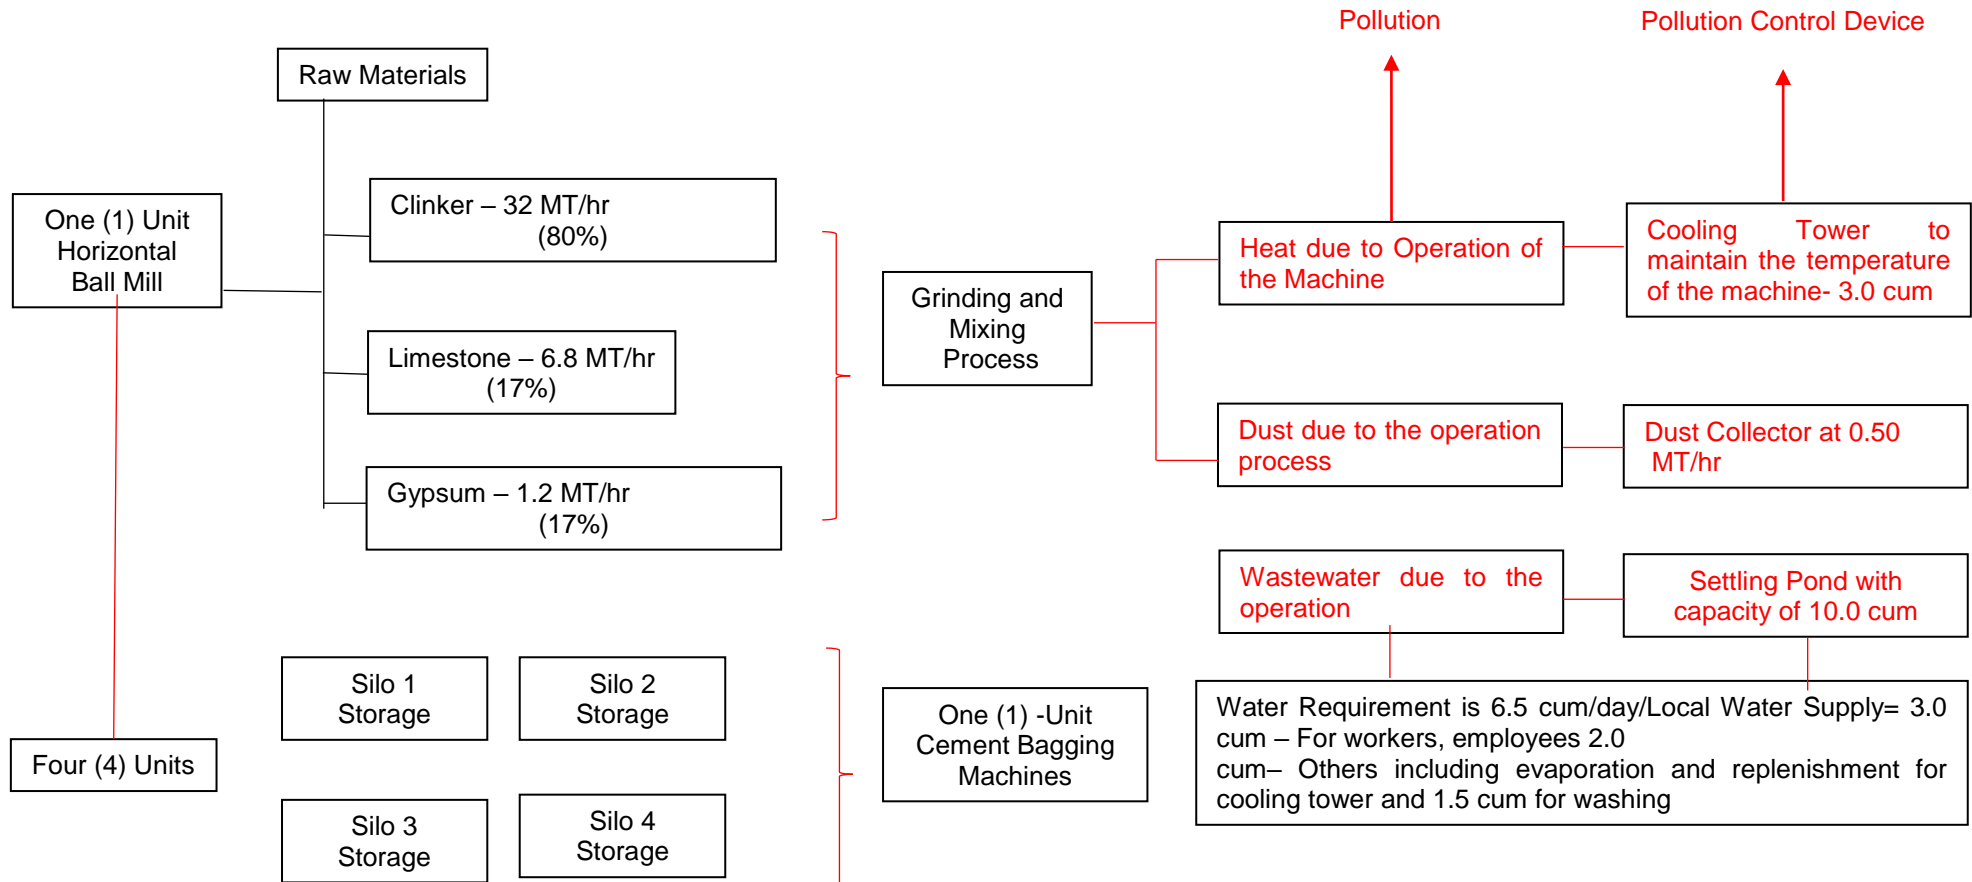
Existing Process Flow and Waste Stream Diagram 1B

Existing based on ECC issued
40 MT/hr

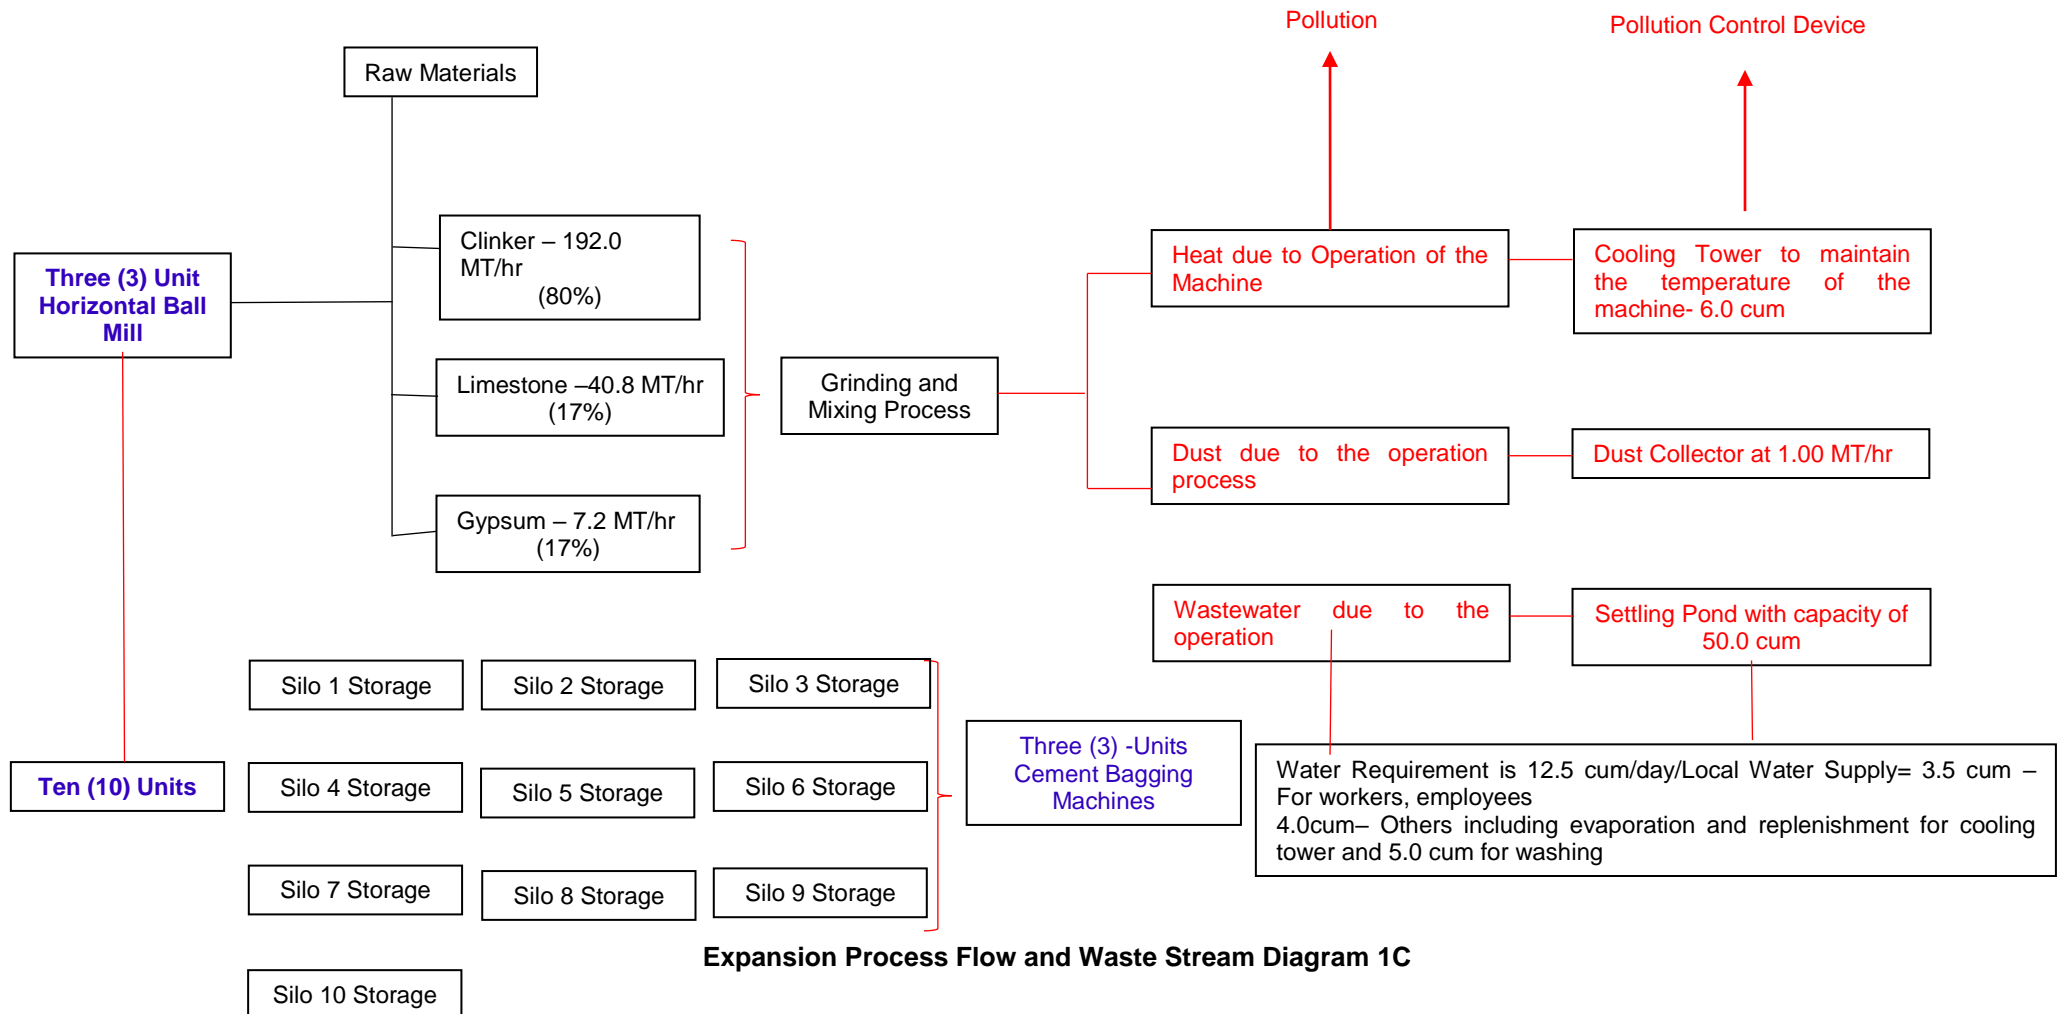
Expansion Process Flow and Waste Stream Diagram 1C

**Proposed Expansion of Capacity
240 MT/hr**

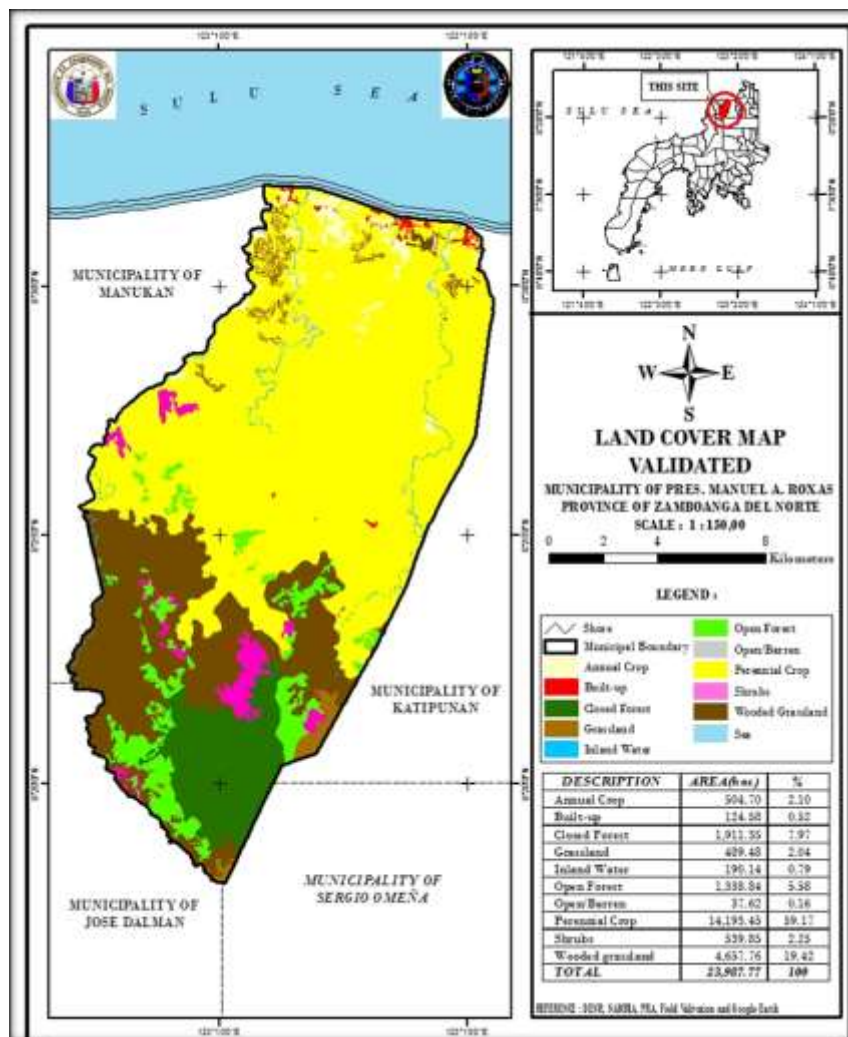
Figure 2-1 Validated Land Cover Map of the Municipality of Pres. Manuel Roxas

About 53 percent (12,732.04 hectares) that comprise the land area of Pres. Roxas are classified as forestland. The rest (11,255.73 hectares) is classified as alienable and disposable (A&D) lands, **Figure 2-1**.

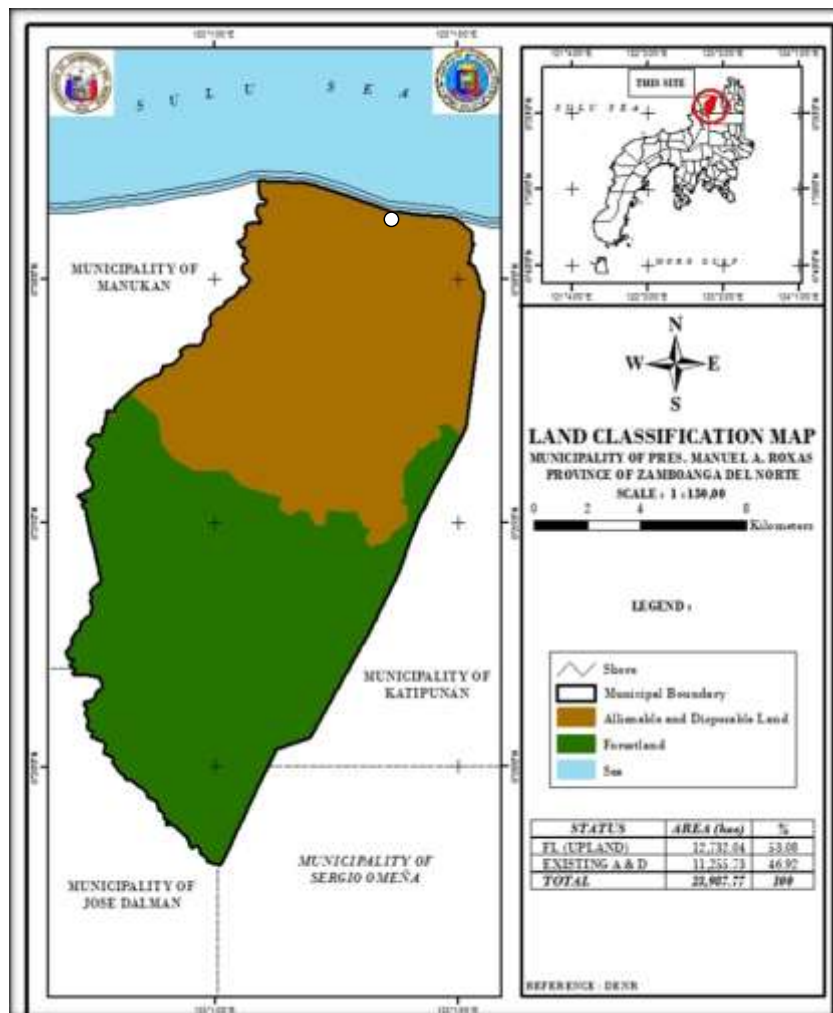
Figure 2-3 Land Classification Map of the Municipality of Pres. Manuel Roxas

The project site lies within an area classified under industrial use as shown in **Figure 2-3** (Pres. Roxas CLUP 1998-2008). It is surrounded by agricultural, agro-industrial, and industrial lands. The built-up (and populated) areas are distant from the site, approximately 1.4 km away.

There is no conflict between the project and the land use and classification of the host municipality because it is located inside an area classified for industrial use (Pres. Roxas CLUP 1998-2008). It is distant from built-up and populated areas. In addition, authority of proponent over is defined by its ownership of this land parcel covered by TCT No. T-27983.

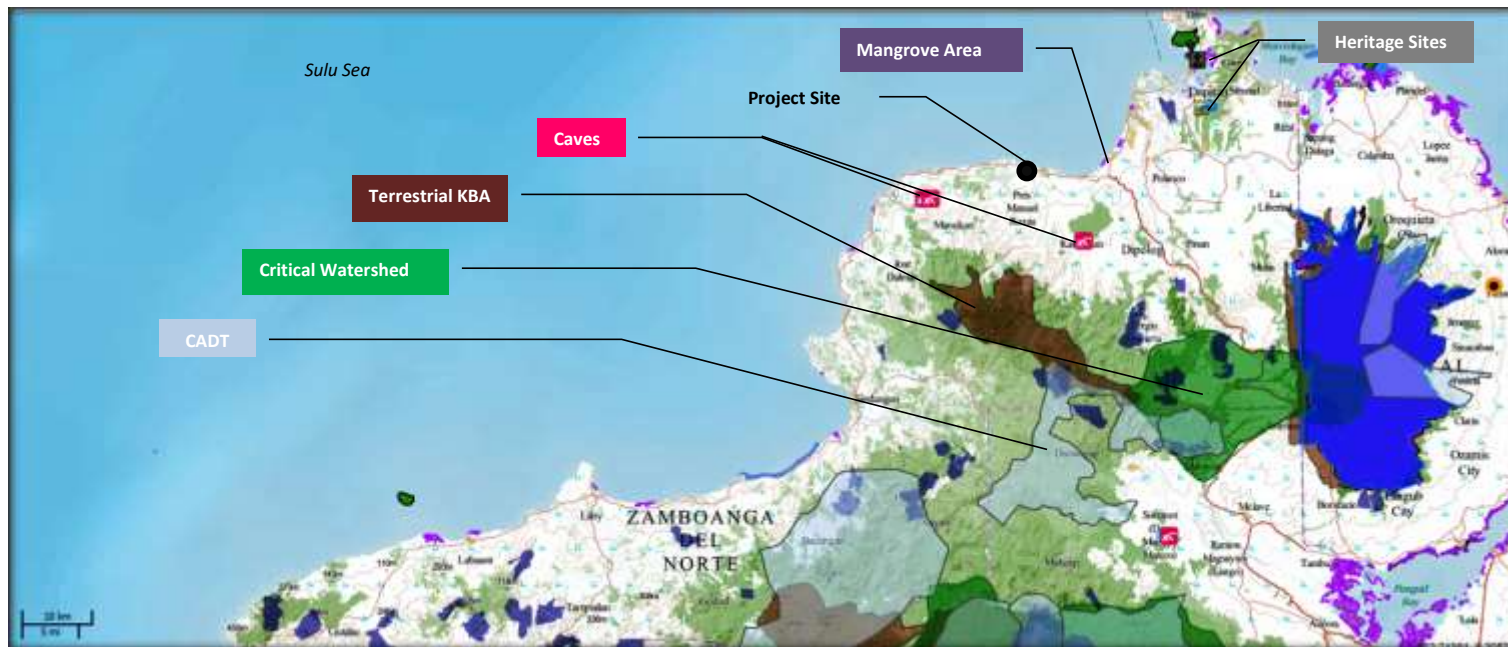
Figure 2-4 Environmentally Critical Areas (ECA) surrounding the Project Area

The Revised Procedural Manual for DENR Administrative Order No. 30, Series of 2003 (DAO 03-30) defined Environmentally Critical Areas (ECA) in twelve categories. An ECA is an environmentally sensitive area declared through Proclamation 2146 of 1981 where significant environmental impacts are expected if certain thresholds of proposed projects are located, developed, or implemented in it. Assessment of project's encroachment in ECAs is presented in **Table 2-1**. **Figure 2-4** shows locations of ECAs within and surrounding the project.

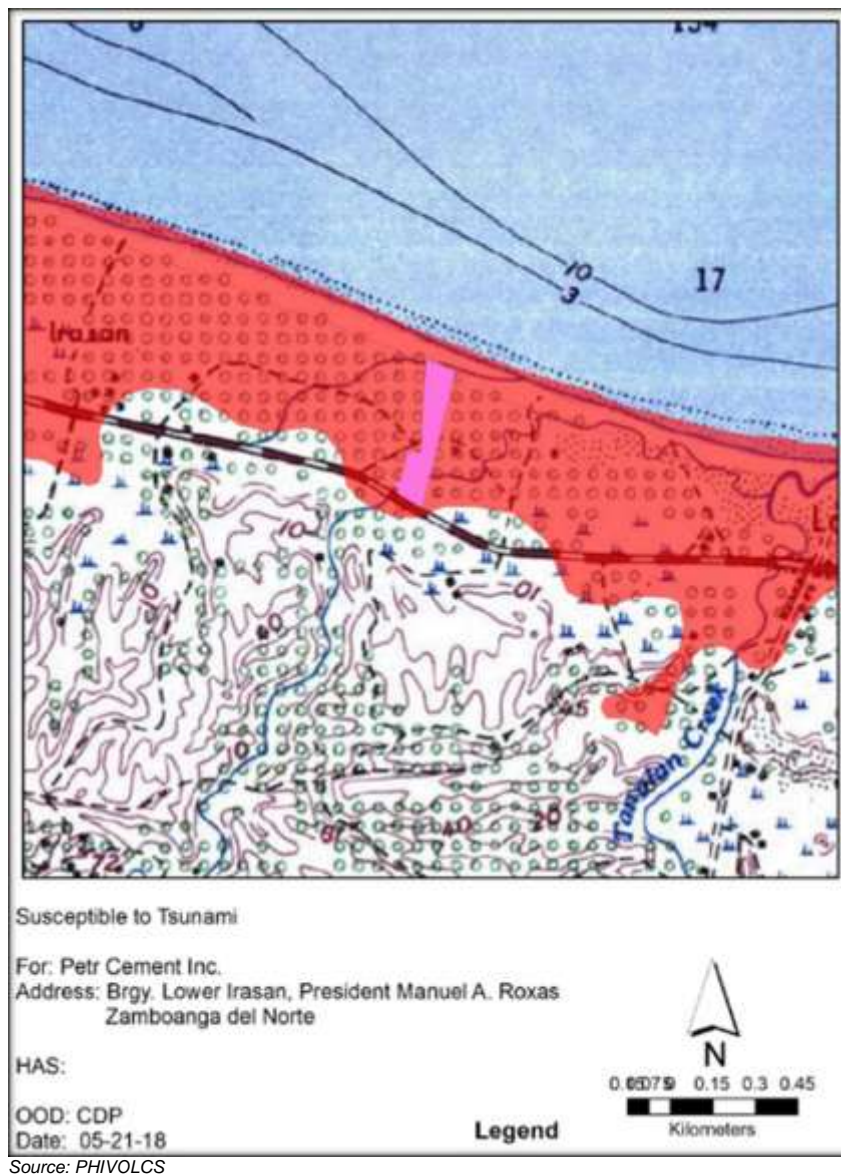
Figure 2-5 Tsunami Hazard Map of the Municipality of Pres. Manuel Roxas

The cement plant is located in two ECAs: areas frequently visited or hard-hit by natural calamities and areas close to waterbodies that support fishery activities. PHIVOLCS showed that the site were projected to be prone to a 7.17-meter high tsunami. **Figure 2-5**.

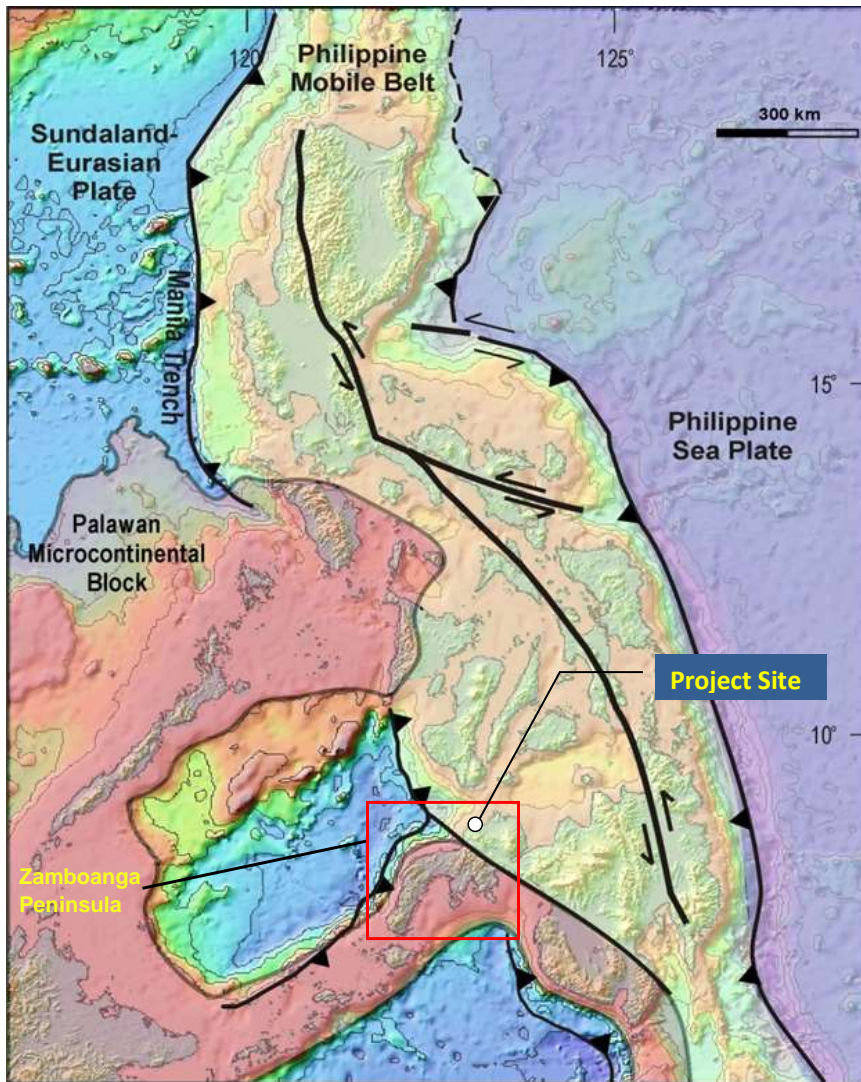
Figure 2-11 Generalized tectonic map of the Philippines. Modified after Yumul et al 2015, Geology of the Zamboanga Peninsula, Mindanao, Philippines: and enigmatic South China continental fragment

trench: an expression of the subduction of Sulu Sea Basin under the Negros and Panay Islands and (3) Cotabato trench: an expression of the subduction of the Celebes Sea basin under Mindanao Island (Hayes & Taylor, 1978). Conversely, it is flanked on the east by the following features: (1) Philippine Trench: an expression of the oblique convergence of the Philippine Sea Plate under the eastern Philippine Arc (Cardwell et al 1980; Fitch, 1970; Hamburger et al 1983) and (2) East Luzon Trough: a nascent subduction zone propagating northwards (Lewis and Hayes, 1983). The present (or past) activities along these subduction zones are indicated by the presence of active, potentially active and inactive volcanoes in the archipelago (**Figure 2-11**).

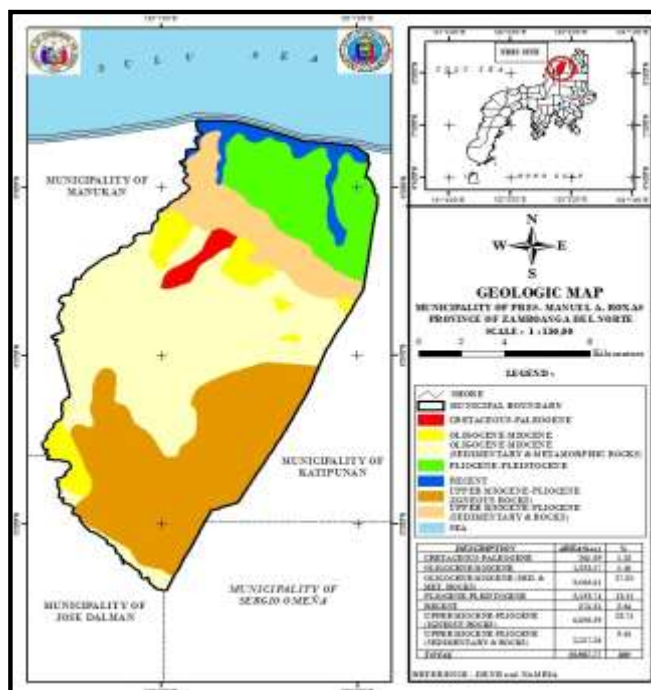
Figure 2-14 Geologic Map of Pres. Manual A, Roxas, Zamboanga del Norte

Seven (7) chronostratigraphic units were identified in the municipality of President Manuel A. Roxas, Province of Zamboanga del Norte, namely these are: (1) Cretaceous-Paleogene, (2) Oligocene-Miocene, (3) Oligocene-Miocene (sedimentary and metamorphic rocks), (4) Pliocene-Pleistocene, (5) Recent, (6) Upper Miocene-Pliocene (igneous rocks), and (7) Upper Miocene-Pliocene (sedimentary rocks).

The Oligocene-Miocene (sedimentary and metamorphic rocks) unit is widely distributed at the central part and is also found at the southernmost tip of the municipality. Also found at the southern portion is the Upper Miocene-Pliocene (igneous rocks). The recent deposits, on the other hand, are located at the northern part engulfing some parts of the Pliocene-Pleistocene unit. Lastly, the Oligocene-Miocene, Upper Miocene-Pliocene and Cretaceous-Paleogene are sparsely distributed throughout the municipality.

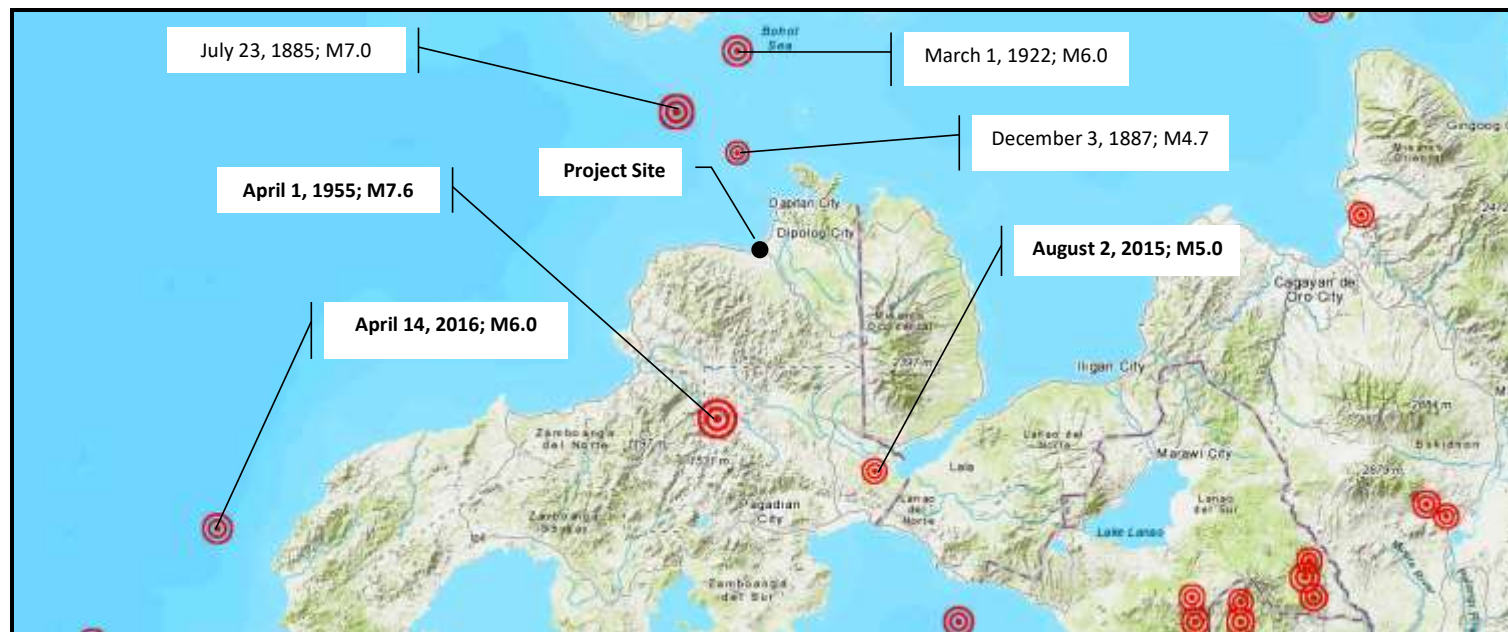
Figure 2-16 Significant Historical Earthquakes in the Zamboanga Peninsula

Active faults which surround and run through Zamboanga Del Norte make it highly susceptible to common hazards that earthquakes bring. The Sulu-Negros Trench is also in close proximity with the province. In the past, the Seismological Observation and Earthquake Prediction Division of the Philippine Institute of Volcanology and Seismology (SOEPD-PHIVOLCS) have recorded multiple minor, light, moderate and strong earthquakes within the area. **Figure 2-15** shows historical earthquake locations from December 1907 to December 2017 with magnitude greater than 4.0. **Figure 2-16** shows significant historical earthquakes in the peninsula.

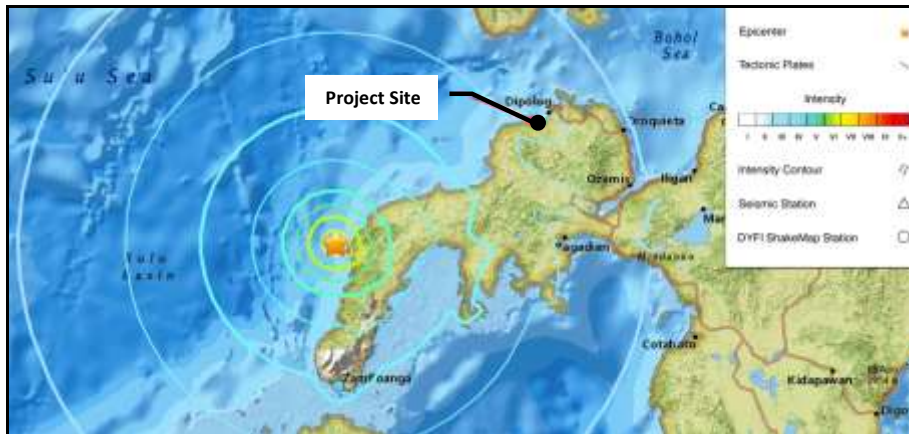
Figure 2-17 Shaker Map of March 14, 2016 M 6.0 - Baliguian, Zamboanga del Norte earthquake

Most recently, in the year 2016, Zamboanga del Norte was hit by a magnitude 6.0 earthquake. The epicentre was located at 17 kilometers northwest of Baliguian, Zamboanga del Norte with a depth of 16 kilometers. (**Figure 2-17**).

- Intensity V (strong) – Zamboanga City
- Intensity IV (moderately strong) – Baliguian, Gutalac, Ipil, Labason, Siocon, Sibuco, and Titay, Zamboanga Del Norte; Isabela Cioty, Basilan
- Intensity III – Sirawai and Liloy, Zamboanga Del Norte
- Intensity II – Dipolog City; Oroquieta City, Misamis Occidental

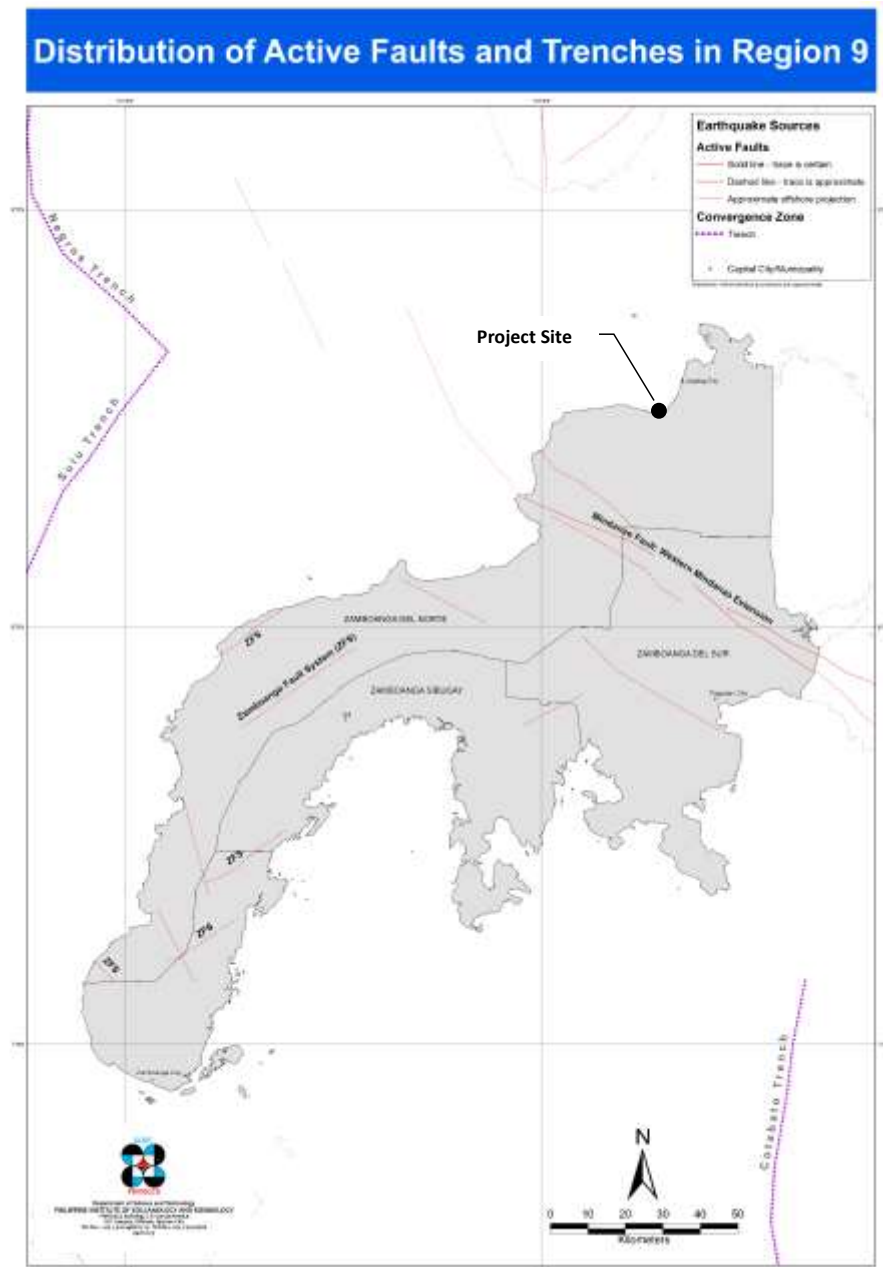
Figure 2-18 Distribution of Active Faults and Trenches in Region IX

According to the map of active faults and trenches by PHIVOLCS (**Figure 2-18**), Zamboanga del Norte is transected by several active faults and is situated approximately 100 kilometers from the Sulu-Negros Trench. Two major faults which are in close proximity to the province are the Western Mindanao Extension of the Mindanao Fault and the Zamboanga Fault System. Several apparent fault traces are also found within and near the area.

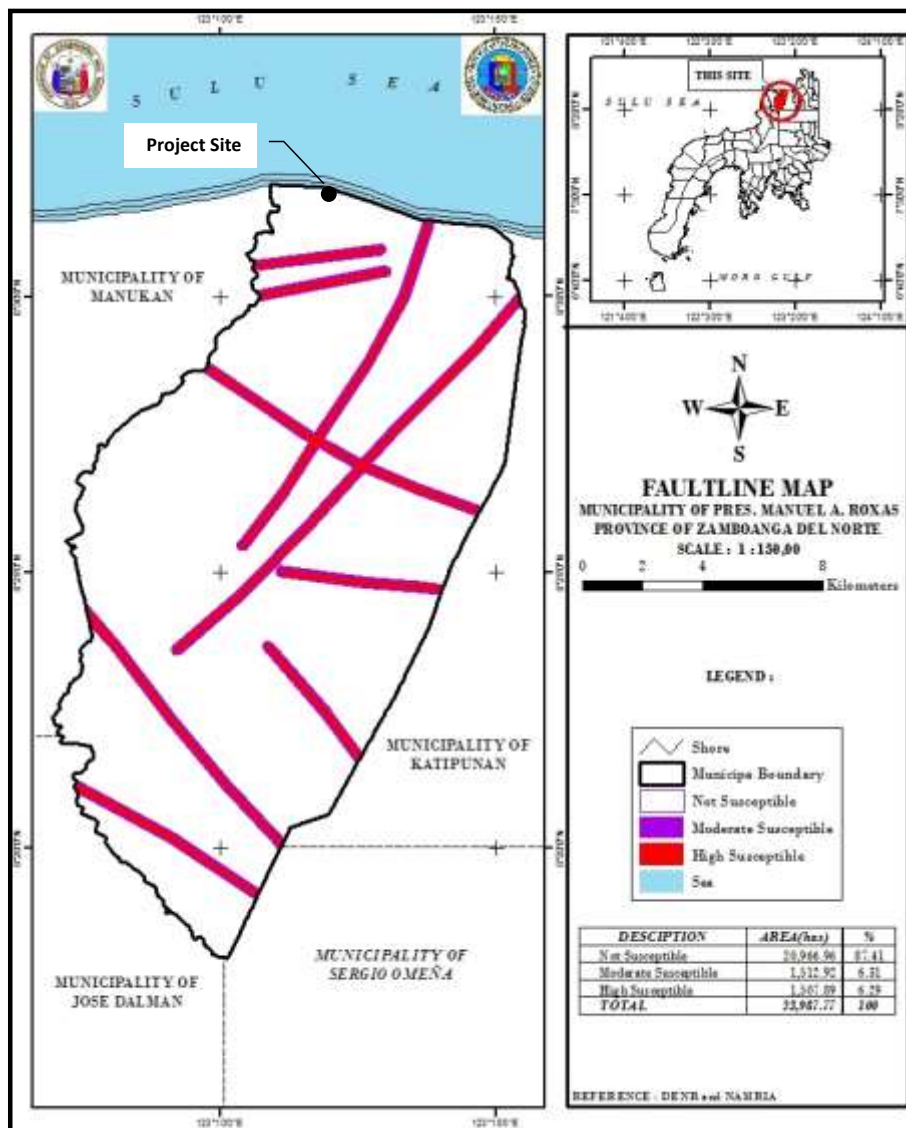
Figure 2-19 Ground Rupture and Ground Shaking Susceptibility Map of Pres. Manuel A. Roxas, Zamboanga Del Norte

Zooming in to the municipality of Pres. Manuel A. Roxas in Zamboanga Del Norte, several local faults and tension cracks were also mapped in the area (**Figure 2-19**). The length of the fault traces and tension cracks ranges from approximately 5 to 18 kilometers.

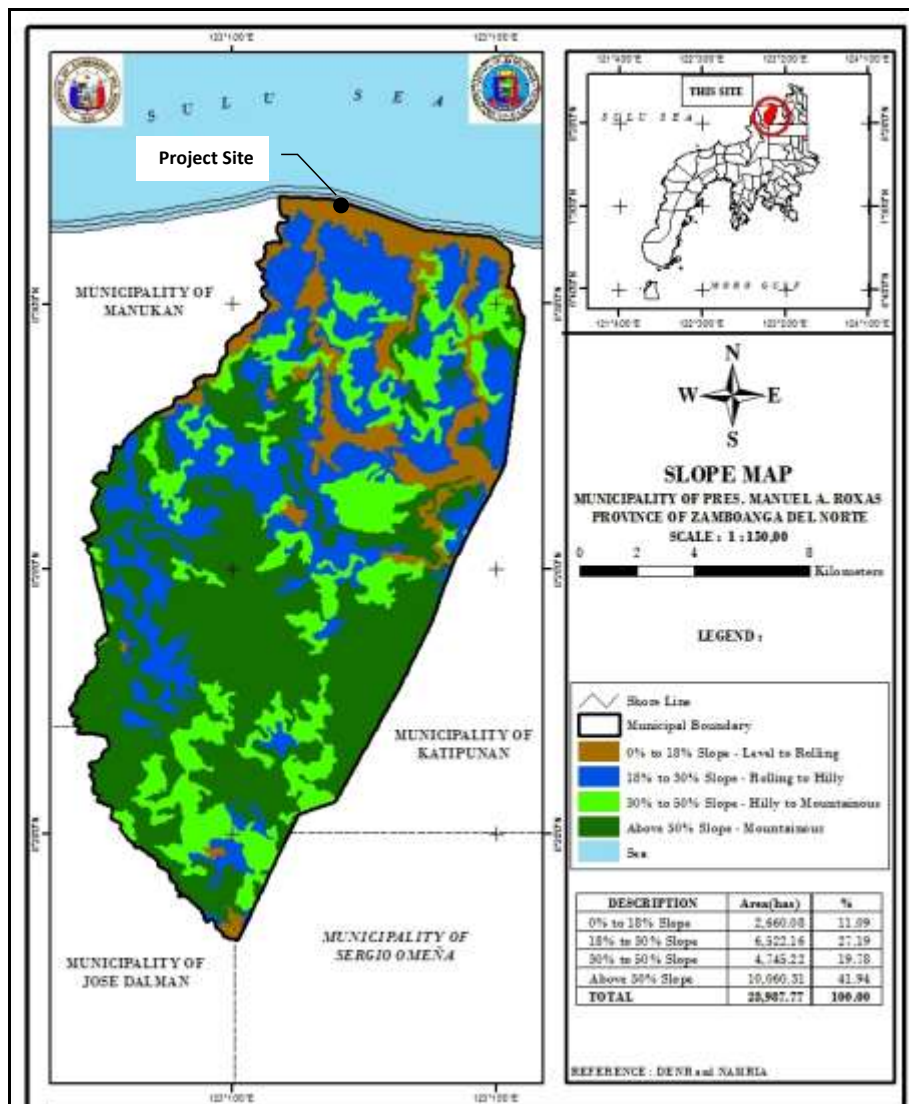
Figure 2-20 Slope Map of the Municipality of Pres. Manuel Roxas.

Present data on slope range, slope characteristics of the areas in the municipality of Pres. Manuel A. Roxas can help assess its landslide susceptibility. Slope map of the municipality is presented in **Figure 2-20**. In addition, **Figure 2-21** shows selected areas of the municipality that are likely to collapse during strong earthquake.

Slope Range	Characteristics	Location
6-8 %	This land is on moderate slopes. This is poorly drained and it is subject to slight erosion. Can be cultivated through the use of special conservation practice.	Part of Dohinob, Upper Irasan, Lower Irasan , Poblacion, Piao and Nabilid.
9-15%	This land has greater slopes but is still suited for cultivation. To obtain high yields, special conservation practice must be employed.	Part of Poblacion, Lower Irasan, Piao and Nabilid.
16-25%	Best Suited for pasture but can be cultivated to crops in good rotation. Needs intensive soil conservation measures.	Pangologon, Denoman, Tanayan, parts of Villahermoso, Lipakan and Piñamar
26-35%	This land is too stepped, too eroded or too shallow for cultivation. Production of forage or woodland production on this land without Special restriction will be profitable.	Part of Villahermoso, Lipakan, Piñamar, Piñalan, Sebod, Capase and Marupay

36-60%	This type of land would be better preferred as woodland. This is more rugged.	Moliton, Balubo, Canibongan, part of Capase, and Marupay.

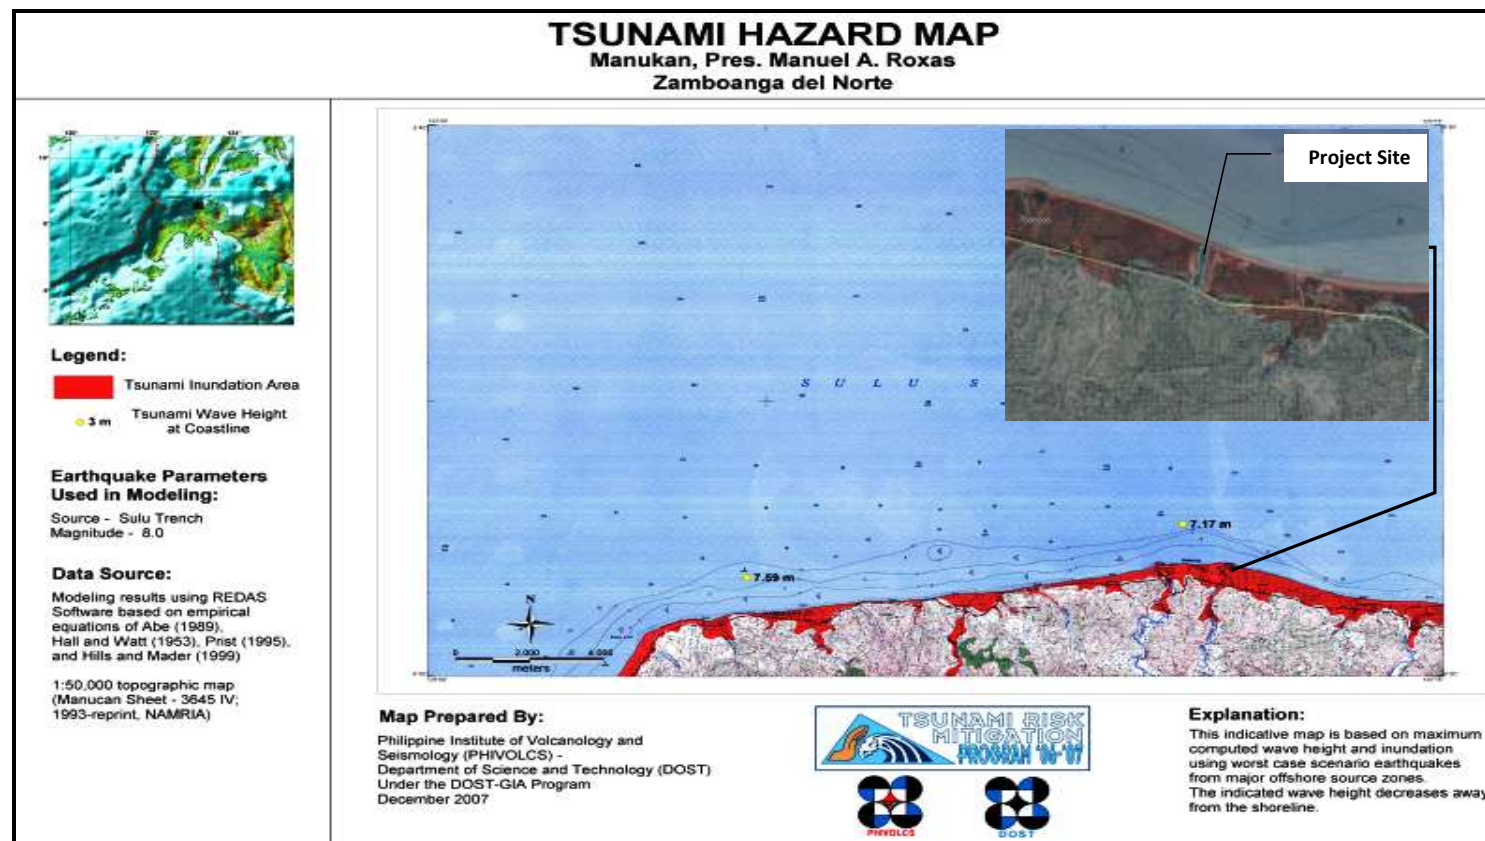
Shown in **Figure 2-23** is the Tsunami Hazard map of Manukan Quadrangle and the project site. Given that the province will be hit by a magnitude 8.0 earthquake coming from the Sulu trench, PHIVOLCS has simulated the tsunami wave heights at the coastlines of each city and municipality. For the municipality of Pres. Manuel A. Roxas, the tsunami wave height can reach up to 7.17 meters.

In case of Magnitude 8.0 earthquake from the Sulu Trench, a 3meter high tsunami will reached the western coasts of Zamboanga, and may result in a tremendous devastation could be expected particularly in Dipolog City. At the project site, such waves were predicted to force inland several kilometers from the shoreline. This natural hazard likewise reflects the damages it may inflict at the project site.

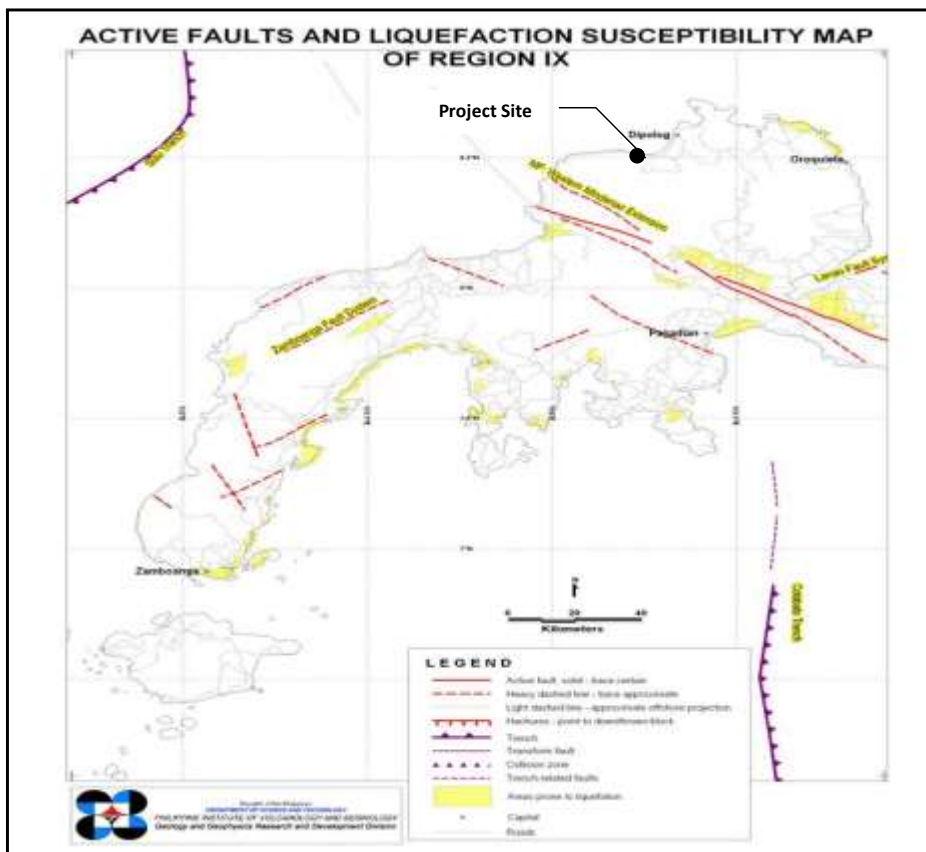
Liquefaction susceptibility map released by PHIVOLCS shows that only sparse areas within the Zamboanga Peninsula are actively prone to liquefaction. Note that these areas are found in close proximity with a fault/fault system.

The project site is prone to liquefaction hazard since it is underlain by alluvial deposits characterized by thick layer of soft, compressible and unconsolidated sand, silt, clay and fine gravelly river deposits. Furthermore, the water table at the site is only about 2-3m from the ground surface.

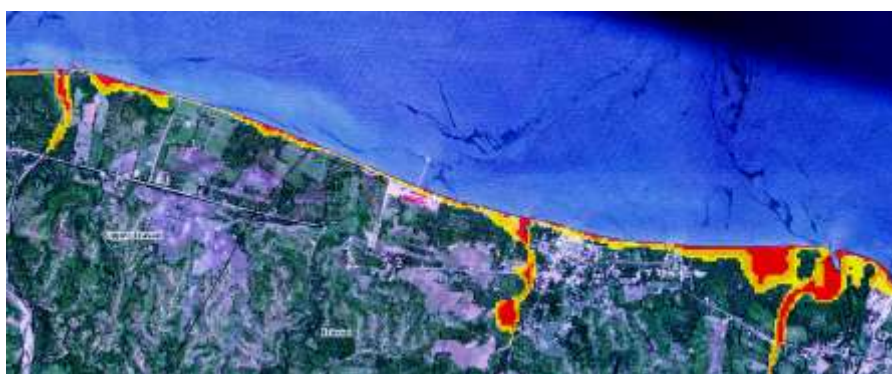
Figure 2-26 Storm Surge Hazard Map: Advisory 1 (2m)

The municipality is particularly susceptible to storm surges as many of its barangays are located along coastal areas. This destructive phenomenon is defined by National Oceanic and Atmospheric Association as the abnormal rise in seawater level during a storm, measured as the height of the water above the normal predicted astronomical tide. This occurs as a result of strong winds which pushes the water onshore. The orientation of the coastline with the storm track, local bathymetry and intensity, size and speed of the storm are among the factors which dictate the amplitude of a storm surge. **Figures 2-26 to 2-29** show storm surge affected areas based on predicted storm surge height at 2, 3, 4 and 5 meters (m).

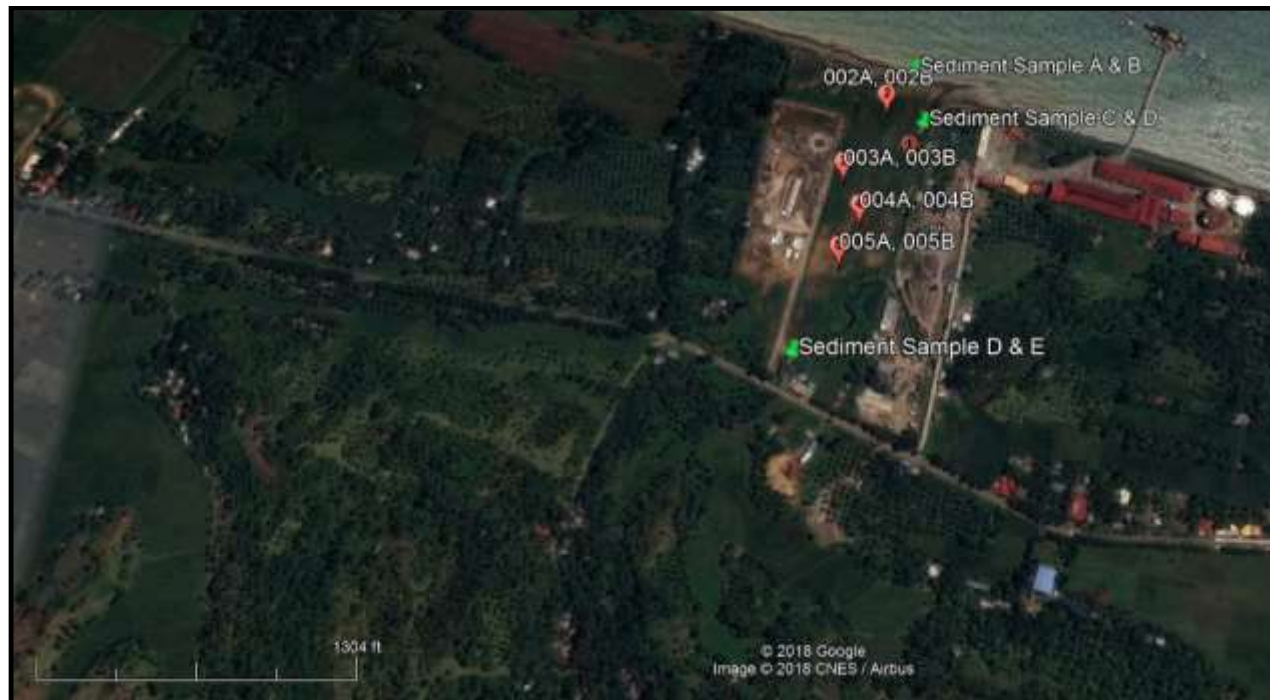
Figure 2-30 Sampling Location Map

A total of 10 soil samples in five (5) locations and six (6) sediment samples in three (3) locations were obtained during the field survey conducted on May 19, 2018. **Table 2-9** and **Table 2-10** summarize the location of soil and sediment samples within the project site. Soil test pits have depths of up to 1.4 meters while the other soil observation sites were collected from voids with depths of approximately 70 cm. Test pits with varying soil layers was noted and samples per layer were collected. The surface sediment samples were collected from the coastal area, north of the project site. **Figure 2-30** shows the locations of the different sediment sampling sites and the soil test pit sites. Approximately 3.5 kilograms of sample were collected per site and kept in thick plastic bags tied with a straw and labelled accordingly

Location	Sample Names	Northing	Easting
North/ Coast of site	Petra Sediment A	8°31'32.46"	123°13'5.43"
	Petra Sediment B		
Northeast of Creek	Petra Sediment C	8°31'29.30"	123°13'5.72"
	Petra Sediment D		
South of creek (near roadside)	Petra Sediment E	8°31'17.38"	123°12'59.37"
	Petra Sediment F

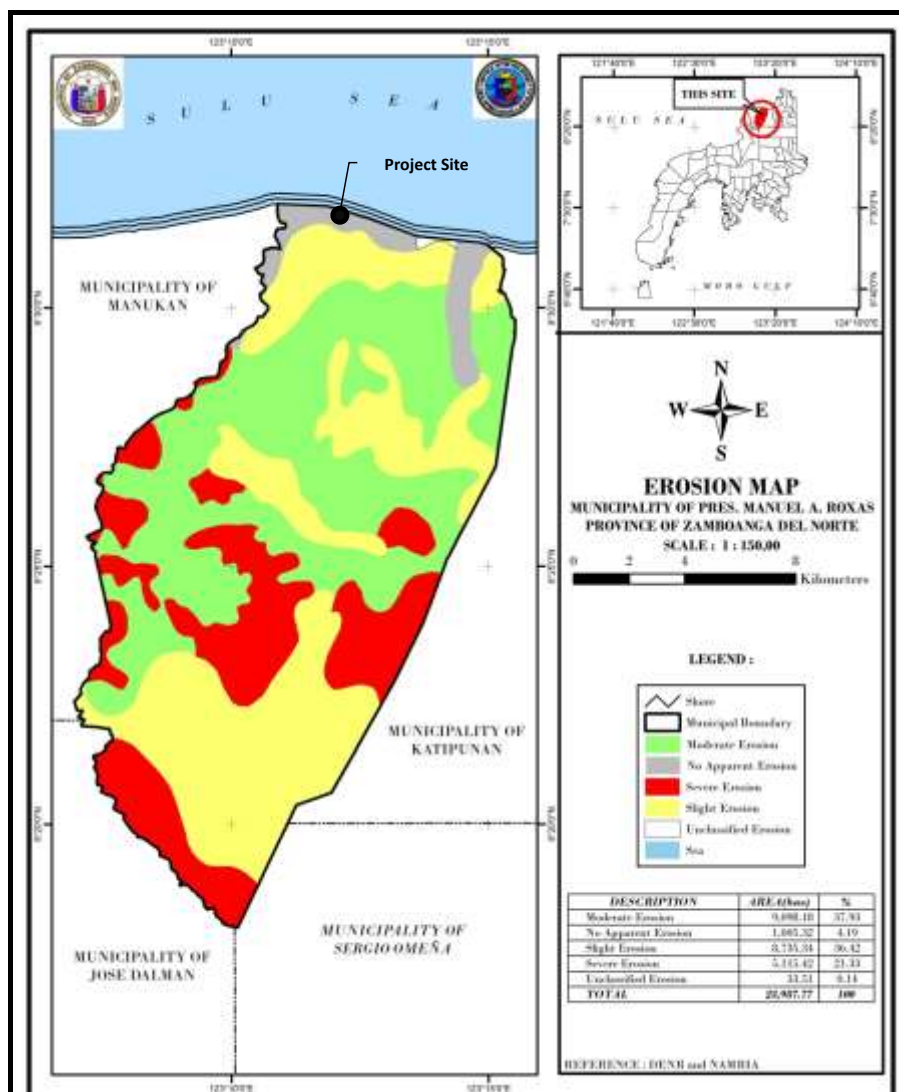
Figure 2-32 Erosion Map of the Municipality of Pres. Manuel Roxas

The site in general has no apparent erosion (**Figure 2-32**). However, the proposed cement finishing plant will entail land development of the project footprint. As construction and development progress, disturbance of the top soil and subsoil will occur. The exposed top soil will be prone to rill erosion if left unprotected. Steep cuts will be unstable and become prone to erosion.
