ENVIRONMENTAL PERFORMANCE REPORT AND MANAGEMENT PLAN (EPRMP)

CEMENT FINISHING PLANT PROJECT

BARANGAY LOWER IRASAN, MUNICIPALITY OF PRES. MANUEL A. ROXAS

JULY 2018

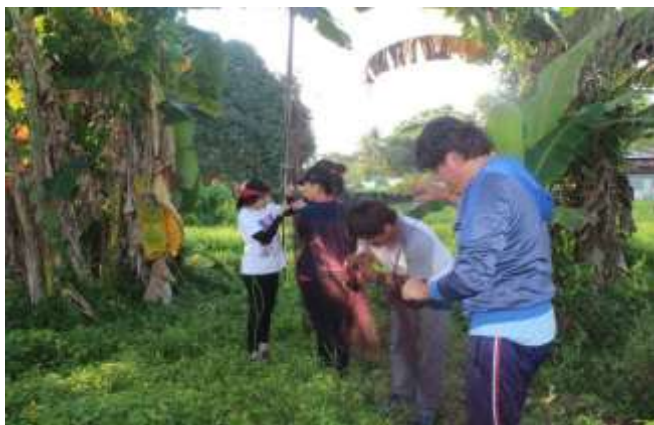
Photo No. 2E Mist-netting method for avifaunal and volant fauna.

Sampling for Volant mammals was conducted using mist nets (see photograph above). The nets were placed along travel lanes of bats at dawn and checked every 8 hours. In each station at least two mist nets measuring 4 m x 12 m with 36 mm mesh size were installed near fruiting trees, in ridge tops or probable flyways. Bats were identified using the Key to Philippine Bats (Ingle and Heaneys, 1992). Captured bats were removed individually and were placed in temporary holding receptacles such as cloth bags. After documentation, bats were revitalized with sugar solution and released back into the wild.

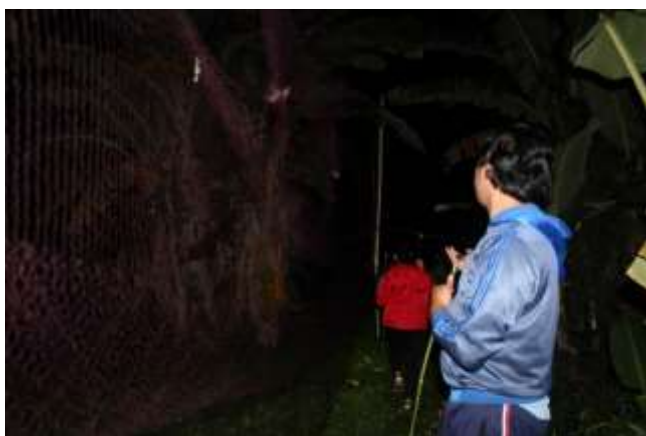
Photo No. 2F Setting up of mist nets for avifaunal and volant fauna.

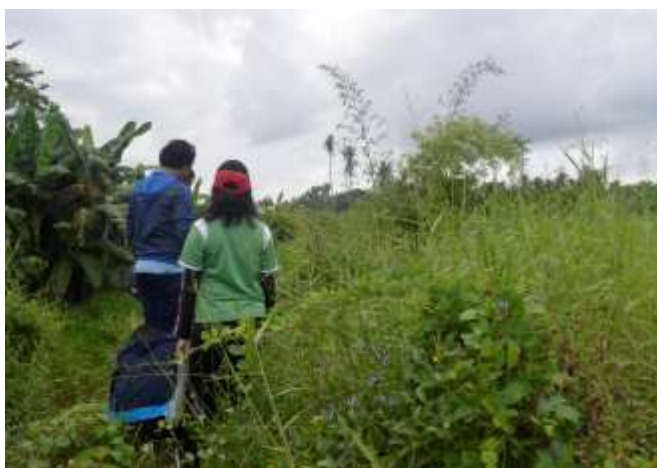
Photo No. 2H Setting up cage traps for non-volant mammals in one of the study areas.

Non-Volant mammals were sampled using live traps and key informant surveys. Traps were set up at about 6:00 in the evening and were checked every four hours until morning. Peanut butter and dried fish were used as bait to attract small non-volant mammals roaming at night and during the day. Traps were positioned along possible runways, near burrow entrances, under root tangles, on top of fallen logs and other probable faunal corridor. Mammals that were trapped in the cage were subjected to basic morphometric measurements and were released thereafter. Identification was based on A Synopsis of Mammalian Fauna of the Philippine Islands by Heaney et al (1998).

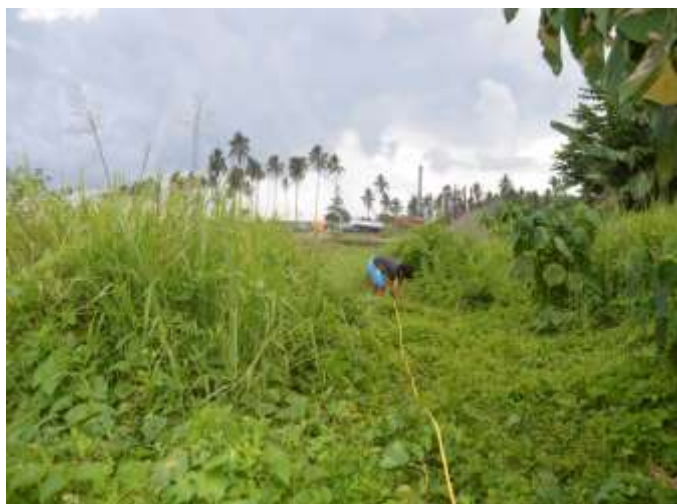
Photo No. 2I Transect-line used in the flora survey.

Flora surveys were conducted using transect- line method. In each station a 50 m line is laid across the sampling stations. All tree species intercepted along the transect with height greater than 4m were identified and counted. Presence of shrubs and grasses were also identified, a 1x1 m quadrat was established within each transect. Sampling collection was minimized hence identification of plants was done on the field. Field information regarding the taxonomic characters of each plant species were recorded. Photographs were taken using a digital camera for further identification and rechecking of the identified species. Identification and Conservation status of each species was based on the following relevant references: Merrill (1926); Zamora, P. and L. Co. (1986); Madulid (1995, 2001) and Van Balgooy (1997, 1998).

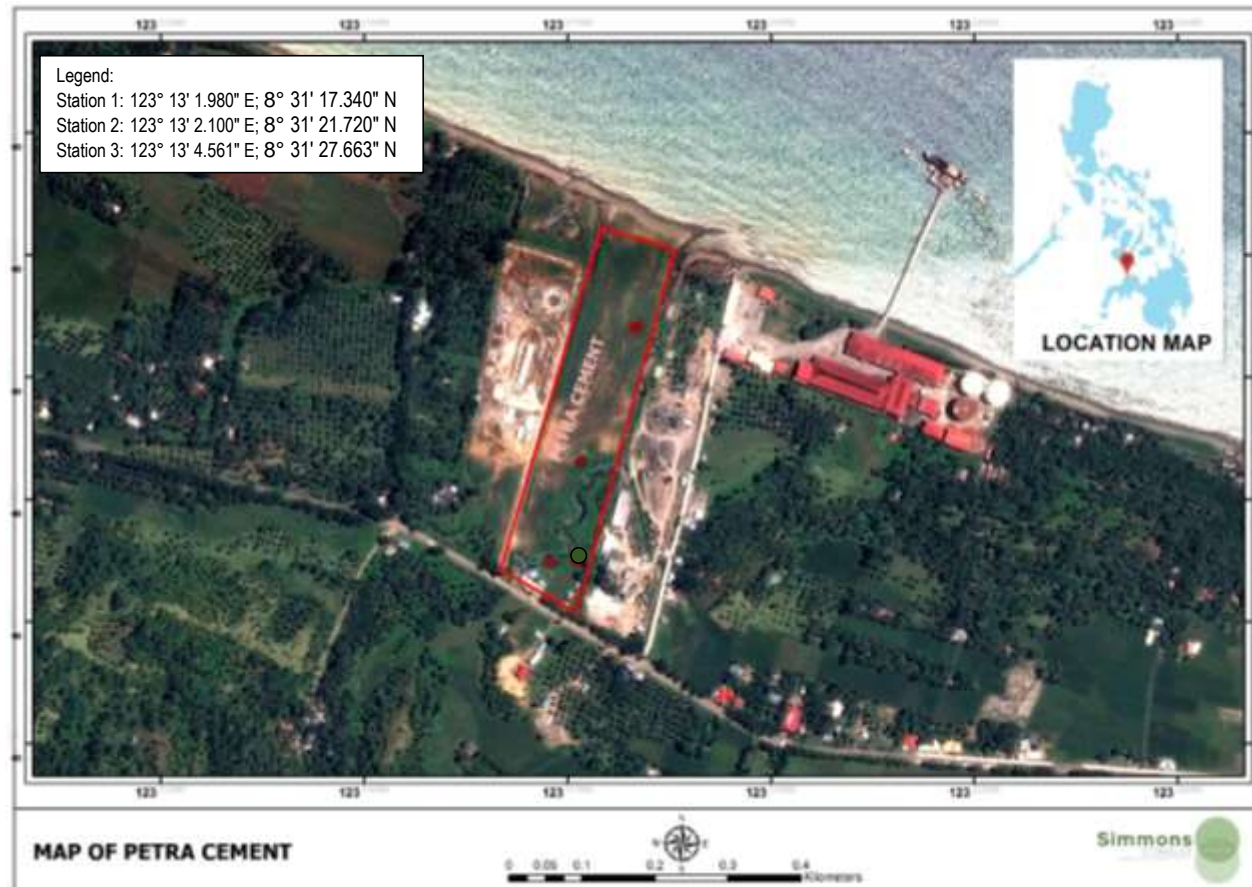
Figure 2-33 Map of the Site for Terrestrial Study

This assessment focuses on the study of terrestrial. Terrestrial Ecology encompass the land faunal and floristic assemblages. All the stations established and sampled are within direct impact areas; secondary impact areas were not sampled due to the areas being privately owned. Figure 2-33 is a Map showing the project located in the Zamboanga peninsula.

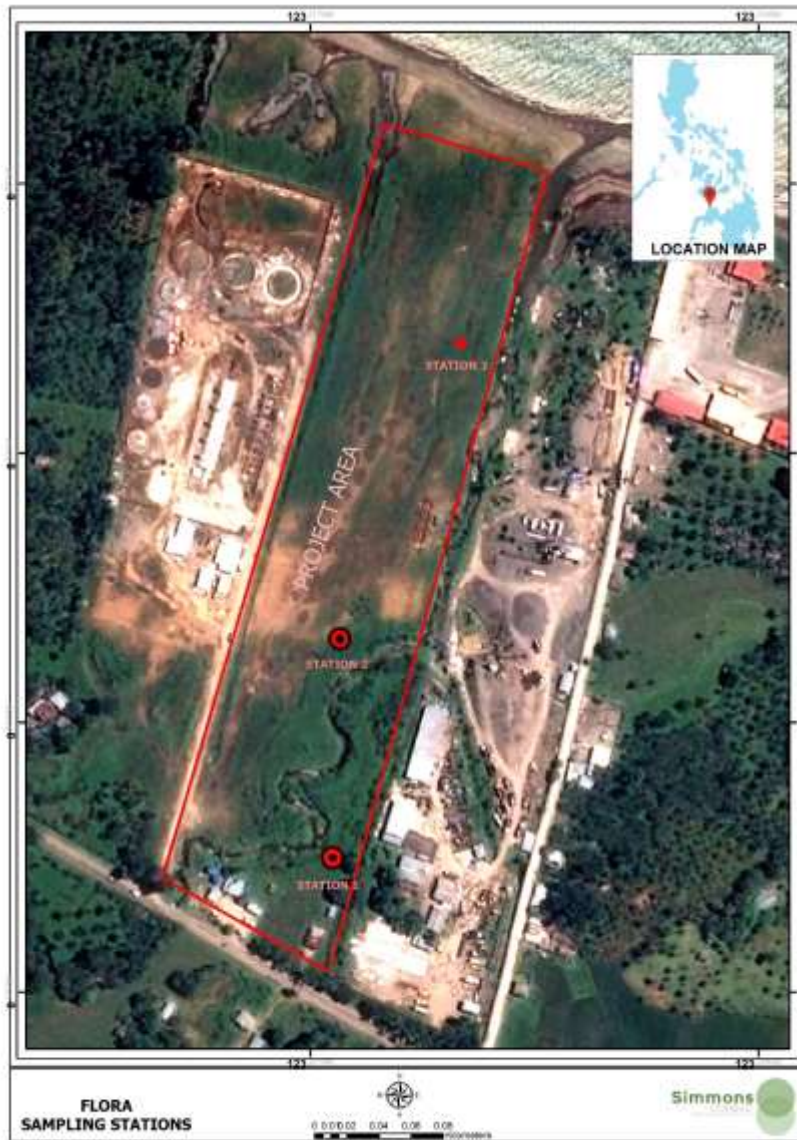
Figure 2-34 Project Site showing the flora stations in the study area.

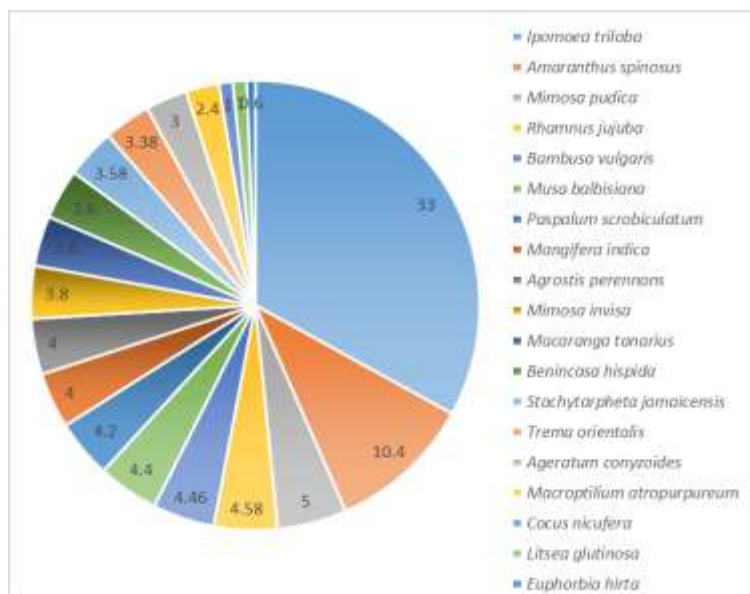
The figure below shows that *Ipomoea triloba* covers the most (33.40%) of the sampling area within station followed by *Amarantus spinosus* (10.40%), *Minosa pudica* (5.00%), *Ramnus jujuba* (4.58%), *Bambusa vulgaris* (4.46%), *Musa balbisiana* (4.40%), *Paspalum scrobiculatum* (4.20%), *Mangifera indica* (4.00%) and *Agrotis perennance* (4.00%).

Figure 2-35. Percent species cover of plants within Station 1

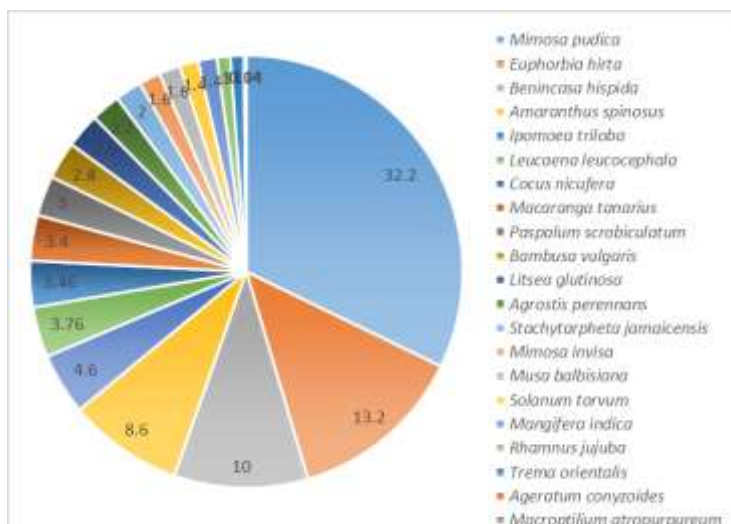
For station 2, the figure below shows that *Mimosa pudica* (32.20%) covers the most of the sampling area followed by *Euphorbia hirta* (13.2%), *Benincasa hispida* (10.00%), *Amarantus spinosus* (8.60%), *Ipomoea triloba* (4.60%), *Leucaena leucocephala* (3.76%), *Cocus nucufera* (3.46%) and *Macaranga tanarius* (3.40%).

Figure 2-36. Showing the percent species cover for station 2.

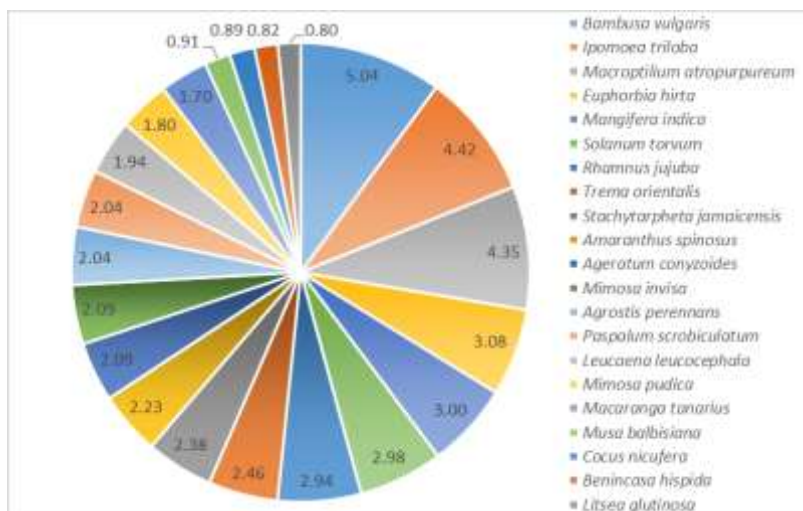
Kawayan killing (*Bambusa vulgaris* 5.04%) covers the most of the sampling area including *Ipomoea triloba* (4.42%), *Macroptilium atropurpureum* (4.35%), *Euphorbia hirta* (3.08%), *Mangifera Indica* (3.00), *Solanum torvum* (2.98) and *Trema orientalis* (2.46%). Other plant species recorded within the sampling station includes, *Amaranthus spinosus* (2.23%), *Ageratum conyzoides* (2.09%), *Mimosa invisa* (2.09%), *Agrostis perennans* (2.04%), *Paspalum scrobiculatum* (2.04%), *Leucaena leucocephala* (1.94%) etc.

Figure 2-37. Percent Species Cover of Plants within Station 3.

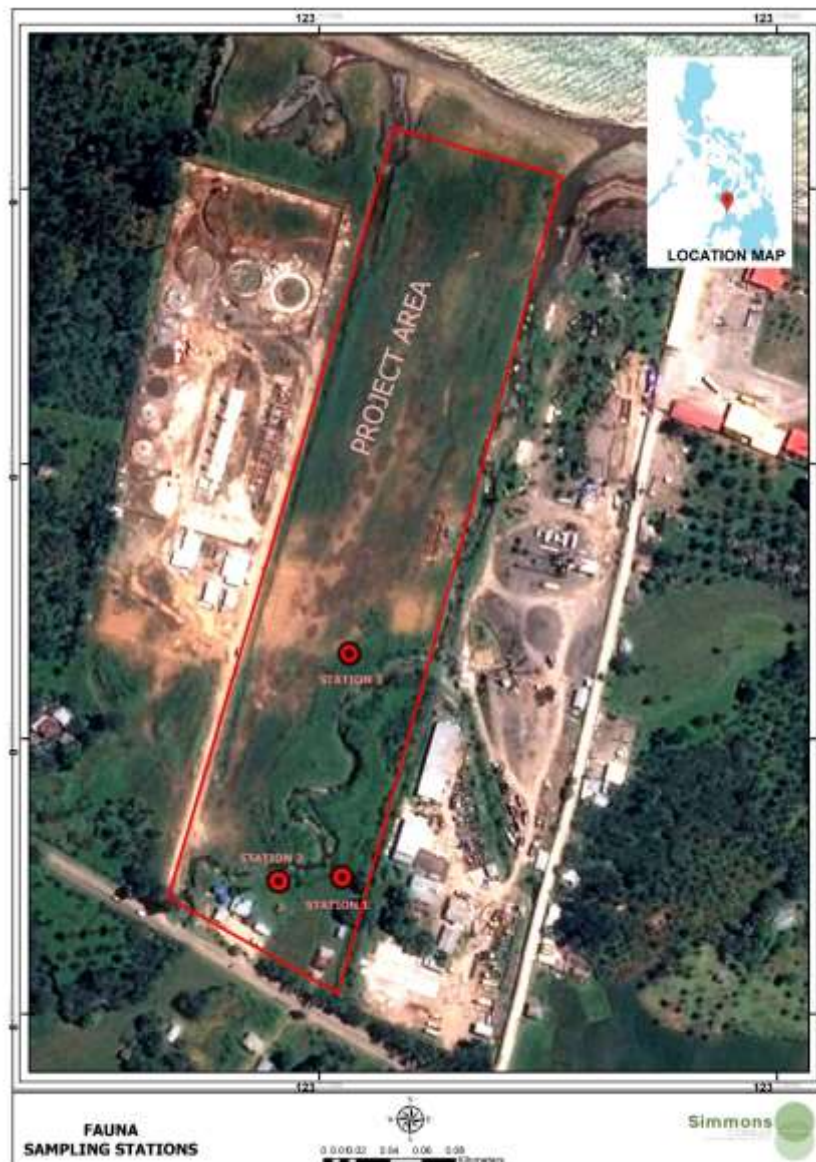
Figure 2-38. Visual representation of the sampling stations for Fauna in Petra Cement Inc.

Points No.	Coordinates	Elevation (ft)
Pt. 1	N 08°31.289' E123°13.033'	85.3
Pt. 2	N 08°31.358' E123°13.028'	36.1
Pt. 3	N 08°31.376' E123°13.059'	72.2
Pt. 4	N 08°31.418 E123°13.069'	62.3
Pt. 5	N 08°31.445 E123°13.083'	88.6
Pt. 6	N 08°31.481 E123°13.090'	23.0

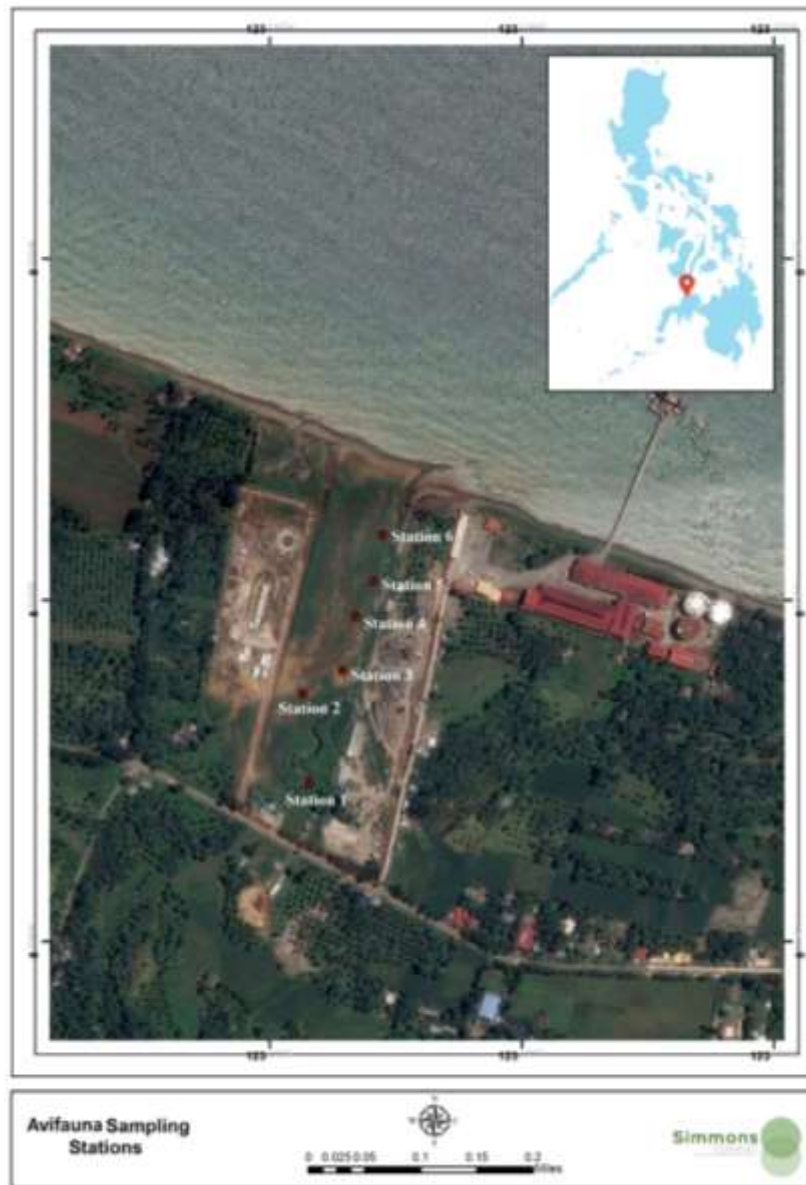
Figure 2-39. Visual Representation of the sampling Area for avifauna in Petra Cement Inc.

Points No.	Coordinates	Elevation (ft)	Elevation (m)
Pt. 1	N 08°31.289' E123°13.033'	85.3	25.99
Pt. 2	N 08°31.358' E123°13.028'	36.1	11.00
Pt. 3	N 08°31.376' E123°13.059'	72.2	22.00
Pt. 4	N 08°31.418 E123°13.069'	62.3	18.98
Pt. 5	N 08°31.445 E123°13.083'	88.6	27.00
. 6	N 08°31.481 E123°13.090'	23.0	7.01

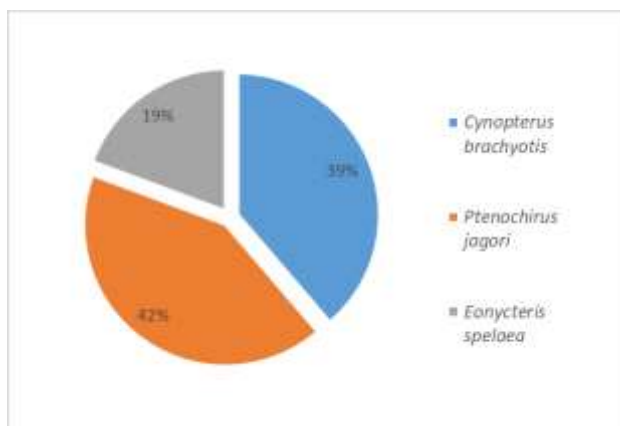
A total of sixty-three (63) bats were collected and identified during the sampling activity. These bats are resolved to 3 species under Family Pteropodidae. The most abundant species identified was *Ptenochirus jagori*. Such species is widespread and abundant with large population (IUCN). It is commonly found in lowland forest but also present in agricultural area. Although forest loss had caused decline on its population, but overall, it remains common and is not significantly threatened

Figure 2-40. Relative abundance of bats in Petra Cement Inc.

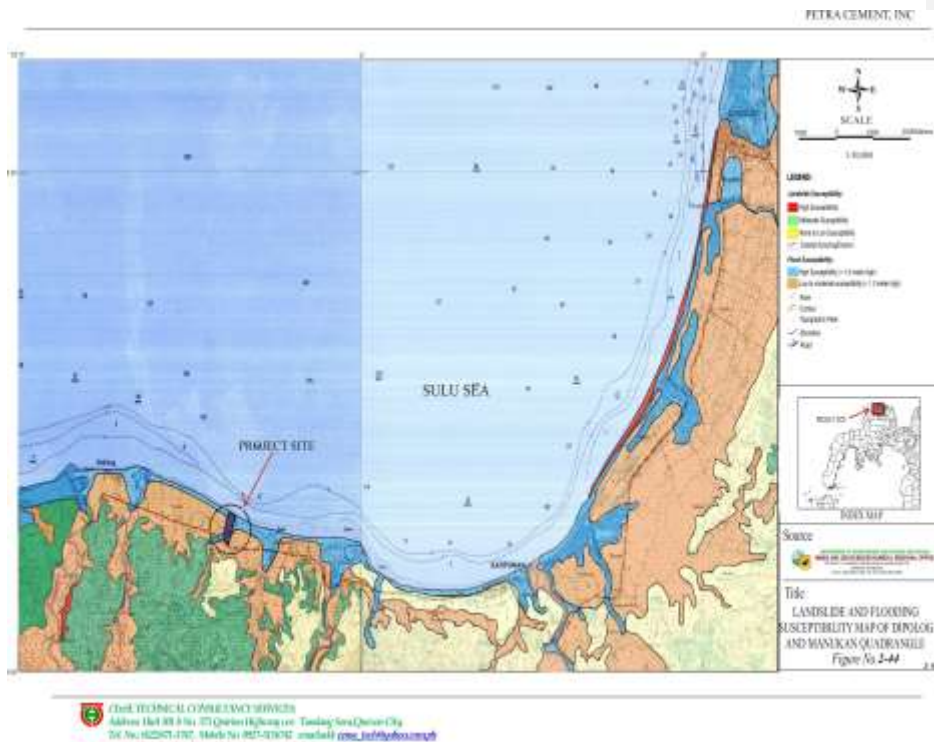
Figure 2-44 Flood Hazard

The proposed site is relatively a flood prone area due to the fact that the site is located adjacent to the coastal zone. The difference in elevation between the proposed project site ground surface and the current river water level ranges from 3.0m to <1.0m in the beach front. Height of the river water dramatically rises to cause overflowing from the river bank especially in times of extreme weather condition and intense precipitation. Based on the **Mines and Geosciences Bureau (MGB)** published flooding and landslide susceptibility map in 2010 suggests that the site is indeed prone to moderate to high flooding hazard (**Figure No. 2-44**).

The area is recommended to increase the elevation at a minimum of 4.0 meters. It is recommended that proper drainage shall be constructed during construction to divert the flow of run-off to the creek.

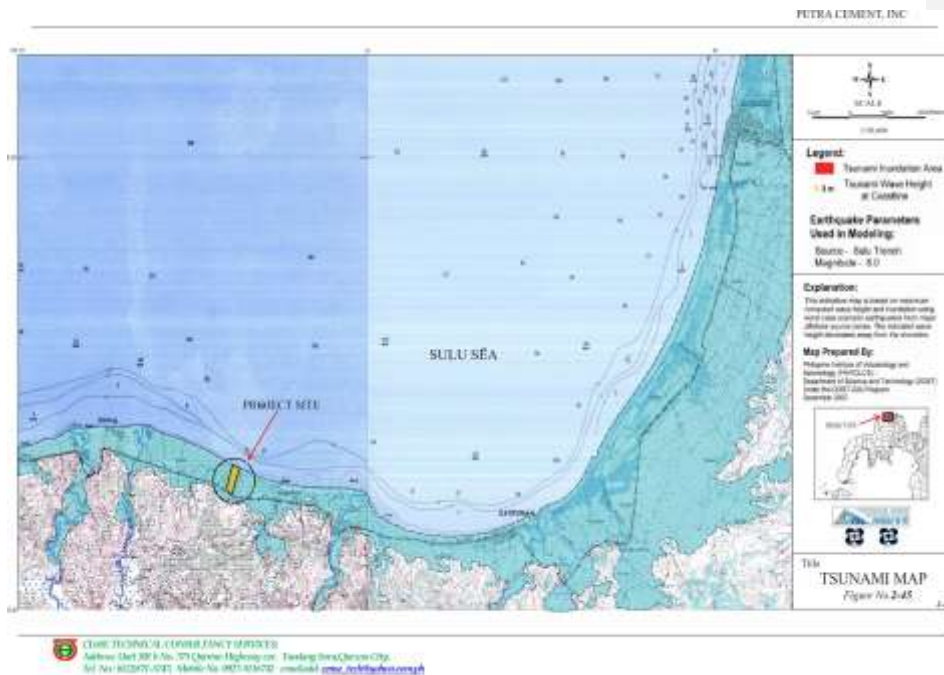
Figure 2-45 Tsunami

A **tsunami** or **tidal wave**, also known as a **seismic sea wave**, is a series of waves in a water body caused by the displacement of a large volume of water, generally in an ocean or a large lake. Earthquakes, volcanic eruptions and other underwater explosions (including detonations of underwater nuclear devices), landslides, glacier cavings, meteorite impacts and other disturbances above or below water all have the potential to generate a tsunami. Wave heights of tens of meters can be generated by large events such as Japan tsunami in 2011. Although the impact of tsunamis is limited to coastal areas, their destructive power can be enormous and they can affect entire ocean basins. The effects of possible tsunami occurrences that could reached the project may have a major effect based on the presently published Tsunami Map prepared by Phivolcs in 2007 (**Figure No. 2-45**).

As gleaned from the map, it appears that in case of Magnitude 8.0 earthquake from the Sulu Trench, a 3meter high tsunami will reached the western coasts of Zamboanga, and may result in a tremendous devastation could be expected particularly in Dipolog City. At the project site, such waves were predicted to force inland several kilometers from the shoreline. This natural hazard likewise reflects the damages it may inflict at the project site.

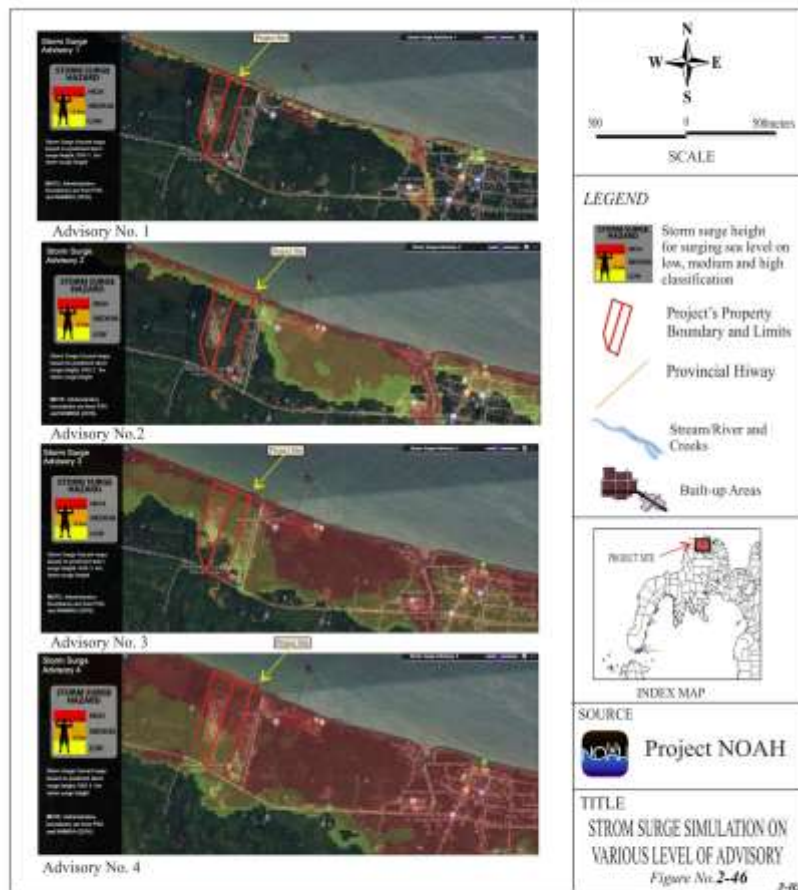
Figure 2-46 Project Noah

Project Noah is a government program that seeks to assist the country in disaster risk reduction and management, climate change adaptation and mitigation efforts and related activities through research, development and extension services. The Program was launched in 2011 after the aftermath of TS Sendong in Central Mindanao. One of the important function attached therein was to provide a 6-hour lead-time warning to agencies involved in disaster prevention and mitigation. In their official website, Noah depicts a simulated presentation of various level of warnings/advisories and its impacts during storm surge event (**Figure No. 2-46**). As shown, Advisory No. 2 and 3 indicates a probable severe impact of raising sea water to the project site.

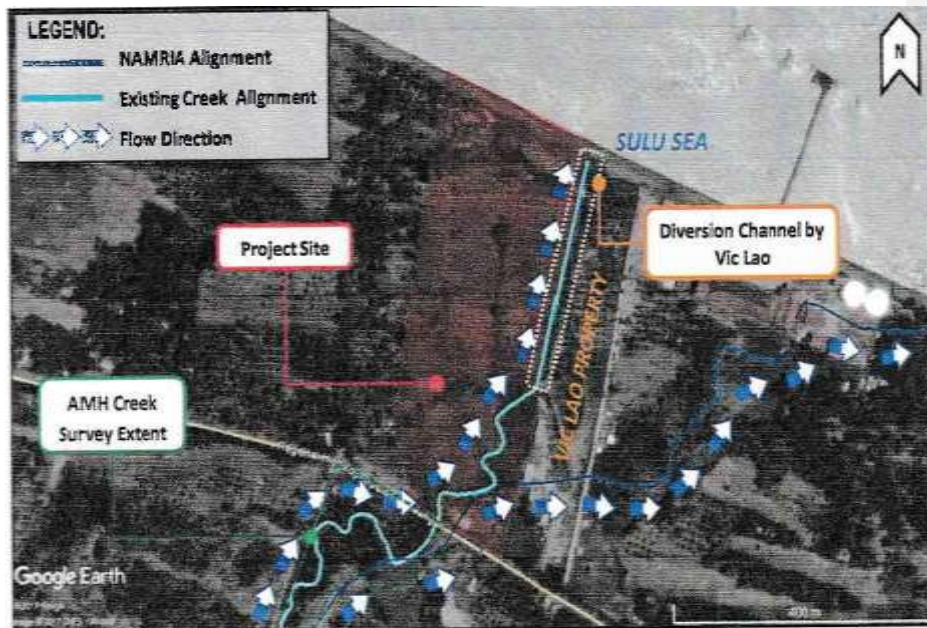
Figure 2-47 Existing Creek Alignment

Figure 2-47 shows the existing creek alignment and the alignment based on NAMRIA Map. Based on the survey conducted, the alignment of the waterway upstream of Irasan Bridge is no longer the same as its original alignment in the NAMRIA Map.

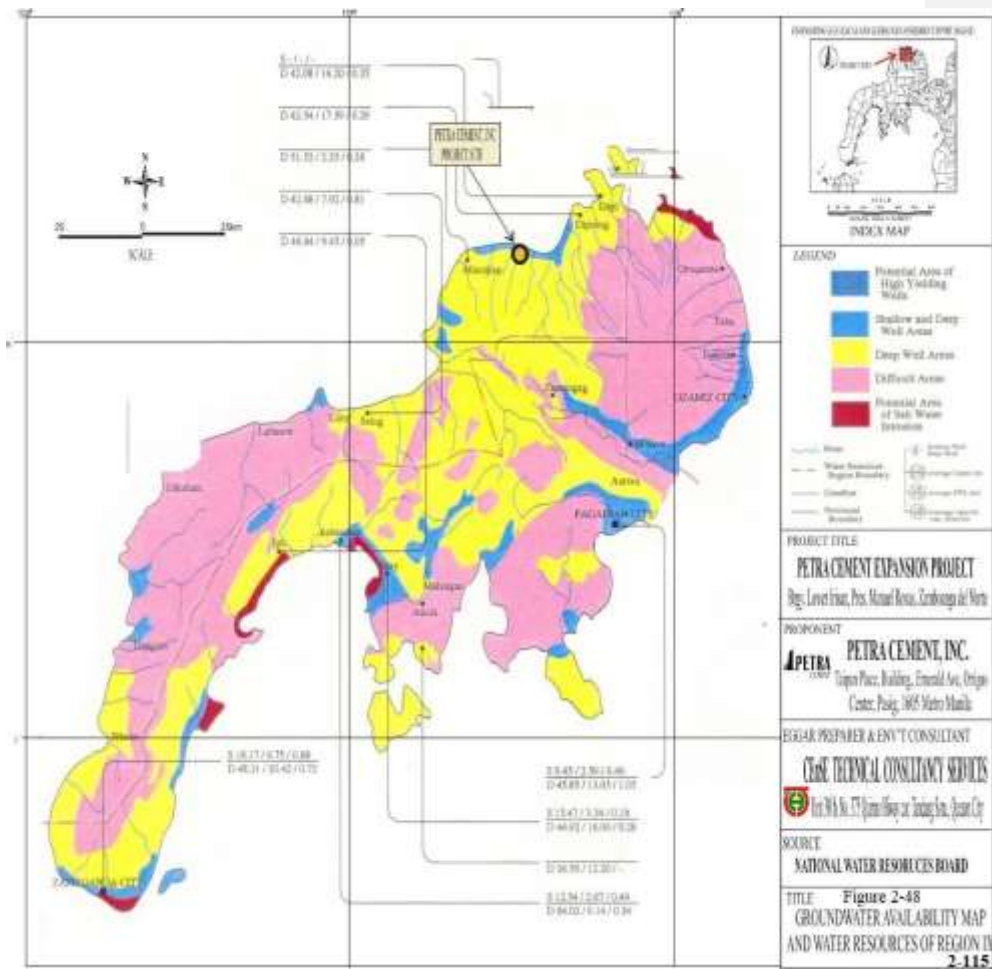
Figure 2-48 Groundwater Availability Map

b. Groundwater; It is define as water lies beneath the ground and had been exploited for domestic, livestock and irrigation. In groundwater, stored water are found in pore spaces between grains of sediment and in bodies of clastic sedimentary rock and in rock openings, cracks and crevices with sufficient quantities embedded on permeable layers and/or underground reservoir known as aquifers. Naturally emerging groundwater to ground surface in the form of water table spring or pumped from a well normally fills rivers, streams, lakes, ponds, and wetlands. Based on the topography and distribution of the major rock units, the area may be classified into two (2) distinct hydrogeologic units (*Figure).* These are: 1) hilly to mountainous areas that are underlain by slightly fractured and generally impermeable rocks which yield little or no groundwater (*localized with insignificant groundwater yield*); and 2) the coastal area underlain by the Quaternary Alluvium, which produce fairly to moderate amounts of groundwater (*fairly extensive to productive aquifers*).

Large portion of the project site are underlain by loose to dense alluvium deposits with water table at depth of 1.5m to 3.00mbgs (*LAGS drilling report, 2017*). This may implies the possible productive groundwater source in the area. Moreover, during the site investigation, majority of houses living nearby the site are supplied through individual shallow hand pumps or dug wells with very few houses are being tapped to the local water district. Although there been reports of abandoned wells due salt water contamination, the used of groundwater through pump tube well

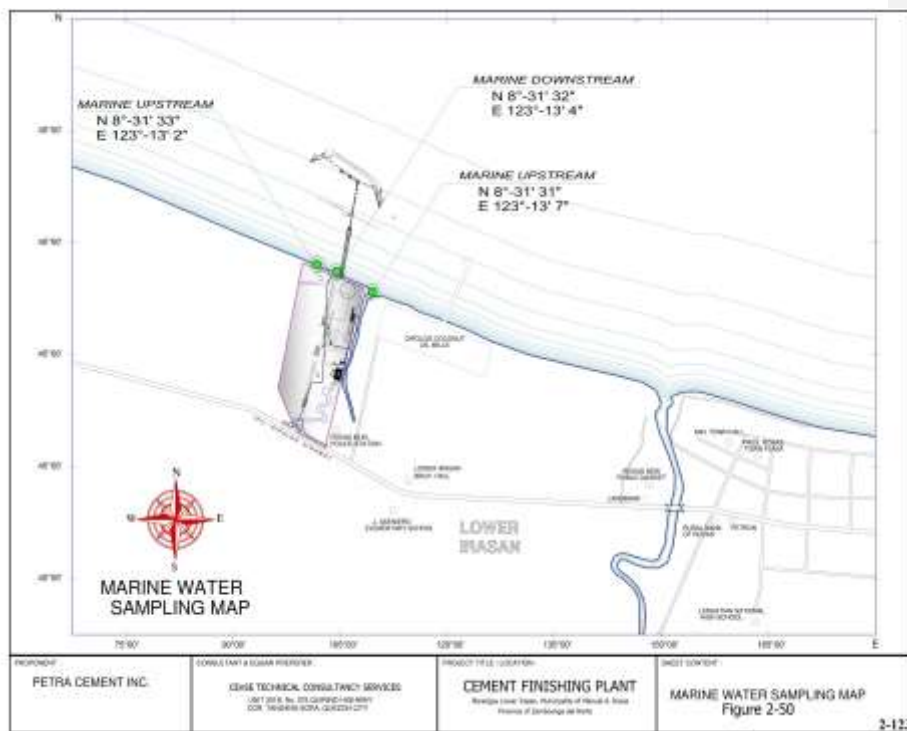
Figure 2-50 shows the Marine Sampling Map Station

Based on the marine water results, all three stations (except for pH at station MW1) are within the prescribed water quality guidelines with reference to DAO No. 2016-08 Class SC waters. Likewise, the surface water results of all three stations are within the prescribed water quality guidelines with reference to DAO No. 2016-08 Class C waters. On the other hand, there is no limiting concentration for COD and total coliform both for marine and surface waters, **Figure 2-50 shows the Marine Sampling Map Station.**

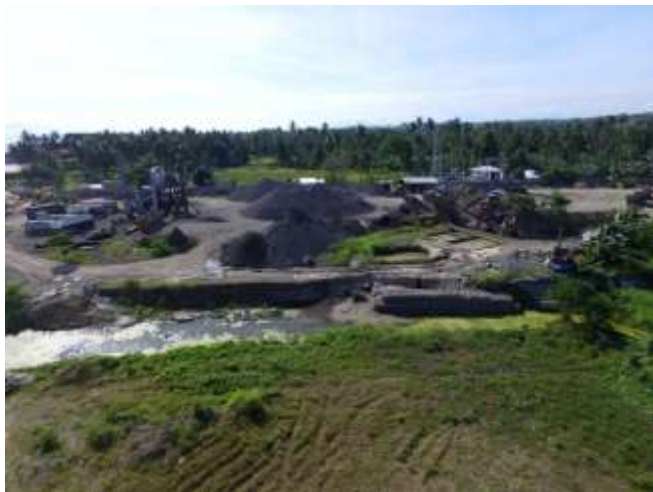
Unlike the first station, the second station has less diversity of vegetative cover. Grasses dominated the area and bank erosion is more conspicuous. To avoid further damage, riprap was installed along the creek but does not sufficiently covers all erodible areas. Station 2 has also stagnant waters with algal blooms. A sewage outlet from the other plant was observed to be connected to the creek.

Photo No. 2NN. Station 2 of Tanalan creek

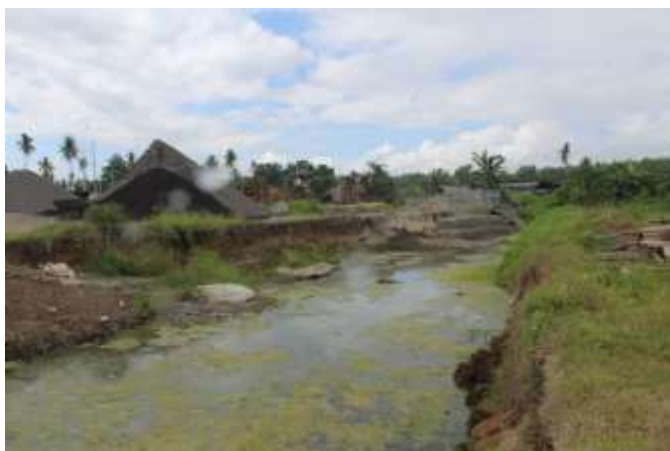
Photo No. 2-00. Station 2 of Tanalan creek, algal blooms evident.

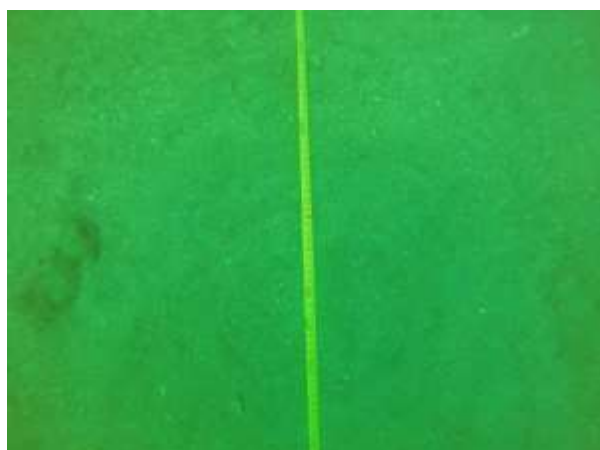
The transect-quadrat method was used in the assessment of seagrass in the area. In each station two (2) 50m transect lines were placed perpendicular to the shoreline and are spaced at 40 meters apart from each other. In each transect line 2 replicate quadrats (0.25m x 0.25m) that are divided further into 25 smaller squares were placed along each transect line at 10m intervals. Seagrass species present in the quadrat were identified, percent cover were estimated and recorded using the SeagrassNet percentage cover photo guide which is based on the methods of Short et.al (2006). Species identification and classification were based on pictures and descriptions on references from Calumpong and Menez (1997) and Philipps and Menez (1988). A 0.5m x 0.5 m quadrat was used to estimate the percent cover for all species of seagrass.

Photo No. 2ZZ. Transect line method used in seagrass assessment

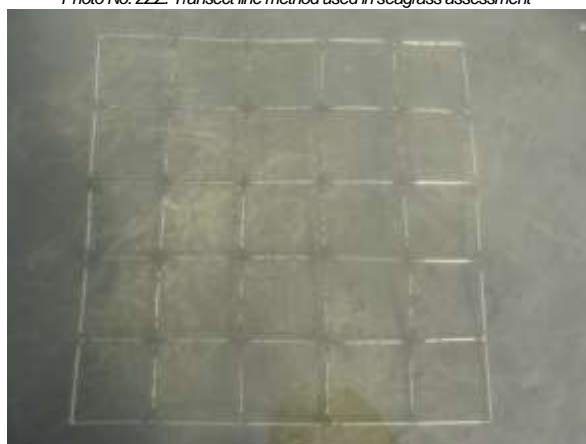
Density of each species of seagrass will be determined using a non-destructive technique by counting each seagrass shoot within each quadrat. For *Enhalus acoroides* species, density will be directly counted within the 0.5 x 0.5 m quadrat. Sub-sampling for density using one 0.25 x 0.25 m quadrat will be used for the density of the smaller seagrass species such as *Thalassia* sp., *Cymodocea* sp., *Halodule* sp. And *Halophila* sp. (PCA manual)

Photo No. 2AAA. Quadrat method used in seagrass and macroinvertebrate sampling

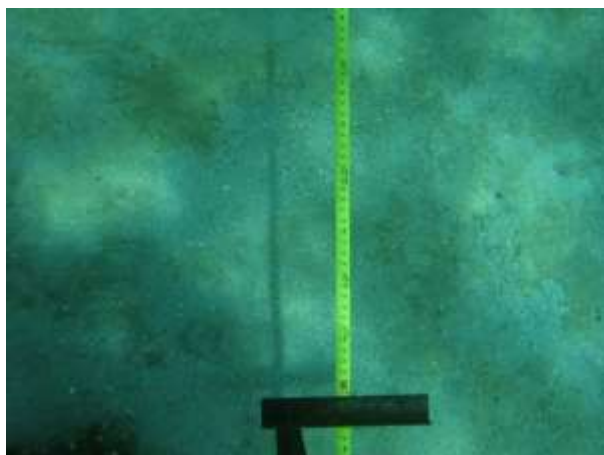
Video-Photo Transect survey technique was used to assess the sessile benthic community of the area using Self Contained Underwater Breathing Apparatus (SCUBA). The percent cover of the major lifeforms in the reef was translated into status categories (Gomez et al., 1981) to indicate the reef's condition. Two (2) stations with a depth of 10m-60m were established using the Global Positioning System (GPS). In each station, a transect line was laid and videography was employed to record the corals present. Identification of corals was based on the references: Veron (1993) and Allen and Steene (1999). Benthic categories identified include soft corals and hard corals

Photo No. 2AAA-2. Video-Photo Transect method used in Coral assessment.

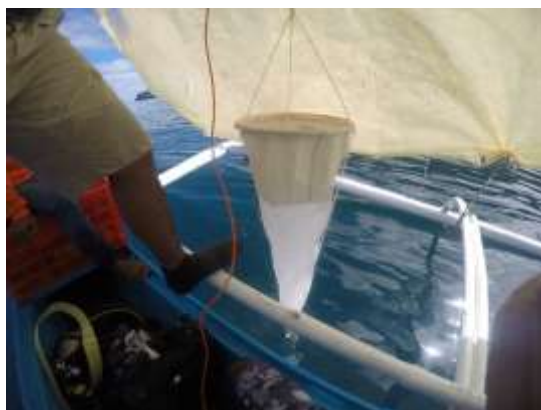
A plankton net with a hoop radius of 15cm and a porosity of 0.44 mm was used. The net was towed vertically from 20 meters depth. Three replicate samples were collected per station. The samples were collected from the bucket into 250ml dark bottles with equal volume of five percent buffered formalin. The samples are then brought to the laboratory for identification and counting. Each 1ml sub-sample was placed on a Sedgewick rafter at a time for identification and counting. A binocular or compound microscope (4x and 10x) was used for said purpose. Taxonomic identification is based on the external morphological structures using Yamaji (1977) and Newell & Newell (1967) as references

Photo No. 2AAA-3. Deploying of the Plankton net used in the coastal area of Petra Cement.

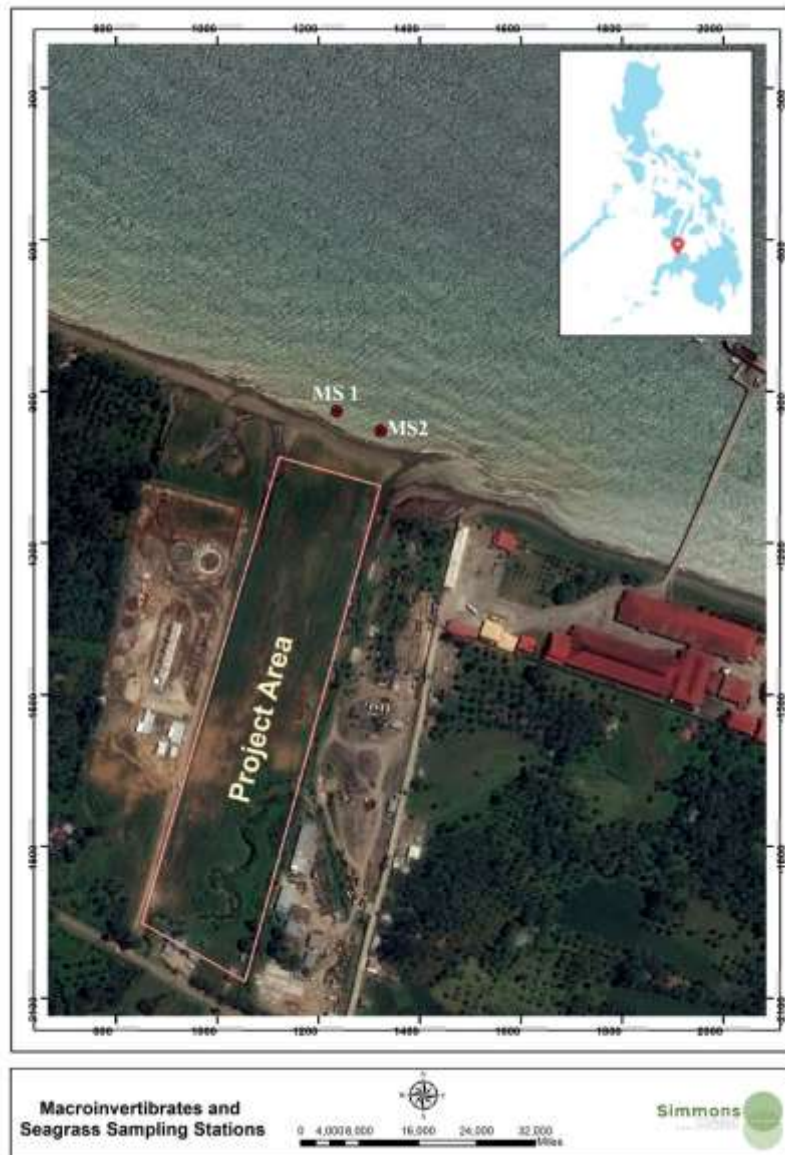
Figure 2-59B Seagrass and Macrobenthic invertebrate stations in Petra Cement Inc.

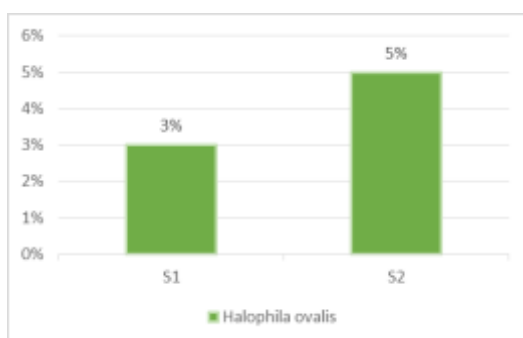
Average cover of *Halophila ovalis* in the coastal area of Petra Cement is between 3%-5%. Station 2 had a higher cover of 5% as compared to station 1 with 3%.

Figure 2-59 C Percent cover of *Halophila ovalis* in the 2 stations of Petra Cement ..

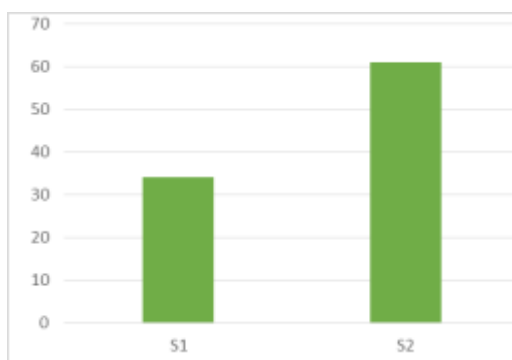
Average shoot density for Petra Cement is 47.5 shoots/m². Station 2 has a higher shoot density with about 61 shoots/m² compared to Station 1 with 34 shoots/m².

Figure 2-59 D. Shoot Density of *Halophila ovalis* .

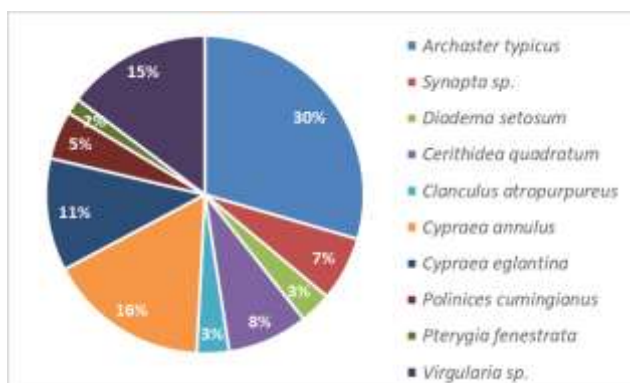
In station 2 the most abundant species of macroinvertebrate is *Archaster typicus* with 30% relative abundance followed by *Cypraea annulus* of about 16% and *Virgularia* sp. with 15% out of the total sampled macroinvertebrates. *Archaster typicus* is a species of sea star that is commonly found in sandy areas. The least abundant species in station 2 are *Pterygia fenestra* with 2%, *Clanculus atropurpureus* with 3% and *Diadema setosum* also with 3%.

Figure 2-59C. Relative abundance of macroinvertebrate species.

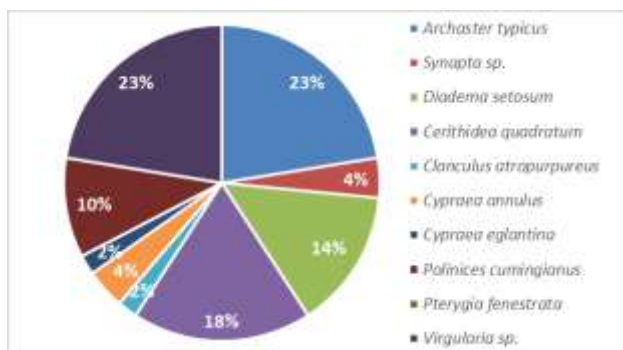
In Station 2 the most abundant macroinvertebrates are *Archaster typicus* and *Virgularia* sp. both with 23% relative abundance. *Virgularia* sp. is a species of seapen that is often found in tropical areas that are sandy, belonging to the same Phylum Cnidaria with corals. These anthozoan feed on plankton and has a peduncle that is submerged in the substrate for stability. Its axial polyp is usually purple and its feeding polyps are white. The least abundant species are *Clanculus atropurpureus* and *Cypraea eglantina* with a relative abundance of 2% each.

Figure 2-59D. Relative abundance of macroinvertebrate species .

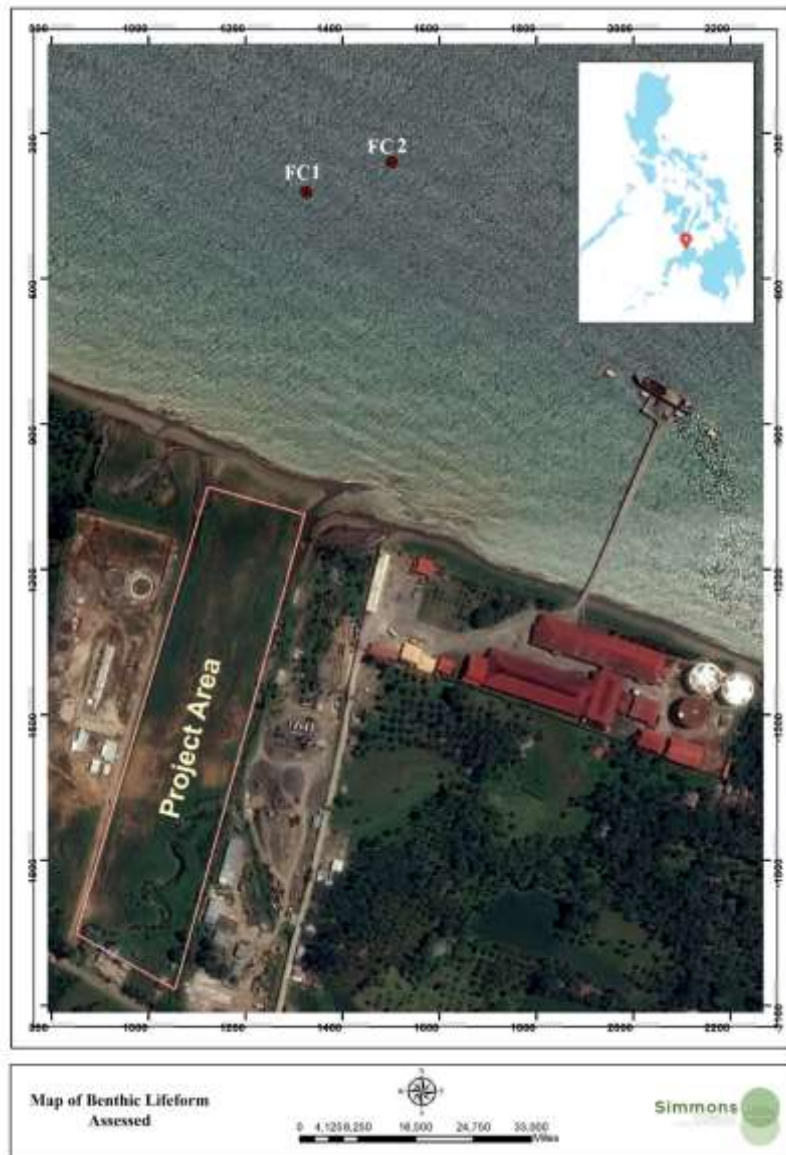
Two (2) sampling stations were established in the coastal area of the project site. From the coast the divers dived to identify the coral areas but no corals were found within the areas. Station 1 (S1) is located westward near the waters of the petroleum depot and Station 2 (S2) at the east near the waters of the construction firm. Dived stations were estimated 200 meters from the beach area of Petra Cement.

Figure 2-59E. Sampling stations where benthic lifeform assessment was conducted.

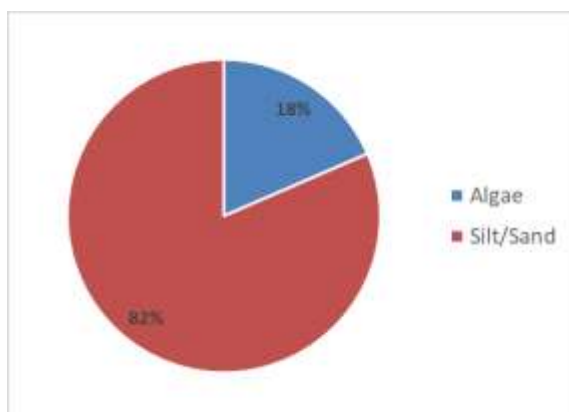
The assessed areas are composed of abiotic mixture of sand and silt that covers 82% of the substrate. Followed by Algae that covers around 18 % only a species of algae *Enteromorpha* sp. is present in both stations covered.

Figure 2-59F. Average percent Cover of benthos.

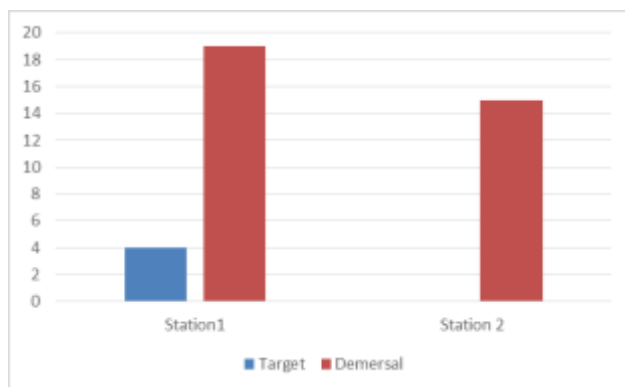
Figure 2-59G. Total demersal and target fishes identified in the 2 sampling stations.

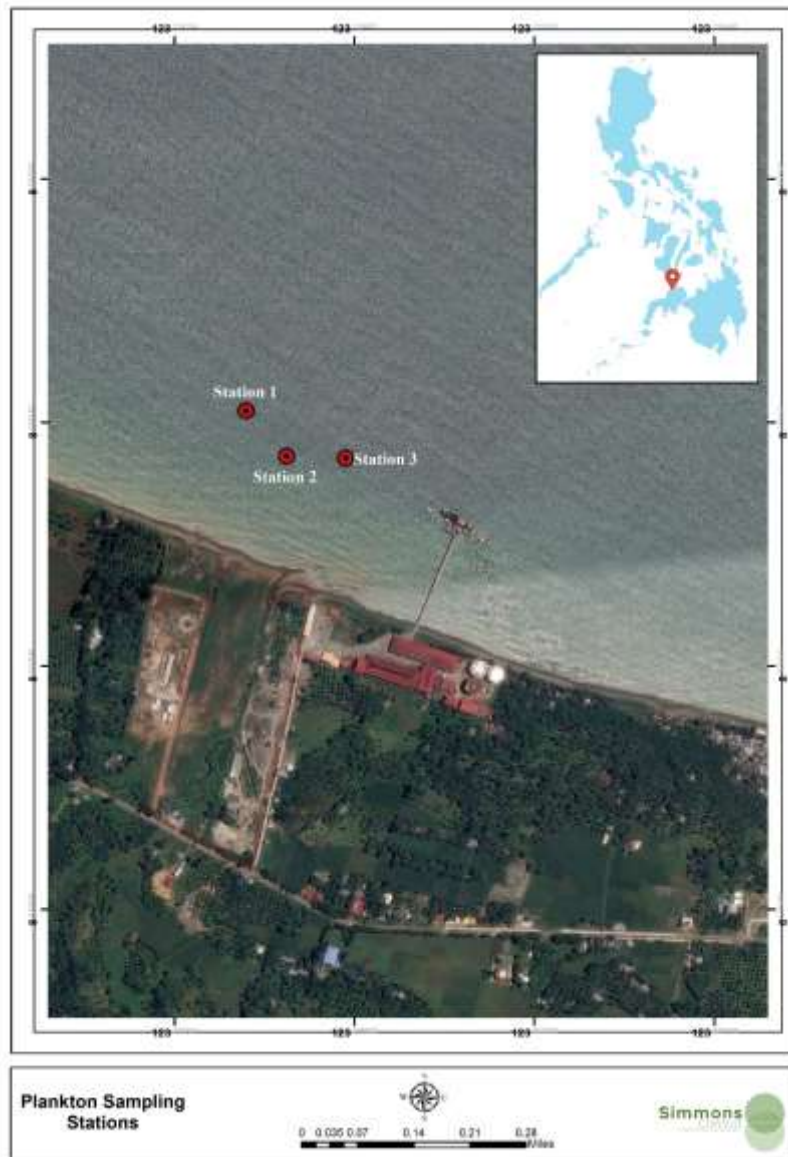
Figure 2-59H. Map of the plankton sampling stations in Irasan.

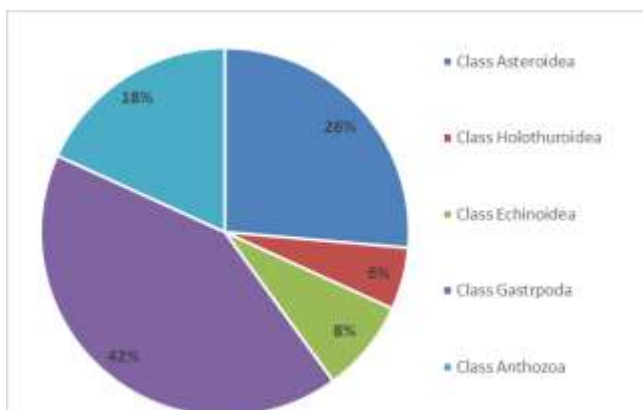
Figure 2-59K. Relative abundance of macroinvertebrates per class in the coastal area of Petra

A total of 110 macroinvertebrates individuals were collected and were classified into 10 species. These species belonged to 5 classes and further in 3 Phyla. The most abundant macroinvertebrates identified belonged to Class Gastropoda which can be characterized by a single shell as represented by *Cypraea annulus* with 42% followed, Class Asteroidea where sea stars such as *Archaster typicus* were abundant with 26%. Class Anthozoa had a relative abundance of 18%, Class Echinoidea where species of *Diadema setosum* were most abundant. The least abundant macroinvertebrates were identified under Class Holothuroidea with 6%.

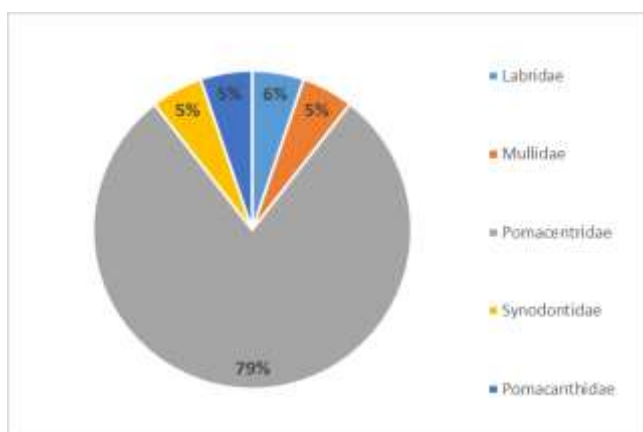
Figure 2-59L. Relative abundance of fishes families.

The figure below is the fish abundance of the five families identified. The most abundant family of fishes belonged to Family Pomacentridae with 79% fishes followed by Labridae with 6% while the least abundant families belong to Mullidae, Pomacanthidae and Synodontidae all with an abundance of 5% as shown in the figure below.

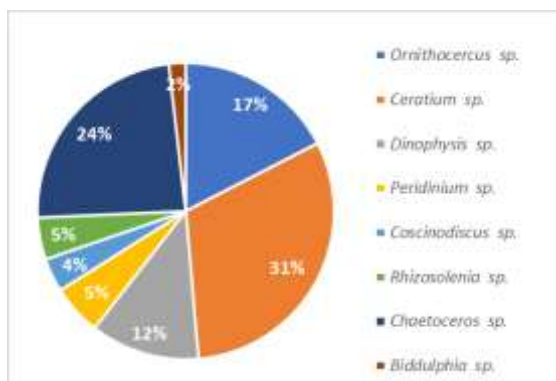
Figure 2-59M. Relative abundance of Phytoplankton in Station 1 of the coastal area of Petra cement.

A total of 654 phytoplankton were counted in station 1 that were identified into 8 species. As discussed earlier phytoplankton identified composed of diatoms and dinoflagellates. The most abundant species of phytoplankton was the species *Ceratium* sp. a dinoflagellate with 31% followed by a diatom *Chaetocerus* sp. with 24% and *Ornithocercus* sp. with 17% relative abundance. The lowest phytoplankton relative abundance belonged to the diatom *Biddulphia* sp. with 2% followed by another diatom *Coscinodiscus* sp. with 4% and both dinoflagellates *Dinophysis* sp. and *Peridinium* sp. with 5% relative abundance each.
