ENVIRONMENTAL PERFORMANCE REPORT AND MANAGEMENT PLAN (EPRMP)

CEMENT FINISHING PLANT PROJECT

BARANGAY LOWER IRASAN, MUNICIPALITY OF PRES. MANUEL A. ROXAS

JULY 2018

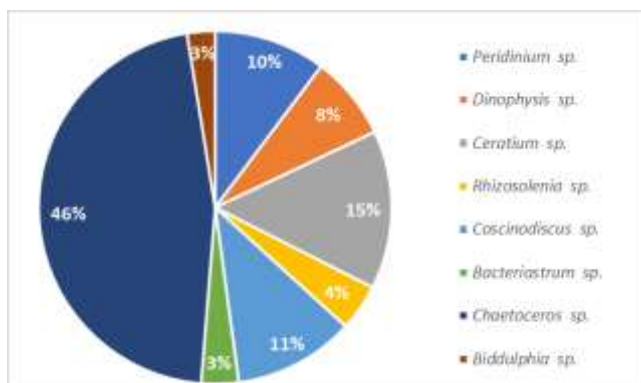
Figure 2-59N. Relative abundance of Phytoplankton in Station 2 of Petra cement.

A total of 702 phytoplankton were counted in station 2 that were identified into 8 species. Compared to Station 1, this station has more phytoplankton but still has the same number of species identified. The most abundant species is a centric diatom *Chaetoceros* sp. comprising 46% of the relative abundance for the whole station followed by *Coscinodiscus* sp. 11% and a dinoflagellate *Peridinium* sp. with 10% abundance. The lowest relative abundance for the whole station belonged to *Biddulphia* sp. and *Bacteriastrium* sp. which both having a relative abundance of 3% followed by the only pennate diatom identified *Rhizosolenia* sp. with 4%.

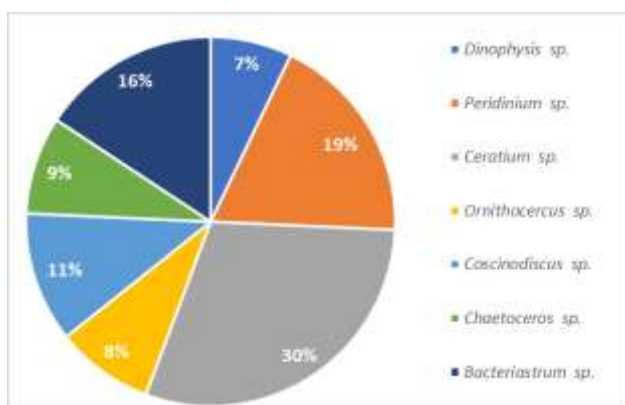
Figure 2-500. Relative abundance of Phytoplankton in Station 3 of Petra cement.

A total of 420 phytoplankton were counted in station 3 that were further identified into 7 species. Compared with the other 2 stations this station had the least number of phytoplankton counted and the least species identified with only 7. The most abundance phytoplankton for this station belonged to *Ceratium* sp. with 30% followed by *Peridinium* sp. with 19% and *Bacteriastrum* sp. with 16%. The lowest phytoplankton species identified in this station belonged to *Dinophysis* sp. a dinoflagellate with 7% followed by *Ornithocercus* sp. with 8% and *Chaetoceros* sp. with 9%.

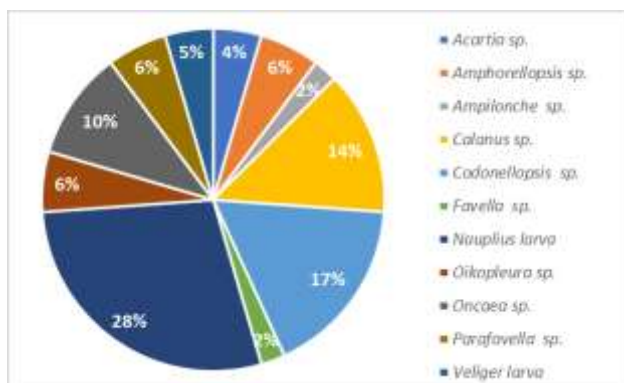
Figure 2-59P. Relative abundance of zooplankton in Station 1 of Petra Cement.

A total of 528 zooplankton were counted in station 1 that were identified into 11 species. The most abundant zooplankton in station 1 is under Phylum Arthropoda and identified as Nauplius larva the larval stage of most copepods with 28% followed by a protozoan tintinnid *Codonellopsis* sp. with 17% and another copepod *Calanus* sp. with 14%. The least abundant zooplankton in this station belongs to *Ampilonche* sp. the only radiolarian under Phylum Protozoa identified in the area with 2% followed by *Acartia* sp. with 4% and the veliger larval stage of gastropods with 5%.

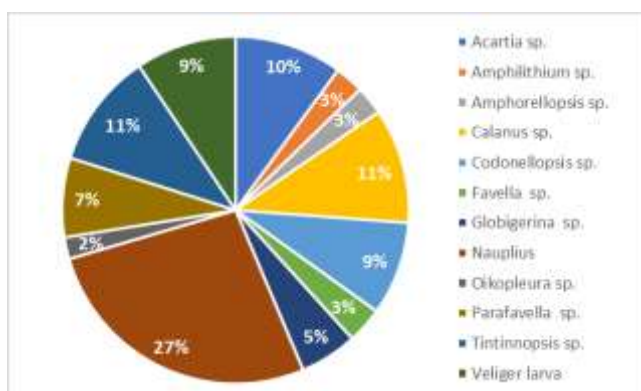
Figure 2-59Q. Relative abundance of zooplankton in Station 2 of Petra cement.

Zooplankton counted in Station 2 totaled to 894 and were identified into 12 species. The most abundant species of zooplankton identified in this station is under Phylum Arthropoda represented by Nauplius larva the larval stages of most arthropods under order Copepoda. The second abundant zooplankton identified in the station belongs to *Tintinnopsis* sp. again a protozoan under order Tintinnopoda and *Calanus* sp. with 11%.

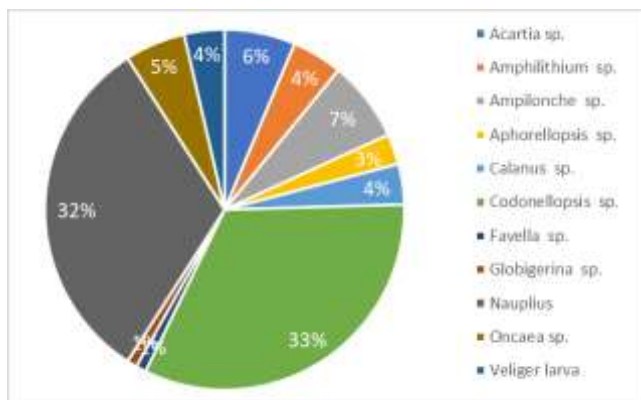
Figure 2-59R Relative abundance of zooplankton in Station 3 of Petra cement

A total of 660 zooplankton were counted in station 3 and were identified into 10 species. Among all the stations in the coastal area of Petra cement, station 3 had the least zooplankton species identified with only 10 and the second to Station 2 in terms of zooplankton counted. The most abundant zooplankton identified is *Codoneilopsis* sp. a protozoan with 33% followed by Nauplius larvae with 32%. The least abundant zooplankton are *Favella* sp. and *Globigerina* sp. both with a relative abundance of 1%.

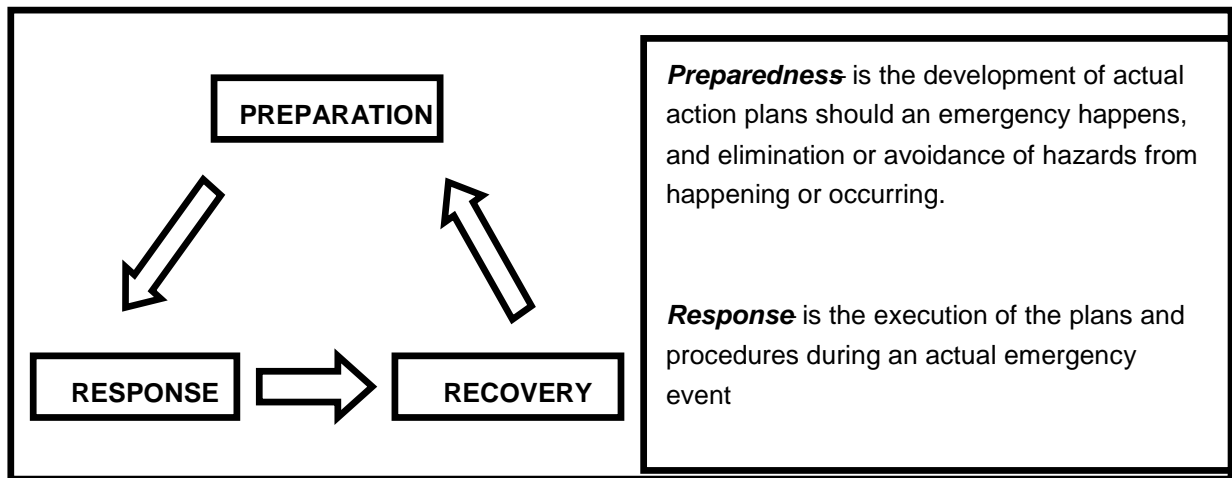
Figure 4-1 Emergency Response Plan Diagram

The proponent will devise and implement Emergency Response Plans (ERPs) to avert or decrease the likelihood of accidents from occurring. It will also provide the proponent to the appropriate strategy on responding to critical situations, which will minimize loss of life and property, and finally, on doing the necessary recovery efforts should an emergency does happen. This principle is summarized in Figure below or the Emergency Response Plan diagram, and further discussed in preceding **Table 4-1**.
