CHAPTER 1 PROJECT DESCRIPTION

1.1	PROJECT BACKGROUND	C1-1
1.1.1	Background of the Project	C1-1
1.1.2	Profile of the Proponent	C1-1
1.1.3	History of the Project	C1-1
1.2	PROJECT LOCATION AND AREA	C1-3

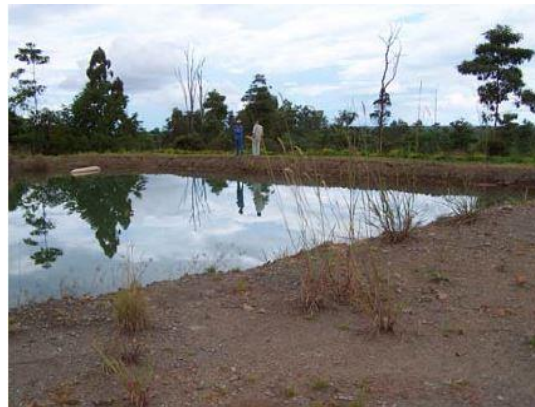
Plate 1.5.3. A view of the 300,000 cu. M. water reservoir

Source	Water Requirement		Permits Issued by NWRB
	Wet Season	Dry Season (Additional source)	
East Ibelnan River Intake dam	9.2 MT/Min	7.7 MT/Min	Water Permit No. 17998
Upper Togpon Siltation Pond (433,175m ³)	3.8	3.23 MT/min (good for 60 days)	-
Water Reservoir in Togpon (300,000m ³)	-	4.4 MT/min (good for 60 days) Note: only 90% of the capacity can be consumed	Water Permit No. 17998
Total	13.0	15.33

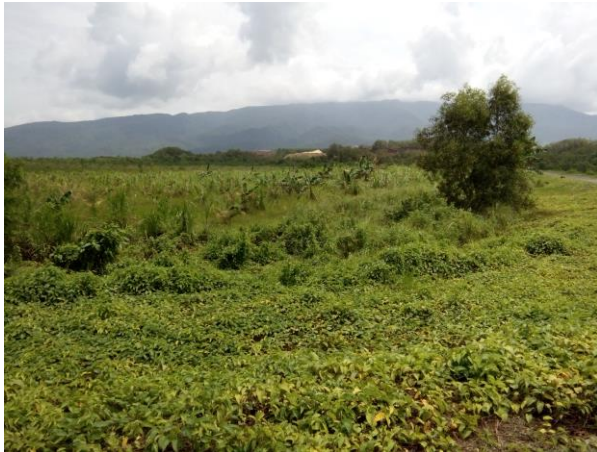
Plate 2.1.2. Panoramic view of the TSF1 taken from the top of the embankment (photo taken in July 2016)

CBNC has successfully implemented the rehabilitation of TSF1 and has submitted the rehabilitation plan for TSF2 once it has reached its full capacity. The Rehabilitation Plan for TSF1 basically covered the final measures to address soil erosion and possible collapse of the dam embankments and improvement of soil quality of the areas inside the TSF1 in order to facilitate plant regeneration and growth. Based on the data from CBNC the tailings were covered with topsoil and carbonized rice hull to augment the soil nutrient content. After a trial planting, species of vines, grasses and herbs were successfully planted and grown. As of 2016, a large section of the TSF surface area is vegetated (**Plate 2.1.2**).

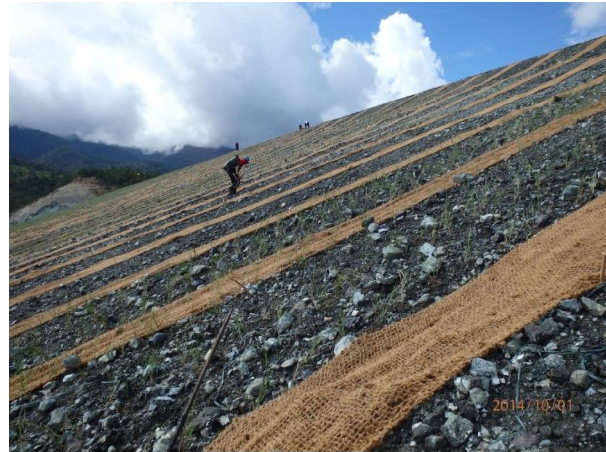
Plate 2.1.3. Slope of TSF2 laid with coconets

Currently, the slopes stabilization activities for TSF2 are being conducted. Coconets are installed to encourage the growth of grasses and other plant species (**Plate 2.1.3**).

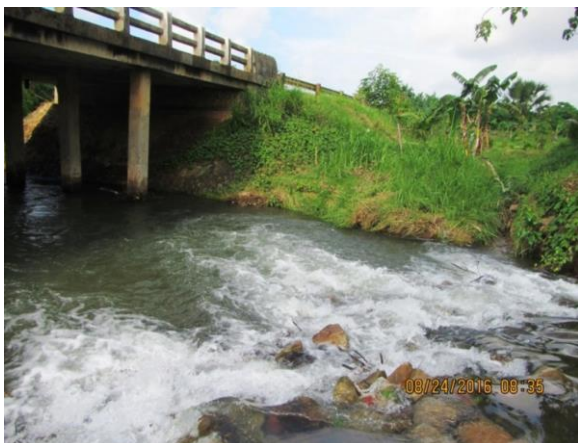
Plate 2.2.1. The main tributary of Ocayan River as viewed at the downstream side of Ocayan Bridge along the highway. The river has a muddy to gravelly bed and its water is used for irrigating farmlands and for bathing and washing clothes.

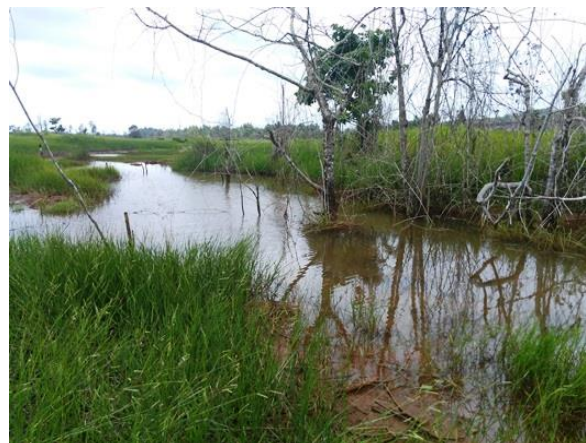
Plate 2.2.2. A section of Tagpisa Creek that is upstream from the proposed TSF3.

Plates 2.2.2 and **2.2.3** show sections of the Tagpisa Creek that are respectively upstream and downstream from the TSF3 area while **Plate 2.2.4** displays the diversion canal which conveys the outflow from Tagpisa Siltation Pond to the Upper Kinurong Siltation Pond.

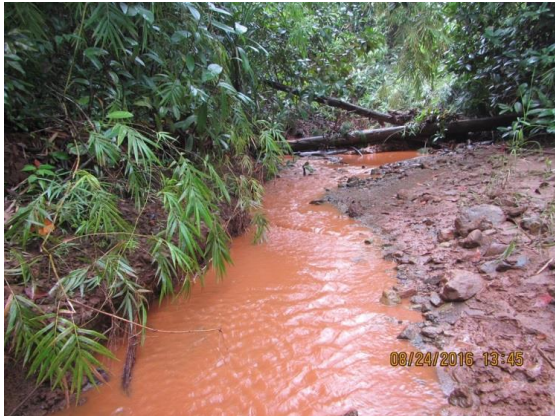
Plate 2.2.3. Downstream section of Tagpisa Creek after draining the proposed TSF3 area. The water is turbid because a portion of the TSF3 site is a mined out area. The creek then flows into the Tagpisa Siltation Pond for sediment settling.

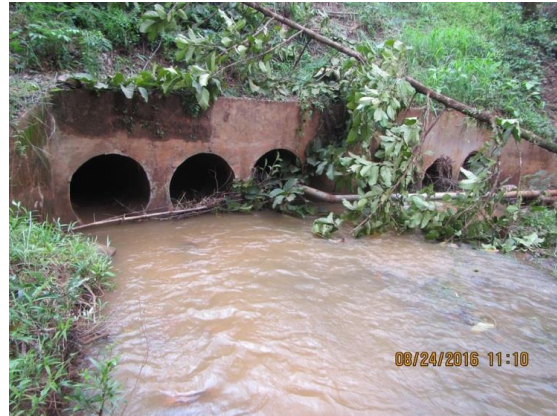
Plate 2.2.4. This diversion canal routes the outflow from Tagpisa Siltation Pond to the Upper Kinurong Siltation Pond which is within the adjacent Tuba River watershed. The water is notably clearer after passing through the Tagpisa Siltation Pond.

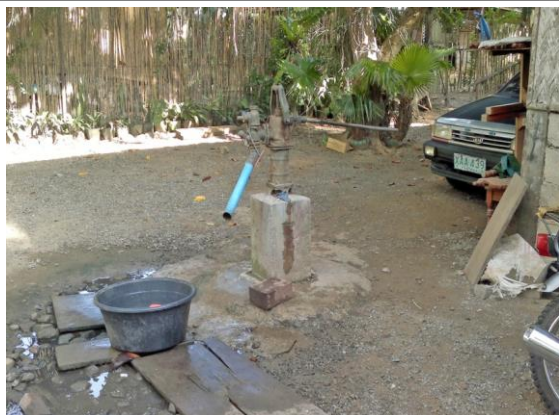
Plate 2.2.5. Shallow cased wells such as this one in Brgy. Ocayan used to be the main source of domestic water in the area surrounding the proposed TSF3.

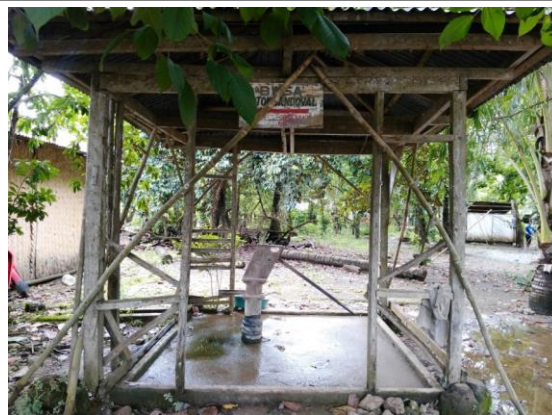
Plate 2.2.6. The PALTUBIG well of Sitio Gotok, Brgy. Sandoval was constructed in the mid 1990s. It still serves as an important water source especially when the supply from the Level II water system is temporarily disrupted.

The more reliable and durable public wells are those installed by the Pilipino-Aleman Proyecto ng Tubig sa Palawan (PALTUBIG) project in the 1990s, which was funded by the Federal Republic of Germany (**Plate 2.2.6**). Many of the PALTUBIG wells function up to the present.

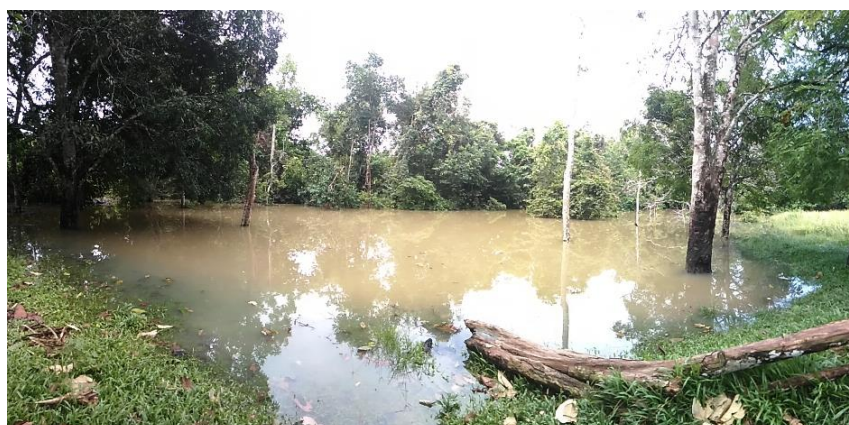
Plate 2.2.7. The Oning Spring in Brgy. Sandoval used to be a major water source of residents in the area prior to the installation of the Level 2 water system. It is still being used occasionally for washing and bathing.

The springs that were used for domestic purposes are invariably depression springs whose water comes out when the water table intersects an abrupt break in the land slope (**Plate 2.2.7**). Residents used these springs mainly for bathing and washing clothes. The spring that served as a major water source for domestic and agricultural use prior to the operations of CBNC was the Oning Spring. This spring continuous to flow large amounts of water that

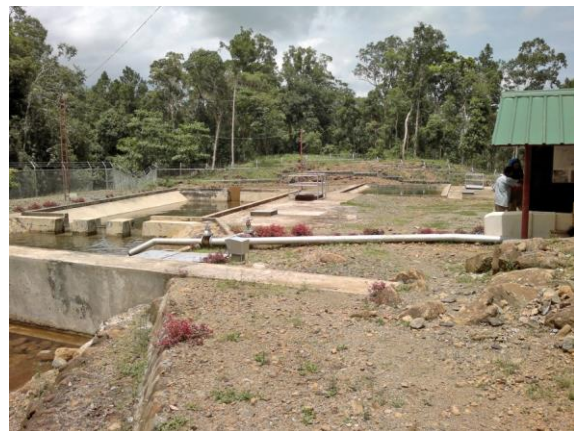
Plate 2.2.9. The raw water treatment facility of the Level 3 water system fed by Umawi Creek. This facility has several screens and settling ponds to filter and settle suspended solids prior to chlorination.

Plates 2.2.8 and **2.2.9** display the Umawi Creek upstream from the intake dam of the Level 3 water system and the treatment facility of this water system, while **Plates 2.2.10** and **2.2.11** show the water treatment facility of the Baracbaracan Level II water system and one of its outlets in Bgy. Sandoval.

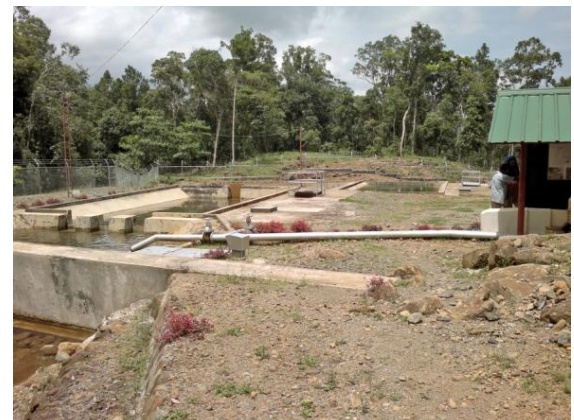
Plate 2.2.11. The raw water treatment facility of the Level 3 water system fed by Umawi Creek. This facility has several screens and settling ponds to filter and settle suspended solids prior to chlorination.

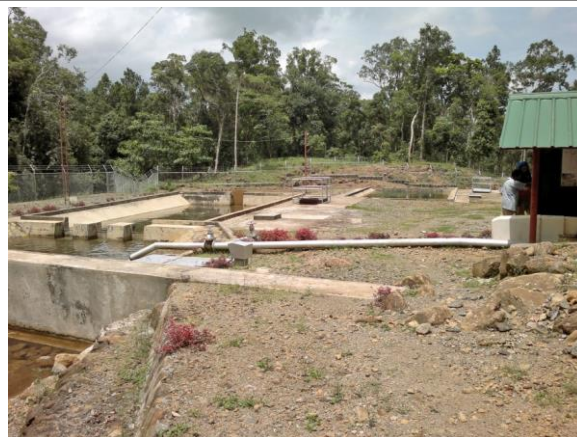
Plate 2.2.13. The raw water treatment facility of the Level III water system fed by Umawi Creek. This facility has several screens and settling ponds to filter and settle suspended solids prior to chlorination.

RTNMC also installed five (5) deep wells in the 1980s and 1990s to supply water to its townsite and mine offices which are located within Brgy. Rio Tuba. These sites now rely also on the Umawi Creek water system for its water supply. Except for the first well which was abandoned in the 1990s because of saltwater contamination, the RTNMC wells are presently maintained for use in the crushing plant operations of RTNMC and CBNC and for emergency purposes (**Plates 2.2.12** and **2.2.13**).

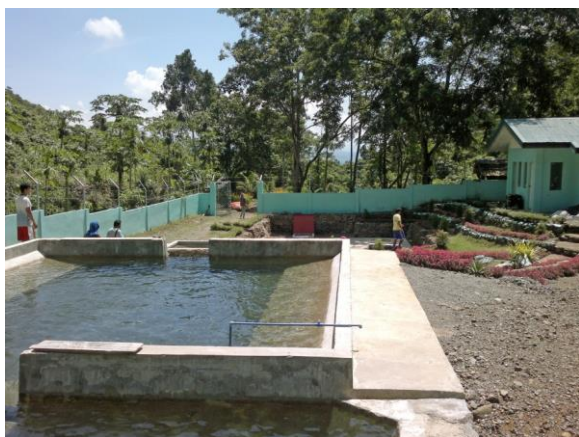
Plate 2.2.14. A series of screens and settling ponds at the raw water treatment facility beside Baracbaracan Creek filter the water of the Level II before it is chlorinated and piped to the users.

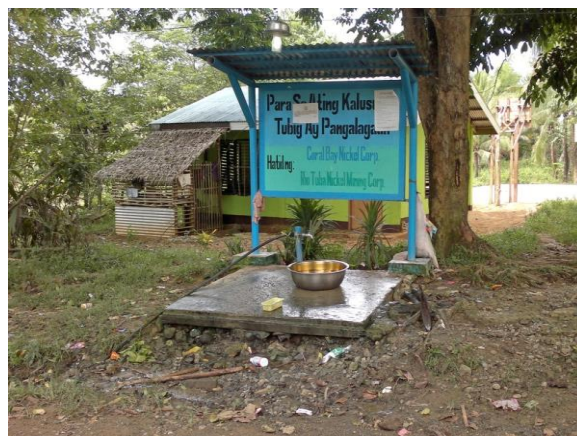
Plate 2.2.15. An outlet of the Level II water system serves a cluster of houses beside an inner road in Brgy. Sandoval.

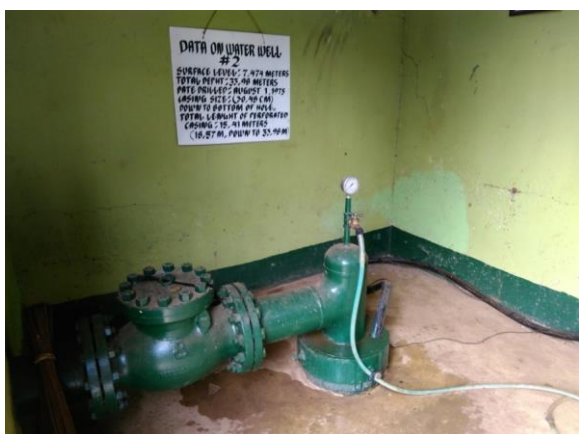
Plate 2.2.16. The well casing and riser pipe of RTNMC Water Well No. 2 (WW2) which is labeled W-6 in the water source location map.

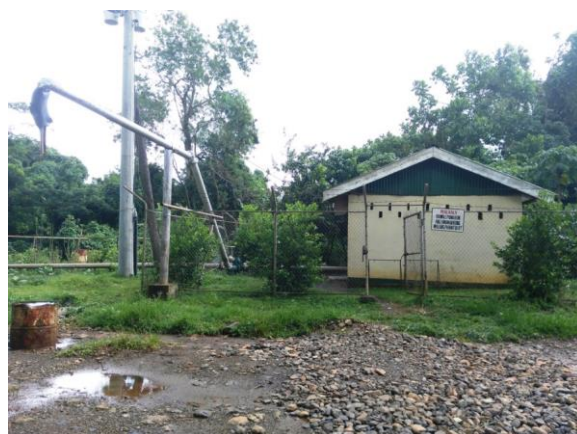
Plate 2.2.17. The pump house and water truck outlet of RTNMC Water Well No. 3 (WW3) which is labeled W-7 in the water source location map.

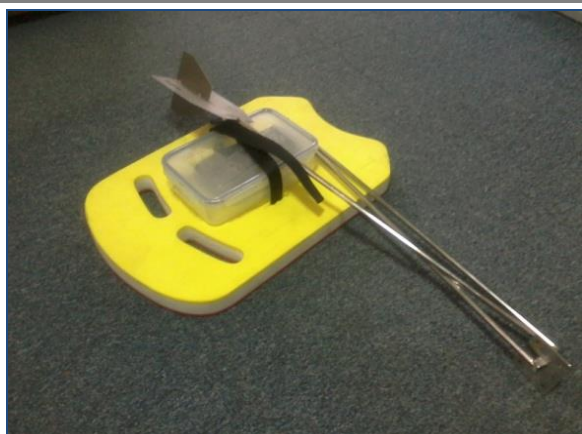
In this survey, sub-surface currents were observed from three stations using a drifter. A float board was attached with stainless fins which can be adjusted from 0.5 - 1.5 meters, and was mounted on top with an airtight container to house a GPS which recorded the geographic location and hence, trajectory of the drift as it is moved by the ocean currents hitting the submerged fin of the drifter.

Plate 2.2.18. Drifter set-up used to track sub-surface current trajectory

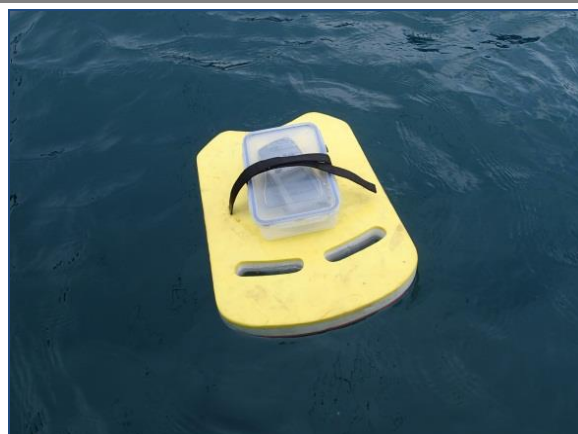
Plate 2.2.19. Actual use of drifter with the submerged stainless fins to track sub-surface current trajectory

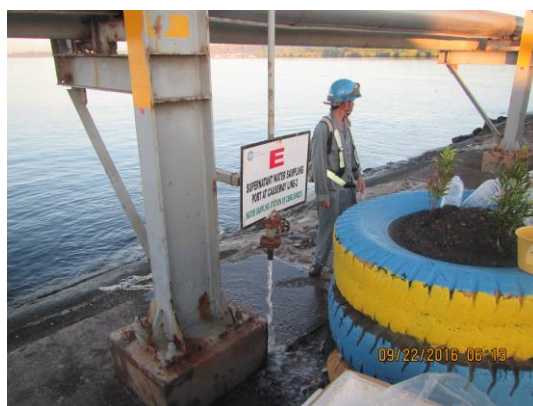
Plate 2.2.24. Station E - Supernatant Water sampling Port at Causeway

The wastewater of CBNC is treated in-plant and delivered to the tailings pond before discharge to Coral Bay. The tailings pond retains the settleable solids containing residual heavy metals. The effluent discharge to Coral Bay is monitored through sampling point E.

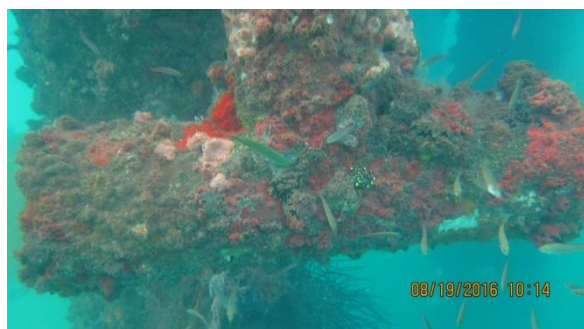
Plate 2.2.31. The discharge pipes (S2) are fully encrusted with colorful sponges.

On the other hand, the discharge pipes (S2) are covered with fouling organisms, mostly sponges and ascidians, with sporadic occurrence of encrusting coral recruits (**Plate 2.2.27**). The pillars also recruited soft corals as well as gorgonians.

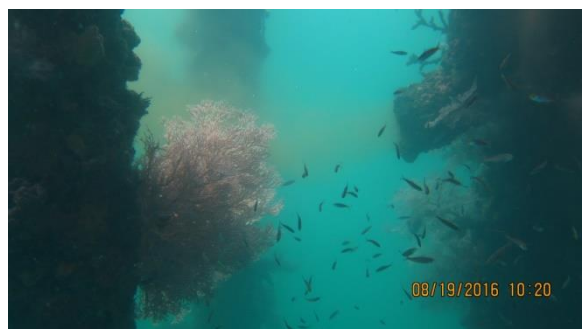
Plate 2.2.32. Soft coral on the pillars of the discharge pier.

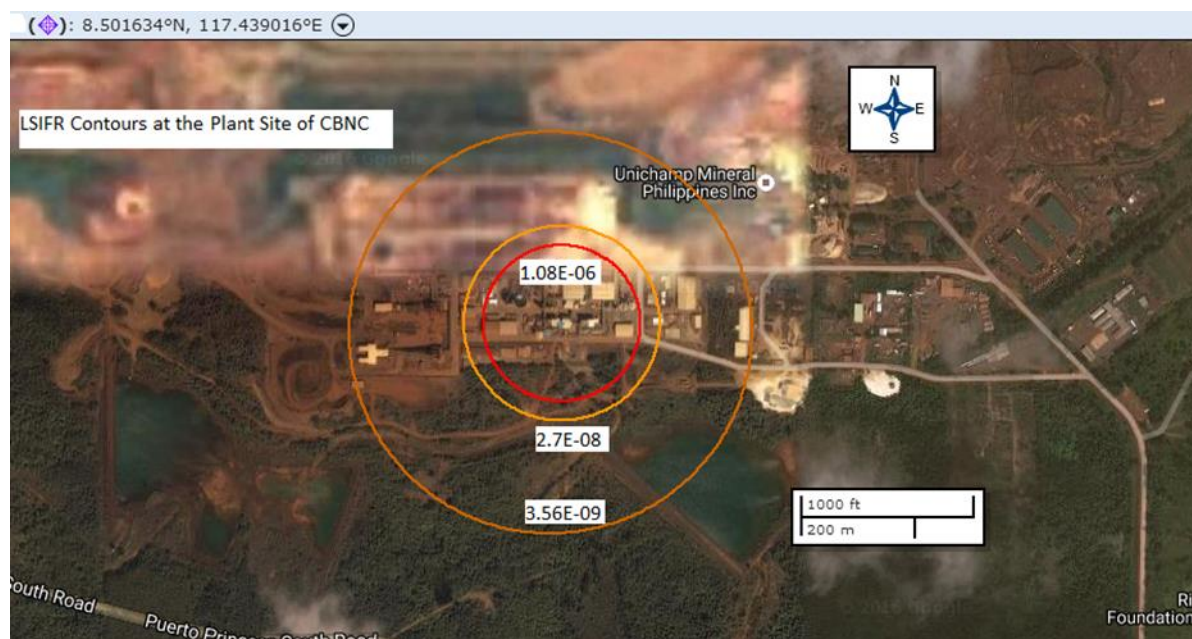
Figure 4.7.1. LSIFR Contours for the LOC event scenarios at the Plant Site of CBNC.

Based on the calculations of the total LSIFR per event scenario per site, the LSIFR contours lines were derived. **Figure 4.7.1** shows the LSIFR contour lines at the Plant site. The contour lines were primarily derived from the hazard distances and corresponding calculated LSIFRs of the worst event scenarios involving the catastrophic release of hydrogen gas resulting to vapour cloud explosion (HPP-H₂-CAT-F2-VCE) and the catastrophic release of hydrogen sulphide gas from the gas holder resulting to toxic vapour cloud dispersion (HPP-H₂S-HO-CAT-F2-TC). Event Scenario No. HPP-H₂-CAT-F2-VCE generated the longest or worst hazard radii among the flammable substances at the Plant site. Event Scenario No. HPP-H₂S-HO-CAT-F2-TC, on the other hand generated the longest hazard radii among the hazardous toxic substances at the Plant site.

The calculated LSIFR of all event scenarios following loss of containment of the various hazardous substances (methanol, sulphuric acid, diesel, hydrogen gas and hydrogen sulphide gas) and using the maximum hazard distance to calculate the event consequences, ranged from $1.08\text{E-}09$ to $7.12\text{E-}06$ chance of fatality per year. The total LSIFR for Plant site was calculated at $1.21\text{E-}06$. The total LSIFR at this site is a little more than the prescribed LSIFR criteria of 10^{-6} fatalities per year. Plots of the LSIFR contour lines (refer to **Figures 4.7**) show that no LSIFR value higher than 10^{-6} chance of fatality per year encroached beyond the boundaries of the project site and no populated communities are affected by such.
