# **PROPOSED BAYAOAS SMALL RESERVIOR IRRIGATION PROJECT (BSRIP)**

Aguilar, Pangasinan

## **Project Description for Scoping**

**Pangasinan Irrigation Management Office (PIMO)  
NIA Region 1**

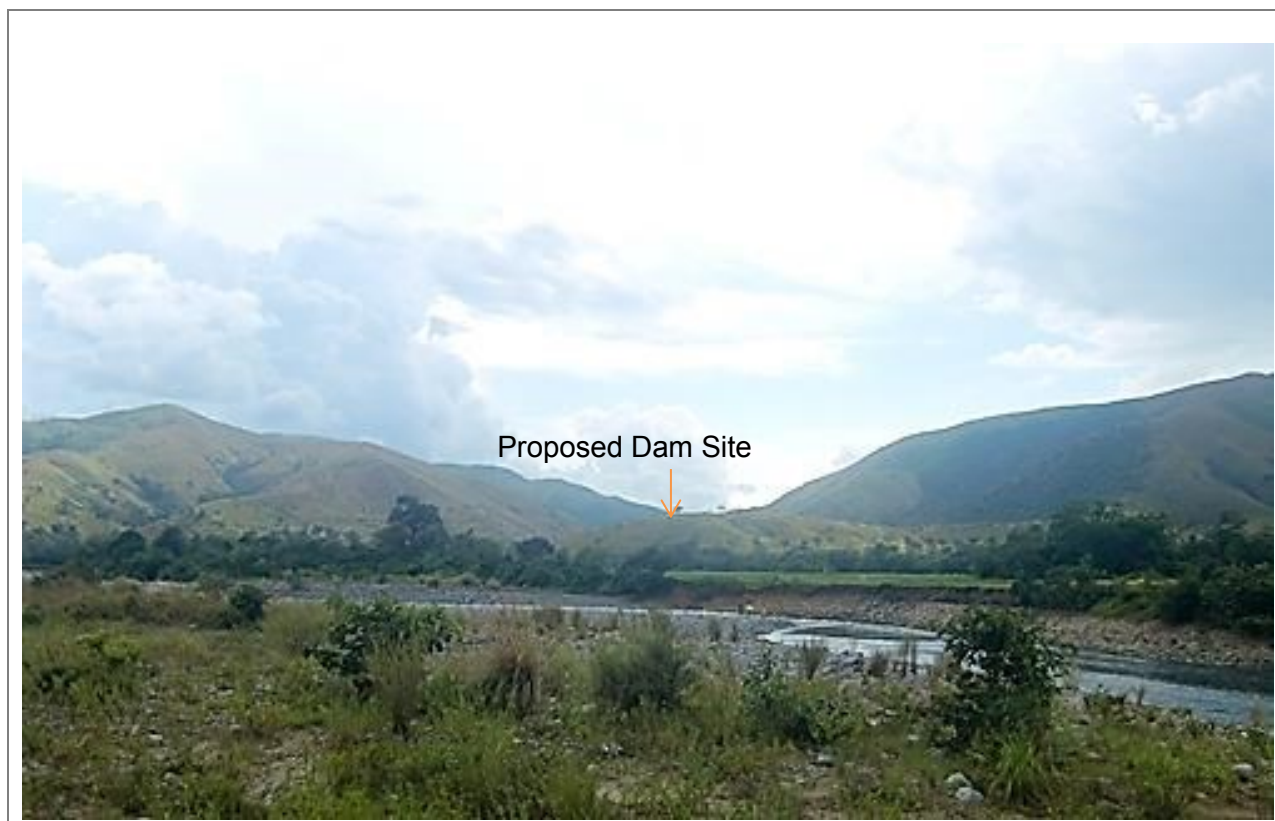
**Figure 6.** Panoramic View of the damsite, Bayaoas River, and Left Bank Irrigation System taken from the Proposed Access Road Area (looking west)

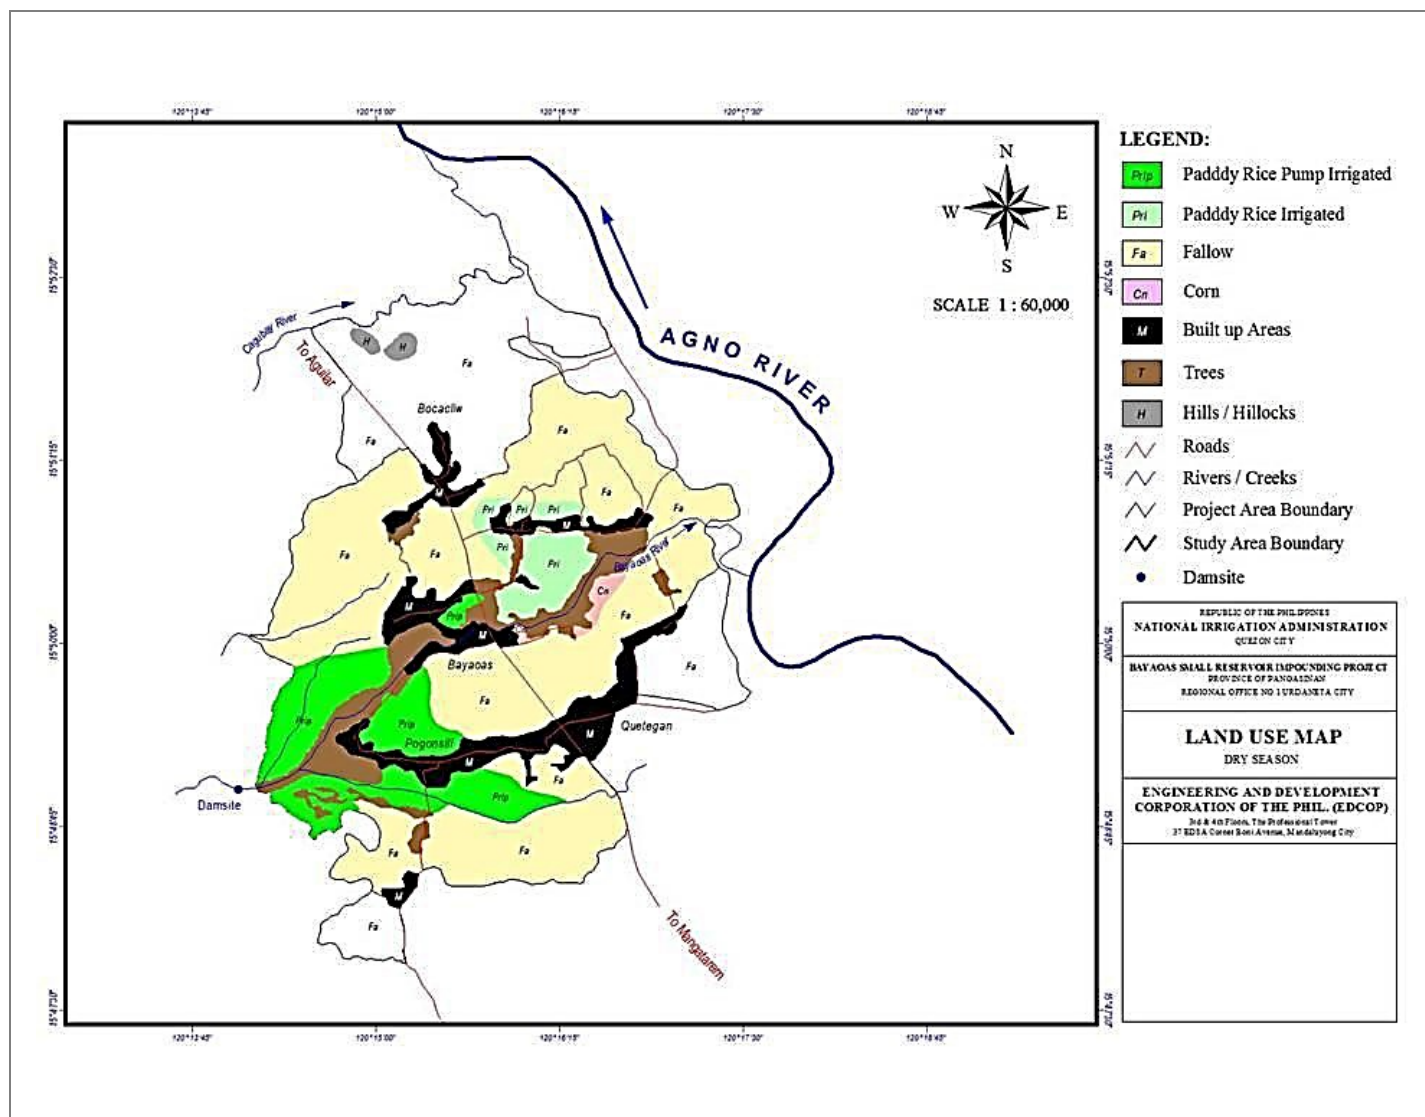
Figure 7. Land Use Map (Dry Season)

**Table 2** shows a summary of the use arable lands in the dry and wet season, while the **Table 3** expands such summary by location. The areas will also be validated with the farmers, starting at the pre-construction stage. **Figures 7 and 8** provide visualization of these areas on maps.

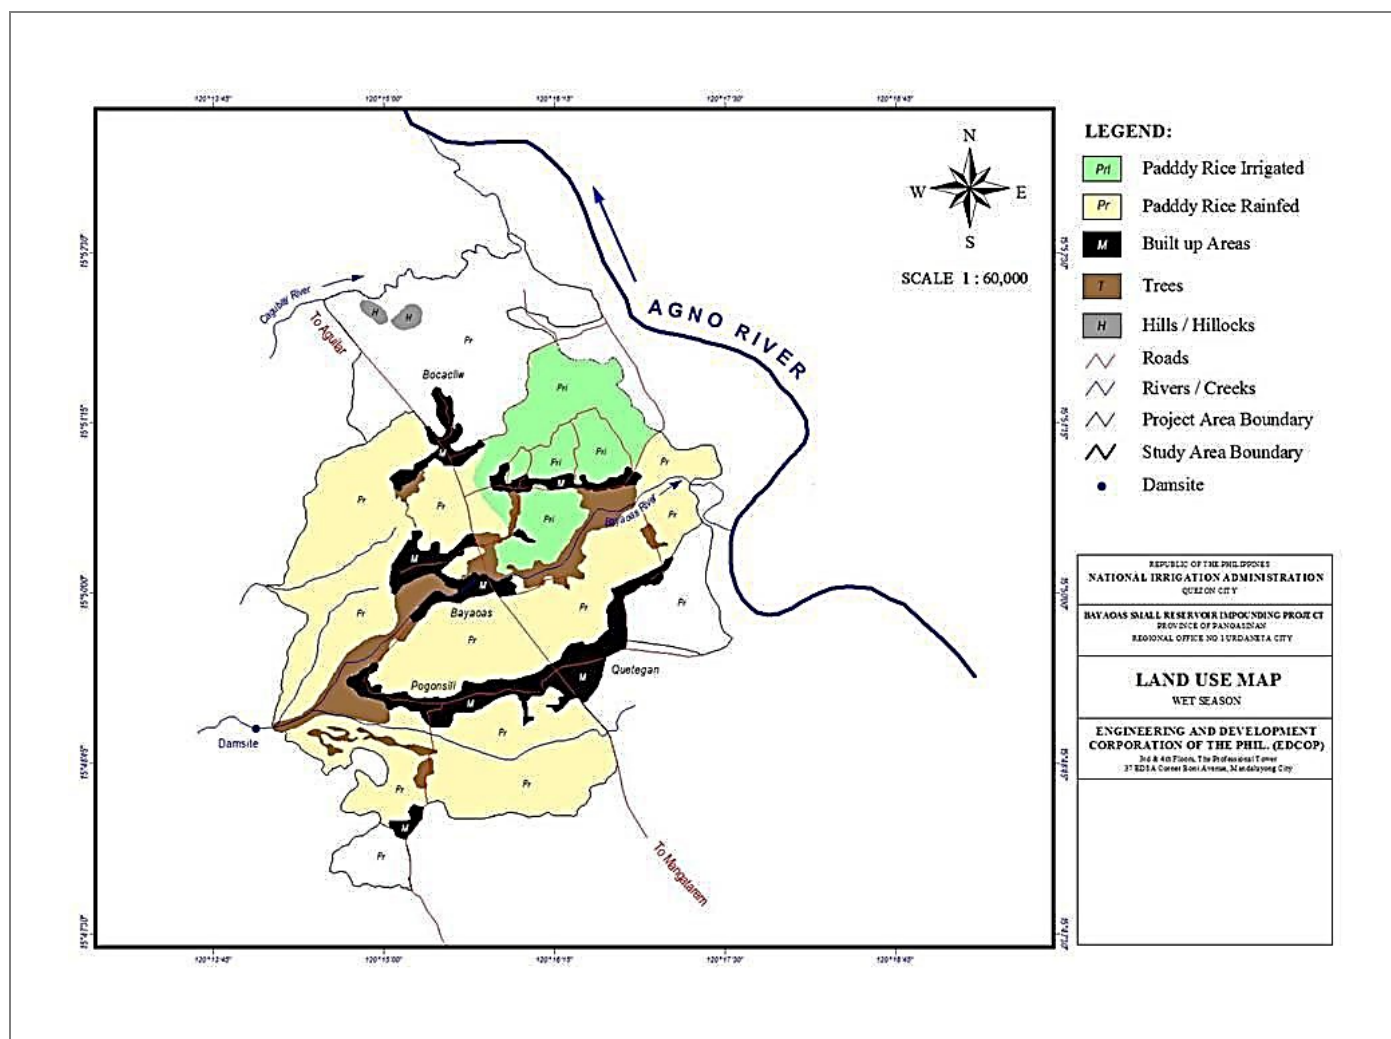
Figure 8. Land Use Map (Wet Season)

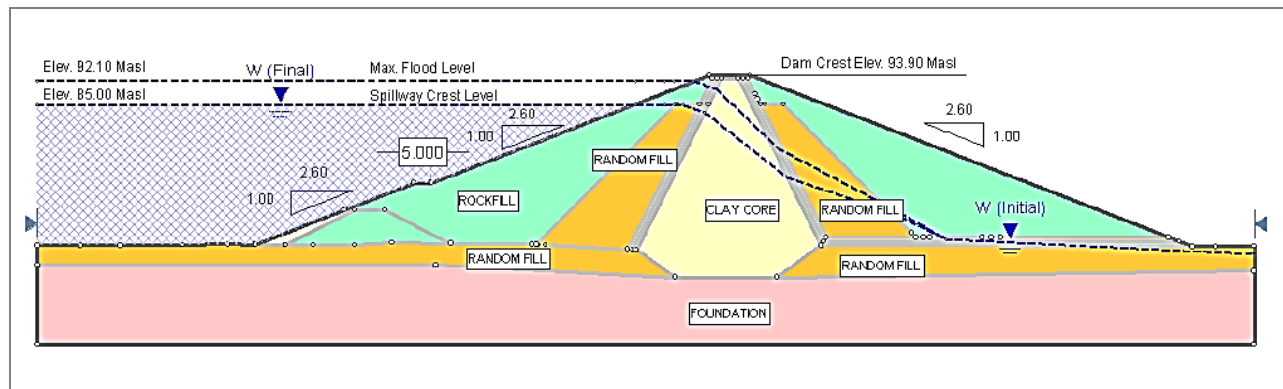
**Figure 9.** Embankment Section of Proposed Indicative Dam

On the issue of dam safety, a slope stability analysis was conducted for the two alternative outer shell materials but with similar height of 48.4 m (at 93.90 m top elevation) (**Figures 9 and 10**). Results show a higher safety of factor for the proposed type, even under an earthquake condition. The indicative dam has an upstream and downstream slopes of 1.00 V : 2.60 H to effect a dam base of 264 m from upstream to downstream. The alternative dam has an upstream slope of 1.00 V : 3.00 H downstream slope of 1.00 V : 2.65 H, and base of around 285 m. Note that the indicative dam with 21-m shorter base would require lesser volume of materials.

The slope stability analysis was done using RocScience Slide software, which requires material properties, loading conditions, peak ground acceleration, and seismic coefficient among others. The material properties used in the stability analyses are listed in **Table 6**. The 45 kPa and 20-degree friction angle for the clay core and unit weights were adopted. All other properties were based on triaxial test and generally accepted material properties established in other similar dam projects elsewhere. **Table 7** shows loading conditions and corresponding widely accepted minimum factors of safety were adopted in the stability analyses.

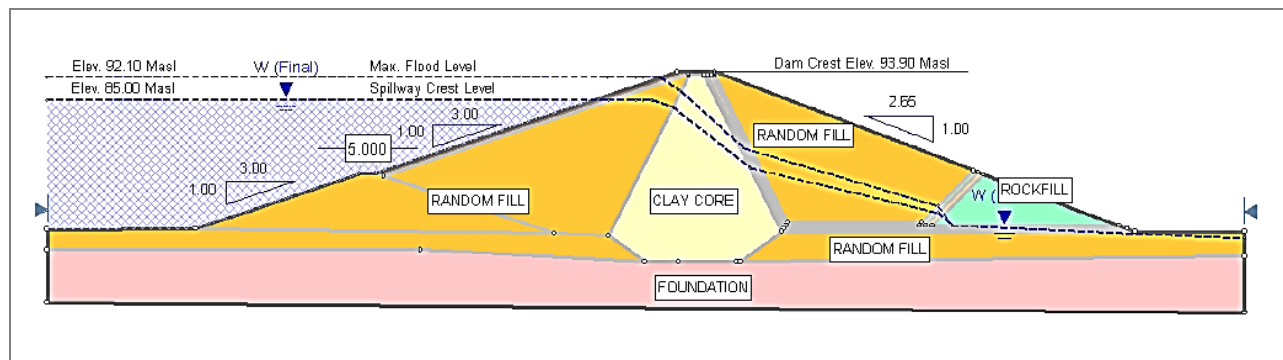
**Figure 10.** Embankment Section of Alternative Dam

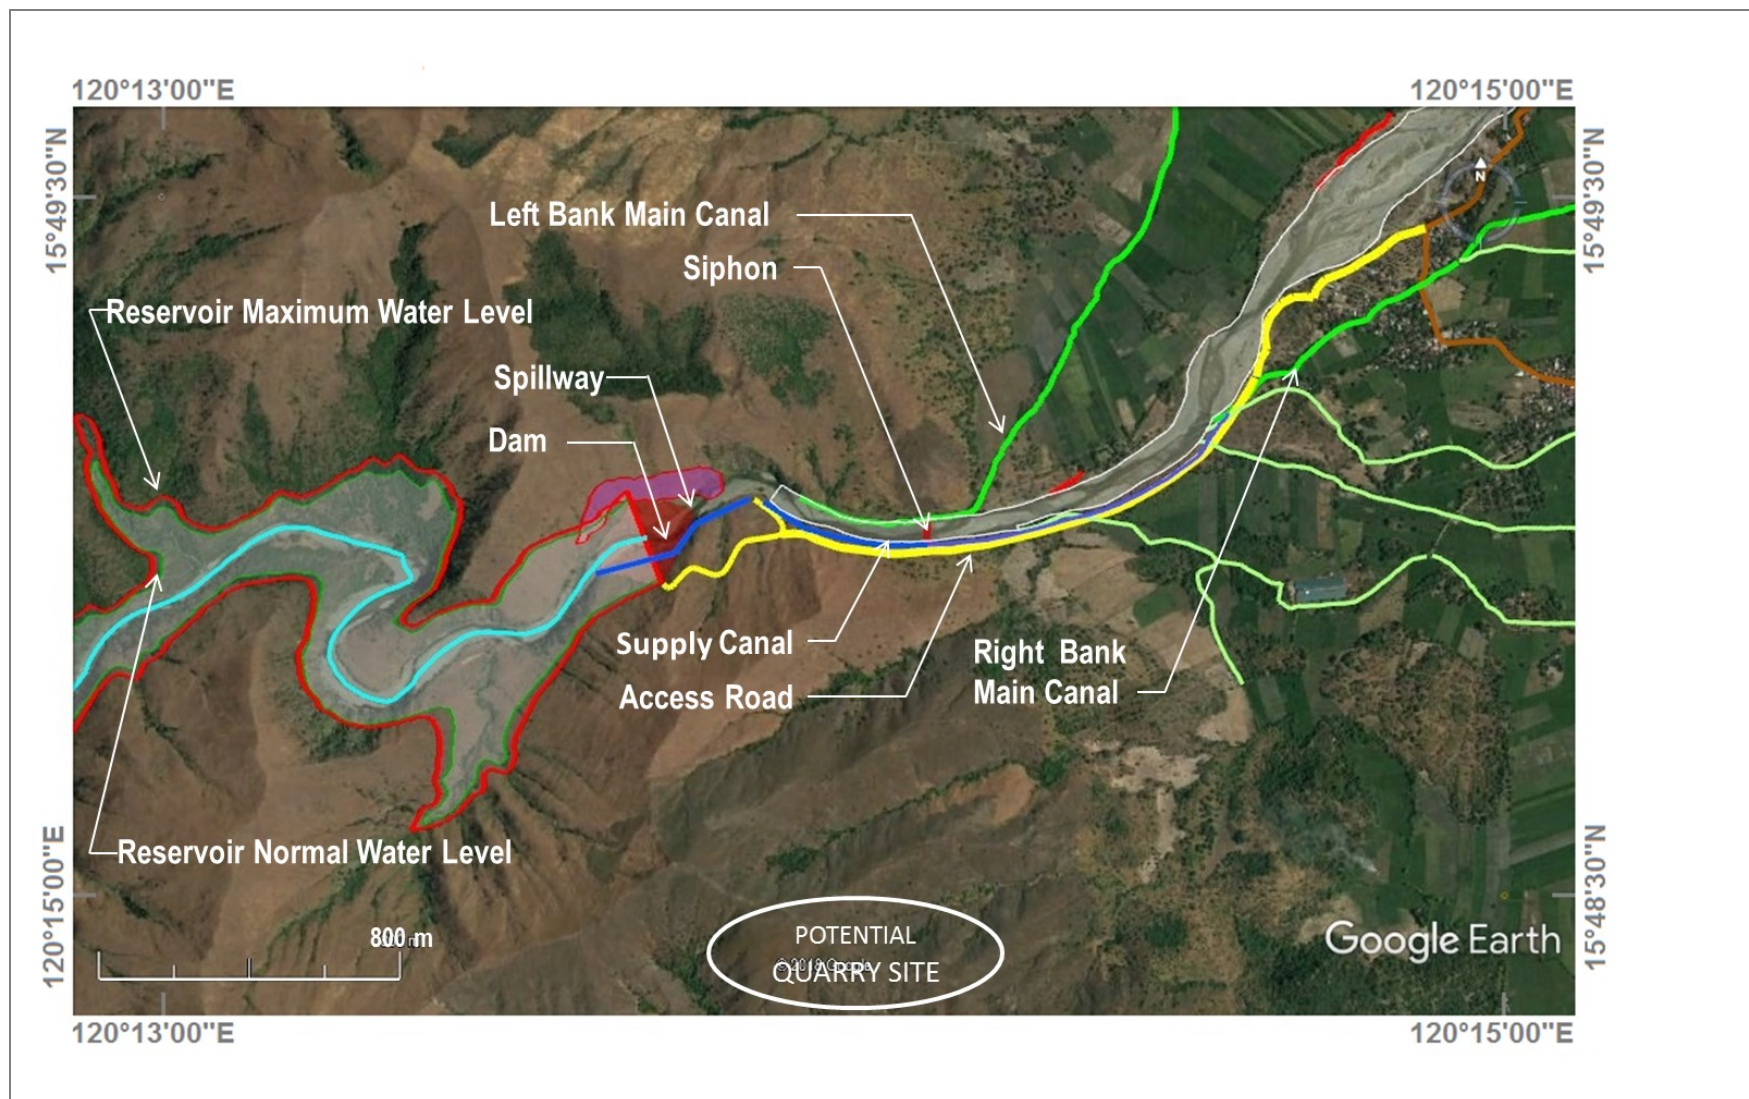
**Figure 11.** Conceptual development layout of BSRIP on satellite image

The initial working location of the dam is a plot on Google Earth Satellite map presented in **Figure 11**, which is based on the dam site development plan in **Figure 12** taken from 2015 BSRIP 2015 Feasibility Study. The Proposed Project will consist of the following (with indicative dimensions and areas in **Table 4**):

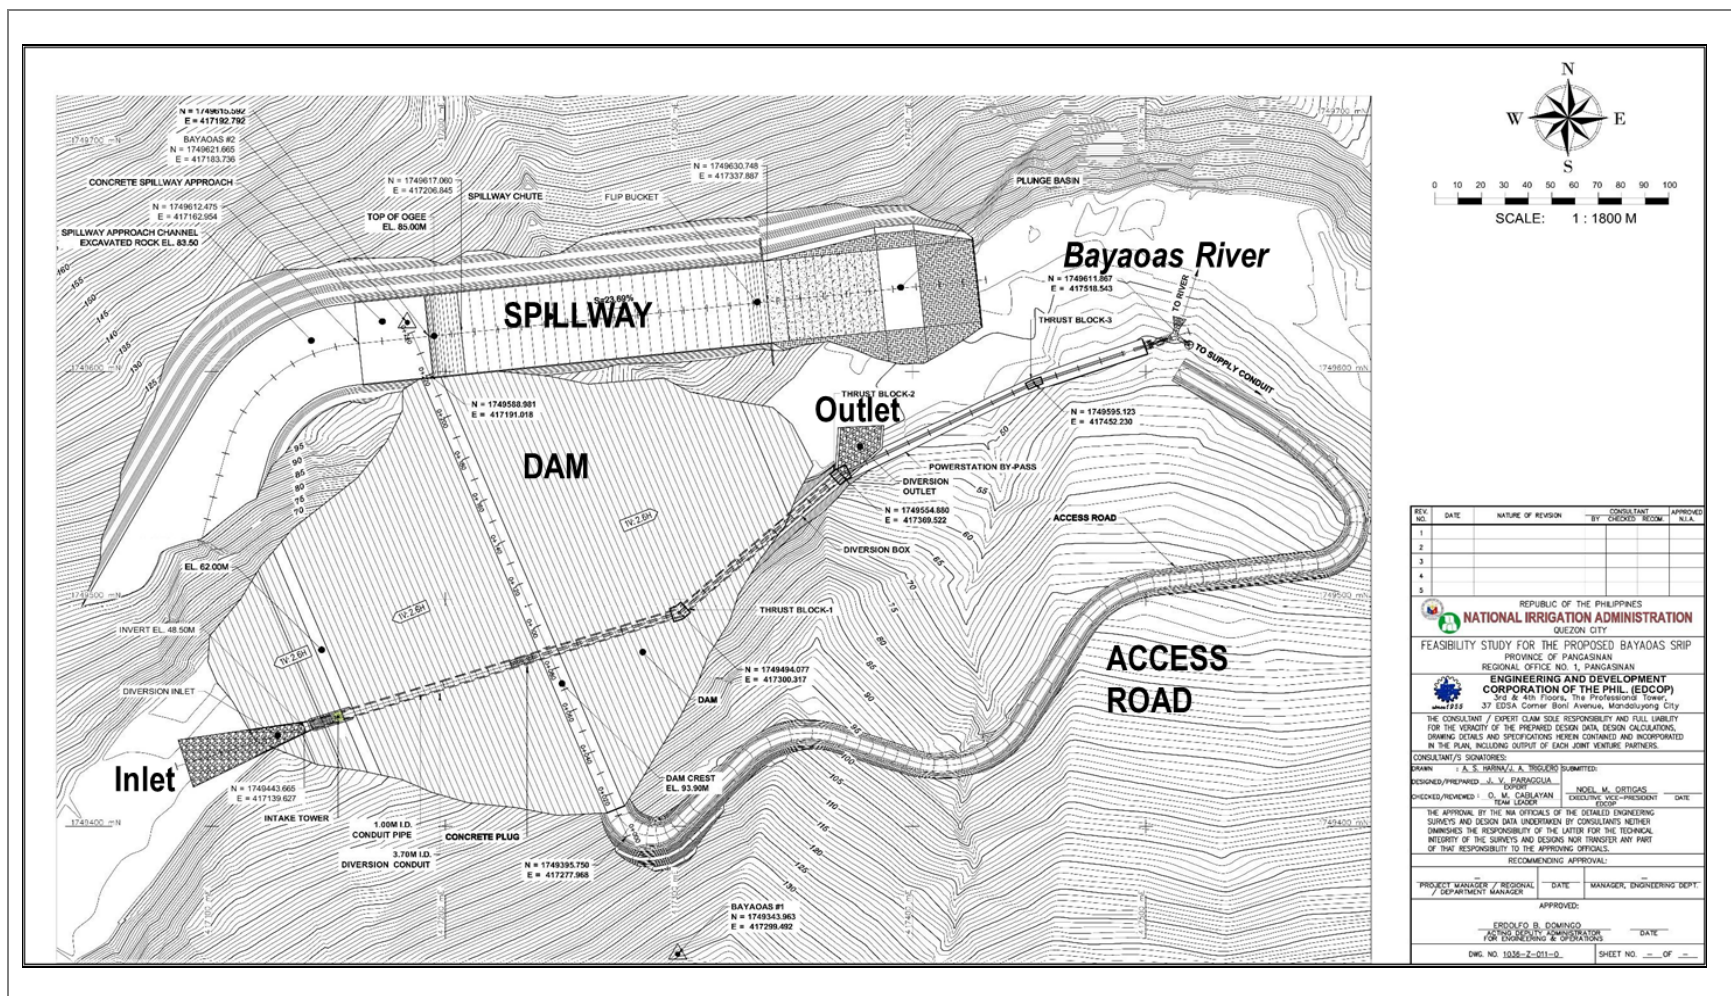
Figure 12. Engineering version of damsite development layout. Source 2015 BSRIP FS.

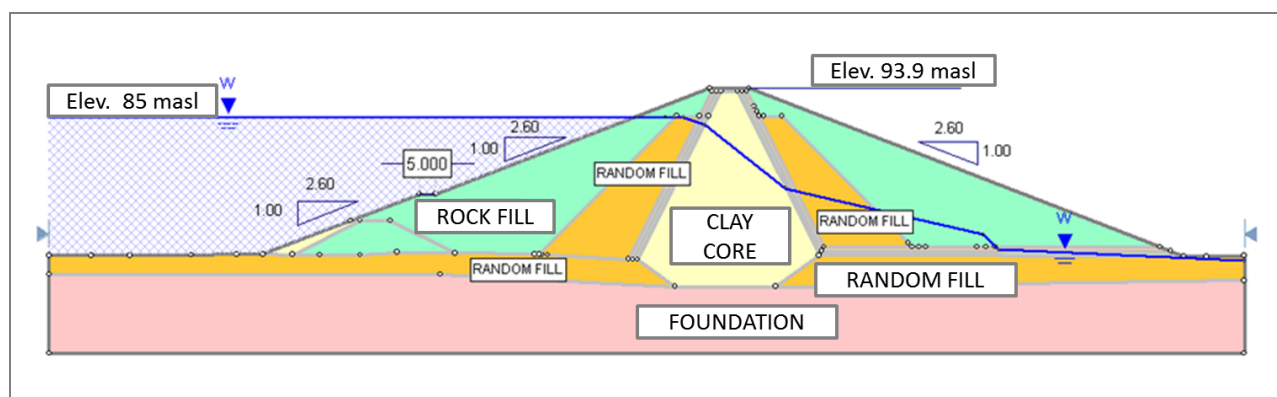
**Figure 13.** Typical Section of Embankment Dam

The typical section of the recommended dam type is shown on **Figure 13**. The complete dam attributes are given in **Table 5**.

**Impervious Core.** The impervious core will have top width of 5 meters to meet the construction requirements. The impervious core will have a 1.0V:0.5H slopes extending to about 1 meter below the crest. At the centerline of the dam crest, the core will also have a positive cutoff to bedrock level 11.5 meters below the riverbed. The bottom will have a width of about 30 meters with sides sloping of 1V:1.4H to provide adequate contact with the rock foundation but also accounting for the loss of head as the water travels vertically through the foundation. Three lines of grout curtains with spacing of 6 meters will be provided for the rock foundation to control seepage.

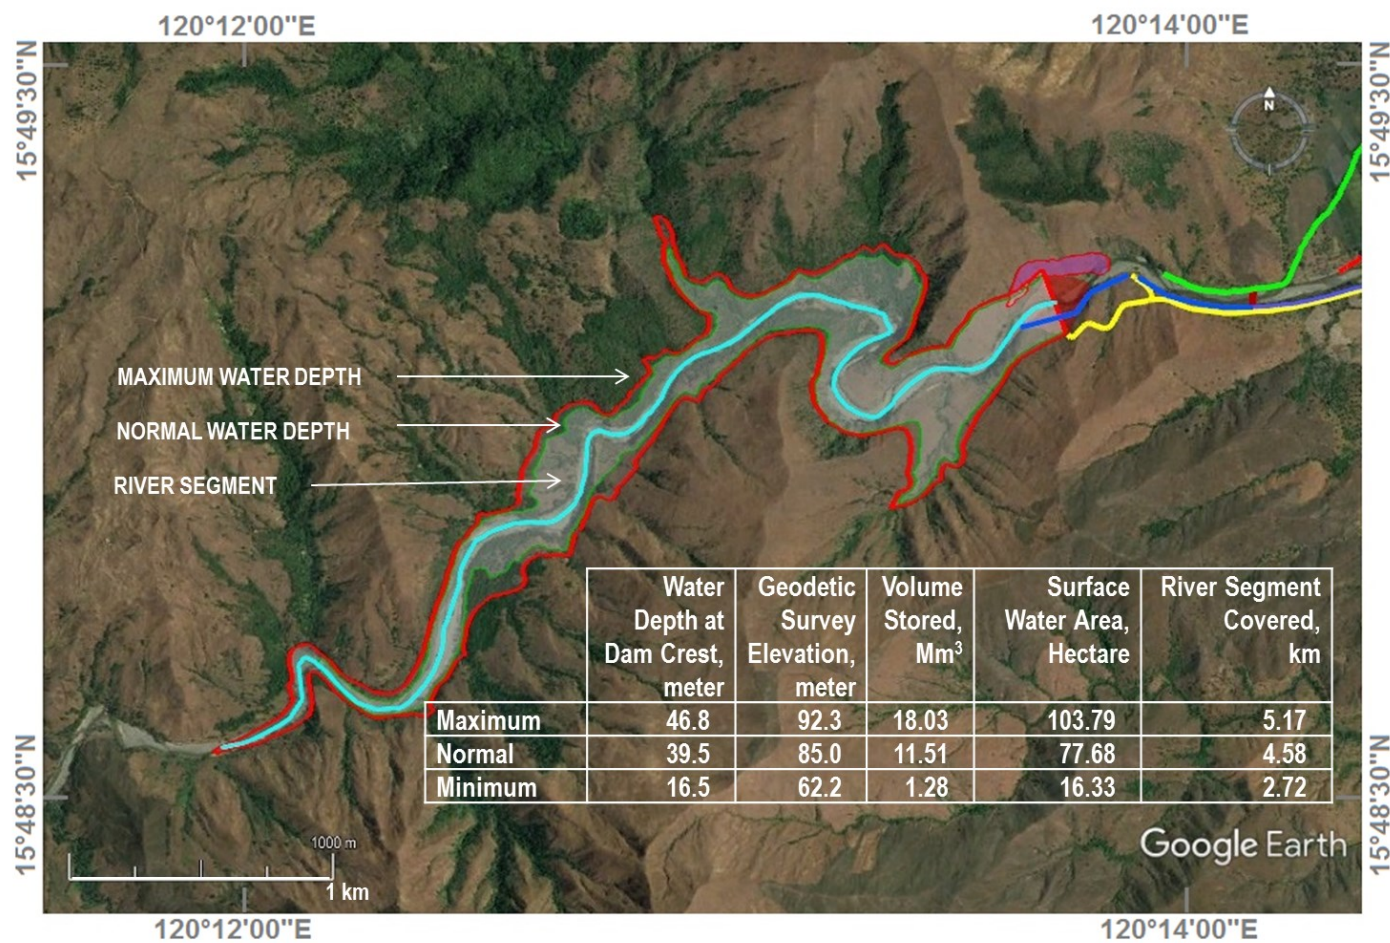
**Figure 14.** Close-up view of the BSRIP Reservoir

The reservoir indicative covered area, maximum water depth, normal operating water depth and river segment of the reservoir is shown in **Figure 14**. The maximum water depth (red line) is a flood condition that would be at 92.3 masl or 46.8 m high from the dam crest river bed (45.5 masl) , with volume stored of 18.03 million m<sup>3</sup> and surface area of 104 ha, covering about 5.17 km of upstream segment of Bayaoas River. The normal (maximum) operating water depth (green line) would be at 85 masl (also the floor level the spillway ogee) or 39.5 m from the dam crest river bed, with volume stored of 11.51 million m<sup>3</sup> and surface area of 78 ha covering about 4.58 km of upstream segment of the river. The minimum level at 62 masl, would be at 16.5 m deep from the dam crest river bed, with volume stored of 1.28 million m<sup>3</sup>, and surface area of 16 ha, covering about 2.72 km of the upstream segment of the river. Additional information on elevation is presented in **Table 6**. The relationship of reservoir surface area and cumulative capacity with respect to reservoir surface water elevation is shown in **Table 7**. The difference in volume between the maximum normal operating level at 85 mas and the minimum operating level at 62 masl is 10.23 million m<sup>3</sup> for the irrigation and environmental flow.

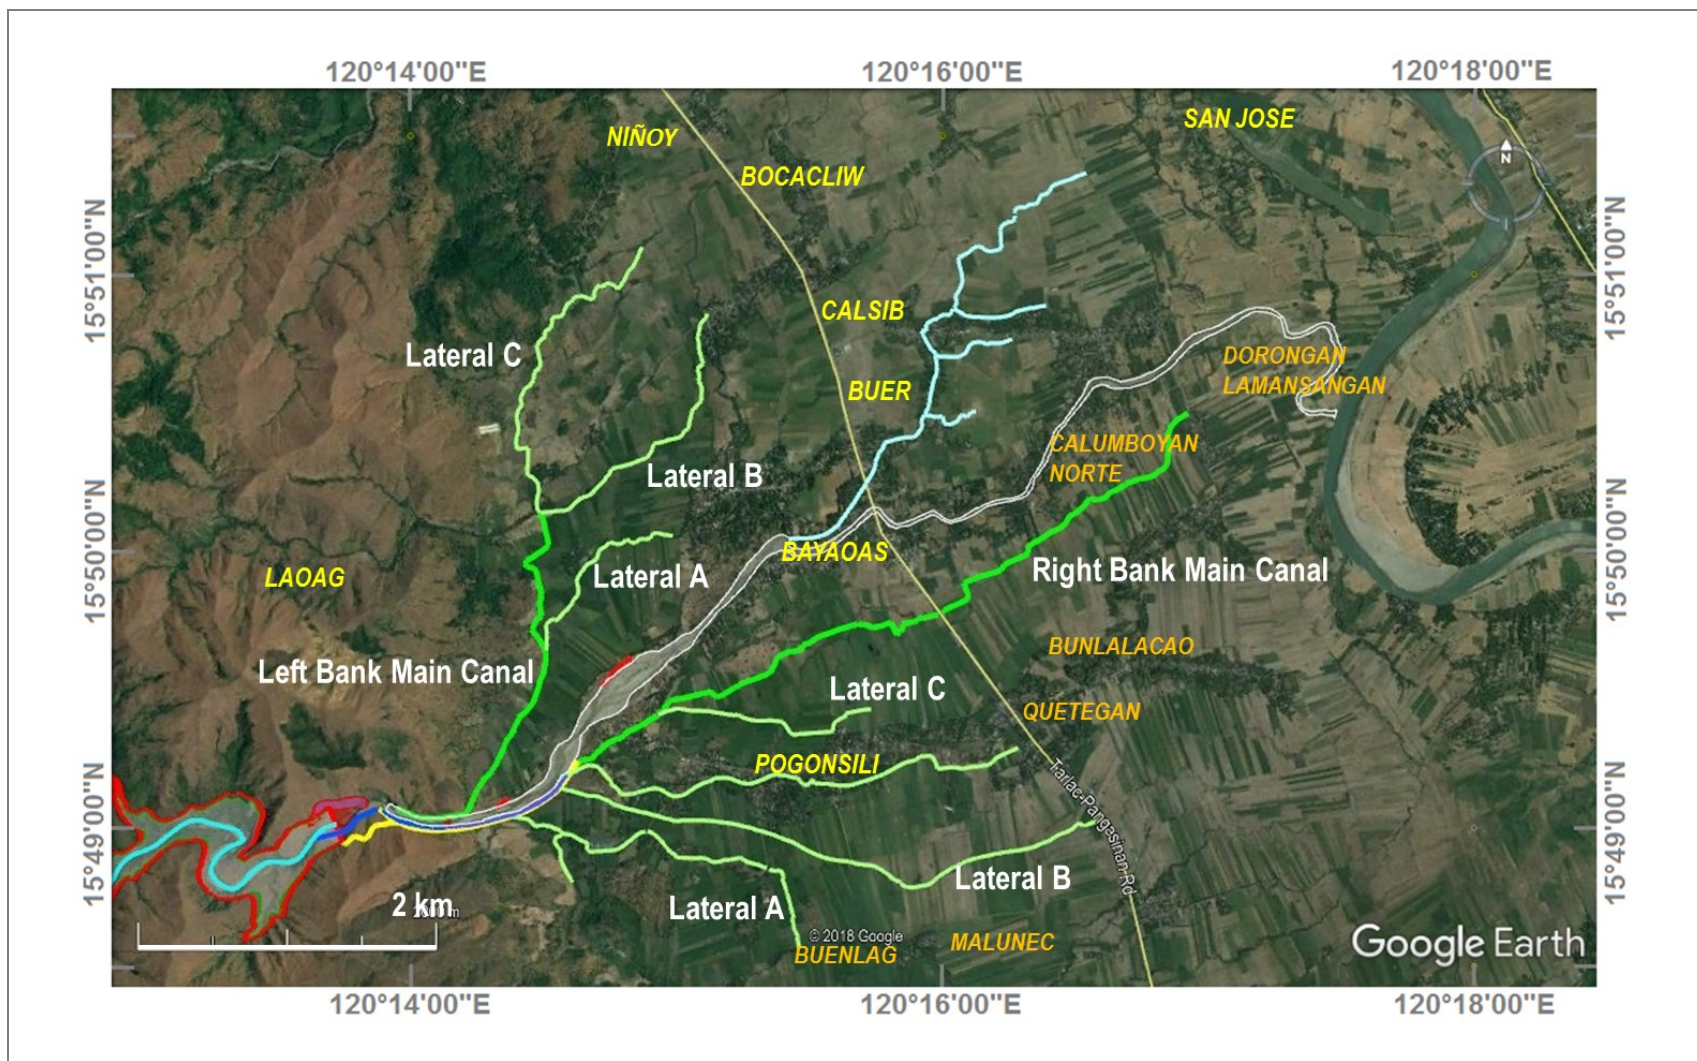
**Figure 15.** BSRIP Irrigation canal network for improvement, and covered and neighboring barangays in Aguilan (in yellow text) and Mangatarem (in gold text)

The covered irrigable area is 1,400 ha of ricefields, however only 1,238 ha could be served during the dry season. The remaining 162 ha that could not be irrigated in the dry season is projected to be idle. There are existing canal networks within the area which farmers traditionally use but most are indigenously constructed. The same canal alignments were mostly adopted in the BSRIP 2015 FS Report, but repair and improvements have to be undertaken to effectively improve the conveyance of irrigation water to the rice paddies. An annotated closer view of the irrigation network is presented in **Figure 15**.
