Environmental Performance Report and Management Plan

DIDIPIO GOLD-COPPER PROJECT

INCREASE IN ANNUAL PLANT THROUGHPUT RATE
(3.5 Mtpa to 4.3 Mtpa)

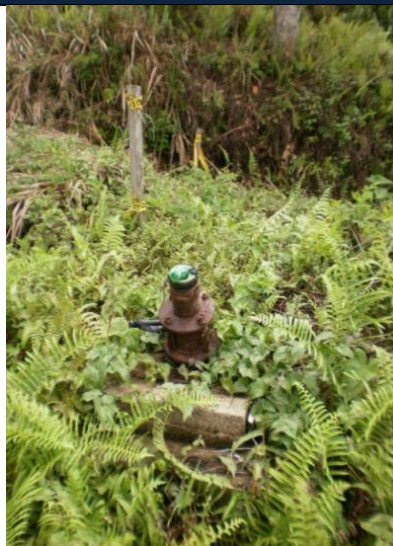
Station	Location/Description	Photo
DDDH26	<p>N: 16° 19' 43.8"</p> <p>E: 121° 27'11.6"</p> <p>A monitoring well located at the western portion of the site. During the time of sampling, it was dry.</p>

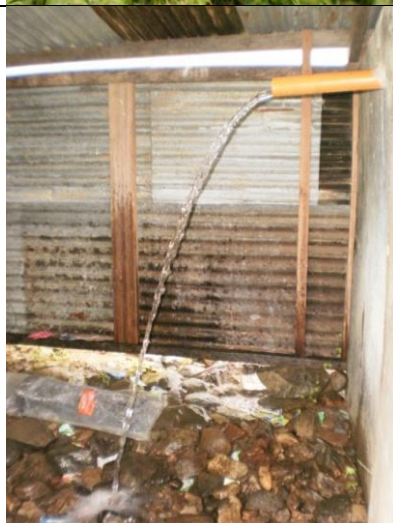
DDDH54	<p>N: 16° 19' 45.9"</p> <p>E: 121° 27'15.4"</p> <p>Located at the western portion of the site and east of monitoring well DDDH26. It is an enclosed artesian well used by employees onsite for bathing and washing clothes.</p>

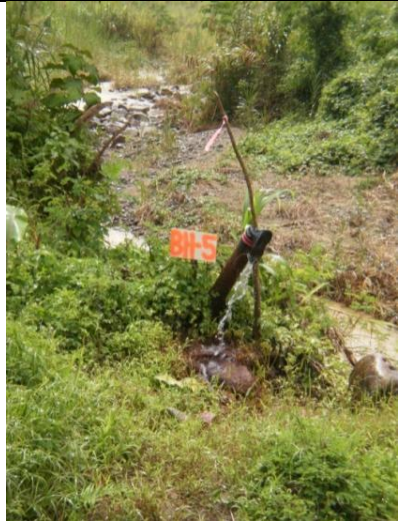
Station	Location/Description	Photo
DDDH51	<p>N: 16° 19' 46.9" E: 121° 27'20.7"</p> <p>Located at the western portion of the site. This well is not enclosed and has a rubber boot attached to the pipe from which water flows out of.</p>

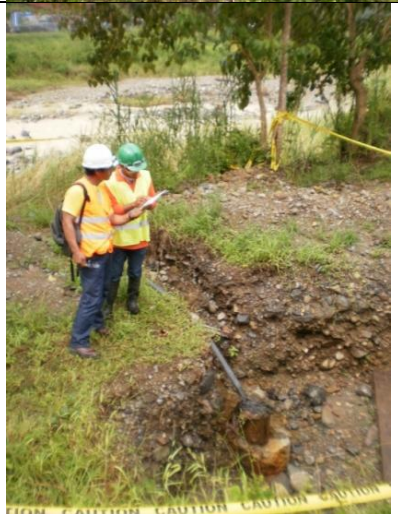
RCPT14	<p>N: 16° 19' 46.5" E: 121° 27'24.6"</p> <p>Located at the central portion of the site. This well is not enclosed and water flows out of a pipe.</p>

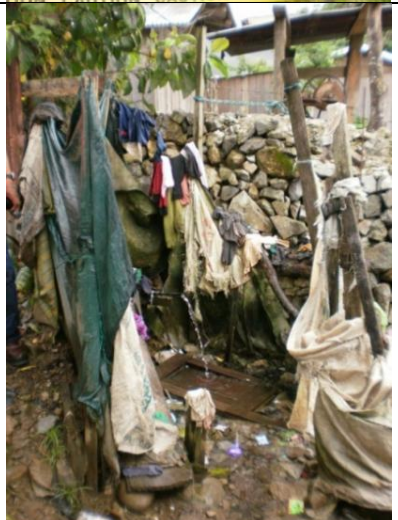
TDDH111	<p>N: 16° 19' 50.9" E: 121° 27'34"</p> <p>Located in the eastern portion of the site. Water from this well surrounded by residential houses, is used for domestic purposes.</p>

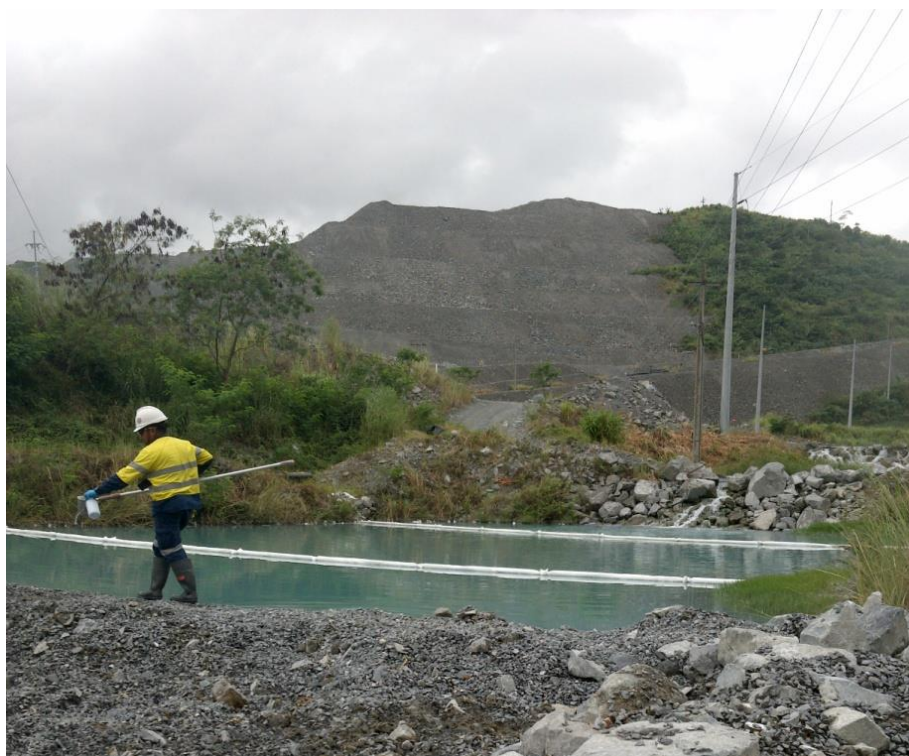
Photo 2-8: SP 06

One of the conditions in the discharge permit for Silt Pond 06 (SP06) is the quarterly monitoring of effluent parameters pH, TSS and oil and grease. Parameters monitored and reported by OGPI in their SMR are TSS, BOD, cadmium, arsenic, lead, mercury, iron, zinc, dissolved copper, nitrate, sulfate and free cyanide.

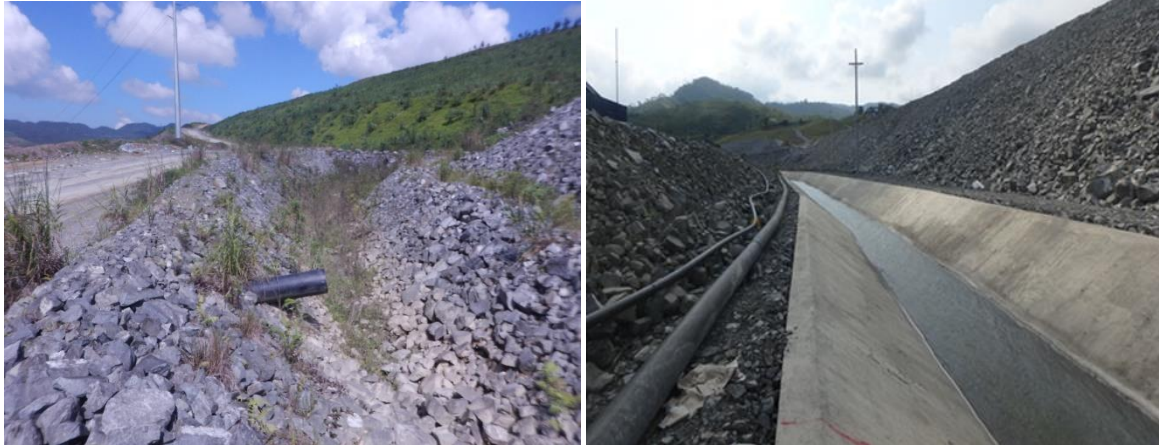
Photo 6-1: Rock lining and rock surfacing

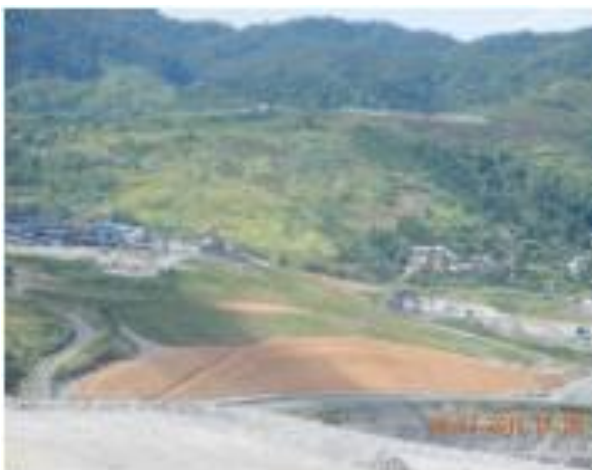
Photo 6-8: Cocomatting and revegetation at ROM northwall

Erosion control blankets are temporary erosion controls that provide cover over exposed soils. It reduces raindrop impacts by providing cover. These controls are commonly use on earth embankments and slopes before and during revegetation phase. Currently, Didipio mine has used and will continue to use cocomats in combination with various revegetation techniques.

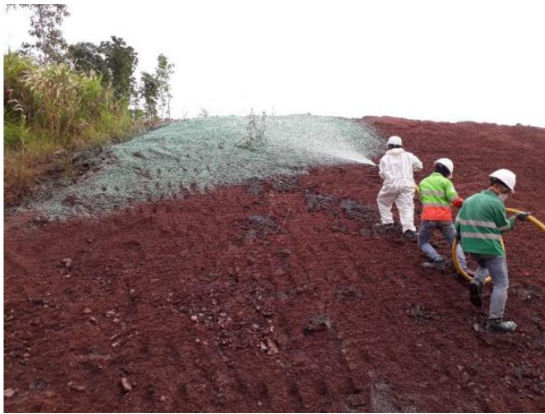
Photo 6-10: MacFlex application on Trial Slopes

Hydroseeding was adopted by OGPI to address the problem of soil erosion control and progressive rehabilitation especially for those areas with insufficient soil and rock phases area.

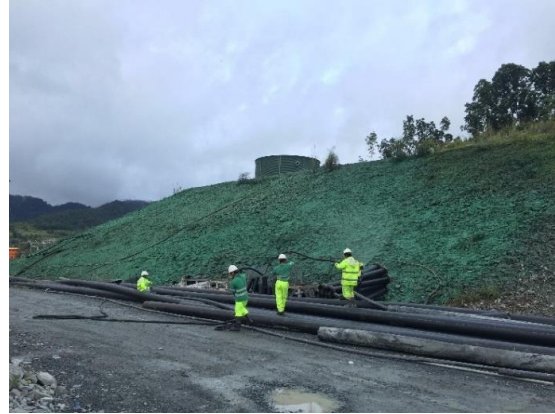
Photo 6-11: Application on the Batch Plant slopes

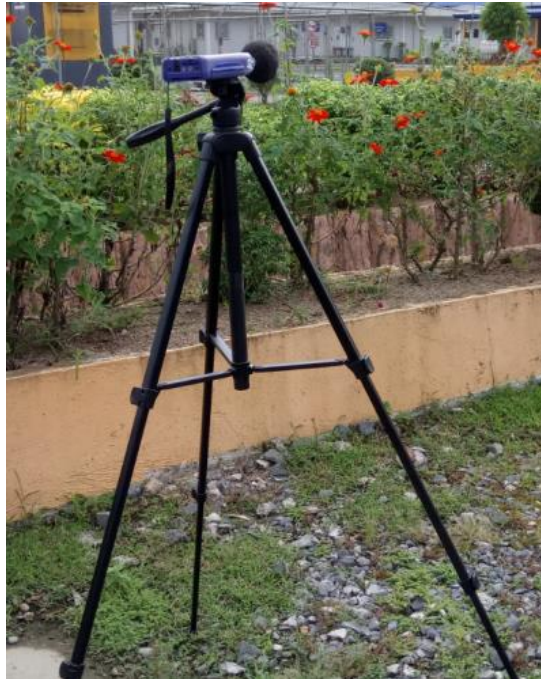
Photo 6-22: Noise level meter

Portable noise monitoring equipment is used to take noise level measurements at different stations. Photo of the monitoring activity is presented in Photo 6-21 and Photo 6-22.
