Environmental Performance Report and Management Plan

DIDIPIO GOLD-COPPER PROJECT

INCREASE IN ANNUAL PLANT THROUGHPUT RATE
(3.5 Mtpa to 4.3 Mtpa)

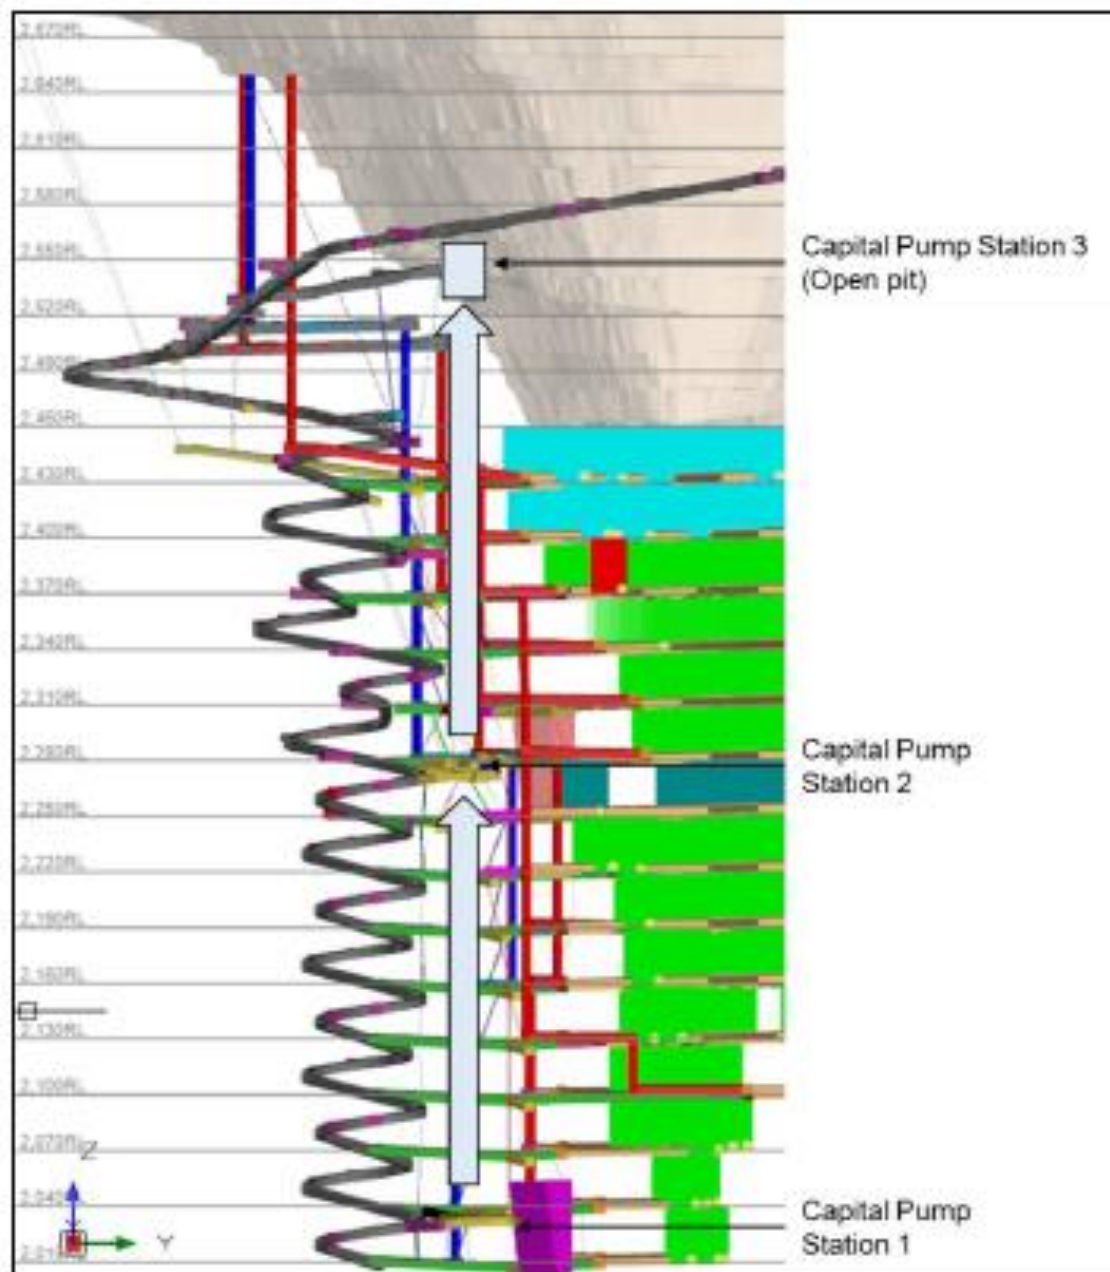
Figure 1-10: LOM Dewatering Schematic

The capital dewatering system for Didipio underground is designed to have three main pump stations at successively higher levels in the mine. The system is designed to pump 450 l/s maximum flow from the lowest level to the sediment ponds adjacent to the green tank at the surface. The capital pump stations and duties are summarized in Table 1-5, and the life-of- mine dewatering schematic is provided in Figure 1-10.

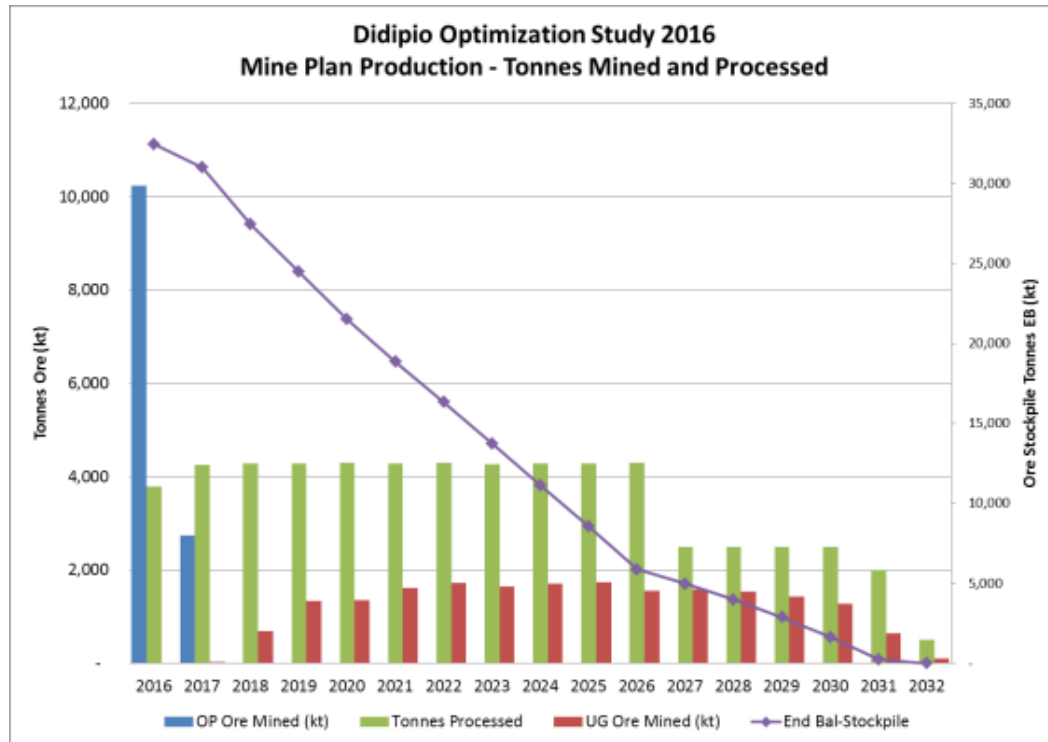
Figure 1-12: Production Summary

Mining will continue to be carried out by open pit methods until the end of 2017 and thereafter by underground mining where mill feed is supplemented by surface stockpiles. The underground access decline development commenced in 07 March 2015. LHOS with paste backfill is planned to mine underground stopes below the open pit. The production profile is reported in Figure 1-12.

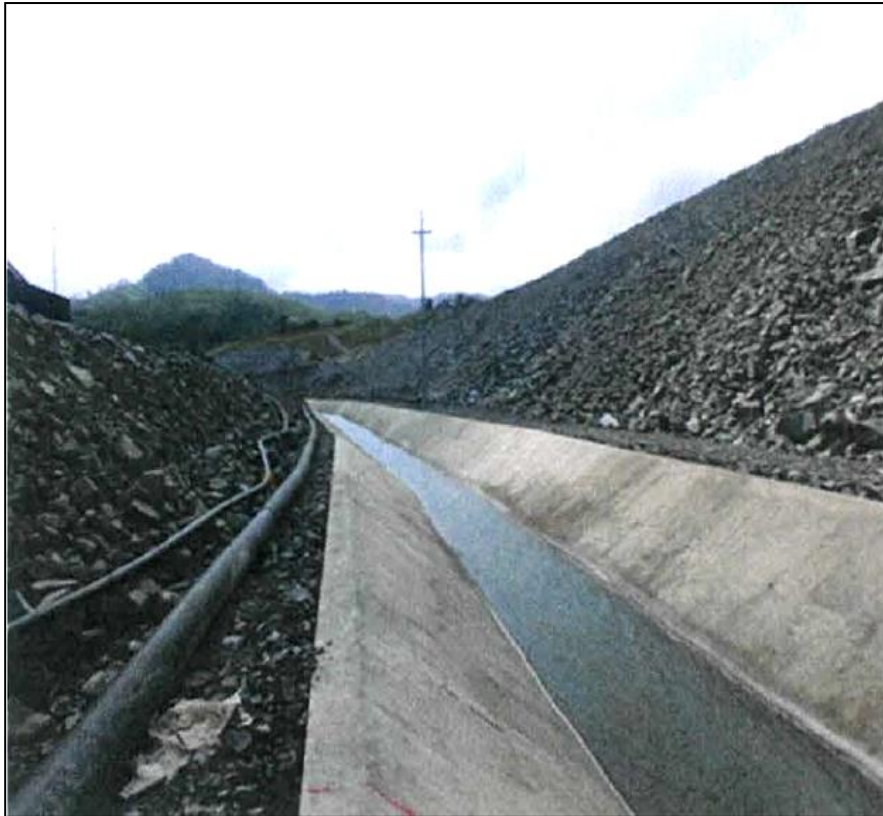
Photo 2-4: Dinauyan River Diversion

One of the major changes in drainage morphology was the diversion of Dinauyan River. Dinauyan River Diversion (Photo 2-4 and Figure 2-32) was constructed in accordance to the OGPI Mining optimization study which incorporate the Stage 4 and 5/6 final pit shells. The 705 m long, 2 m deep by 8 m deep wide engineered concrete channel was designed by GHD to withstand flooding in events up to a 1:100-year flood. A tributary of Dinauyan River particularly Luminag Creek was also diverted to allow the development of the TSF. The downstream portion of the Luminag Creek flows through an underground pipe traversing the northern portion of the TSF. It then joins the Dinauyan River downstream of the TSF. The clay-lined and rock-armored Madadag Levee was constructed to divert clean water around the Didipio mine area directly into the river system.

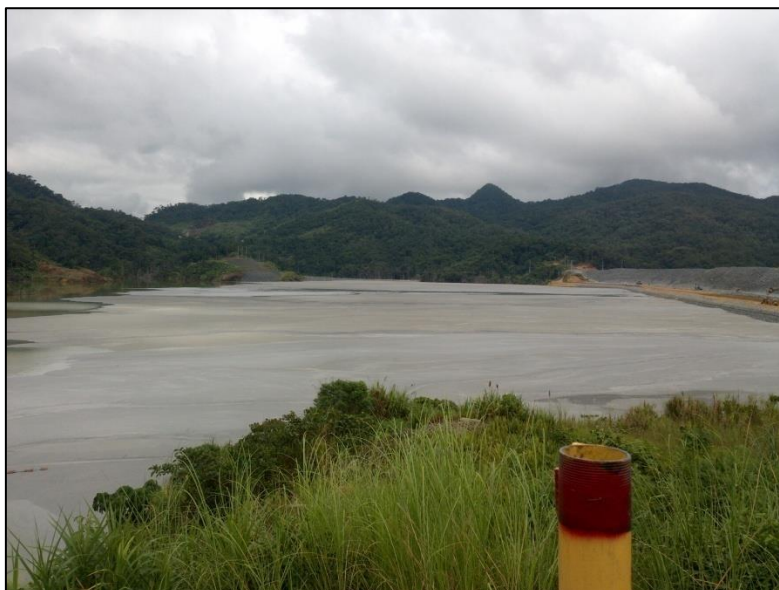
Photo 2-5: Tailings Storage Facility

The Tailings Storage Facility (TSF) (Photo 2-5), on the other hand, is the repository of process plant slurry (solids and water) tailings throughout the life of the mine. About 79% of the water requirement of the Processing Plant is provided by the TSF recycled water. During the wet season, large volume of surface water runoff reports to the TSF. To maintain the level at TSF of 5 m freeboard, TSF water is pumped to WTP for treatment prior to discharge to Dinauyan River. Of the total 6.7 Mm³ of TSF water pumped out in 2017, 71% was treated in the WTP, 28% was discharged directly to river and 1% recycled to the process plant. (OGPI Water Management Plan, 2018)

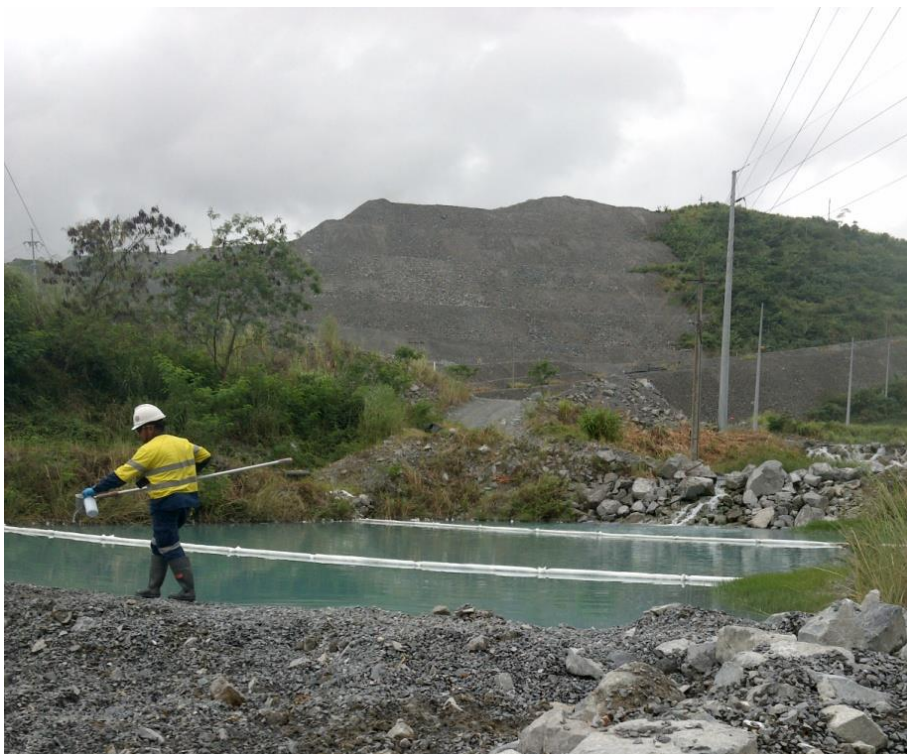
Photo 2-8: SP 06

One of the conditions in the discharge permit for Silt Pond 06 (SP06) is the quarterly monitoring of effluent parameters pH, TSS and oil and grease. Parameters monitored and reported by OGPI in their SMR are TSS, BOD, cadmium, arsenic, lead, mercury, iron, zinc, dissolved copper, nitrate, sulfate and free cyanide.

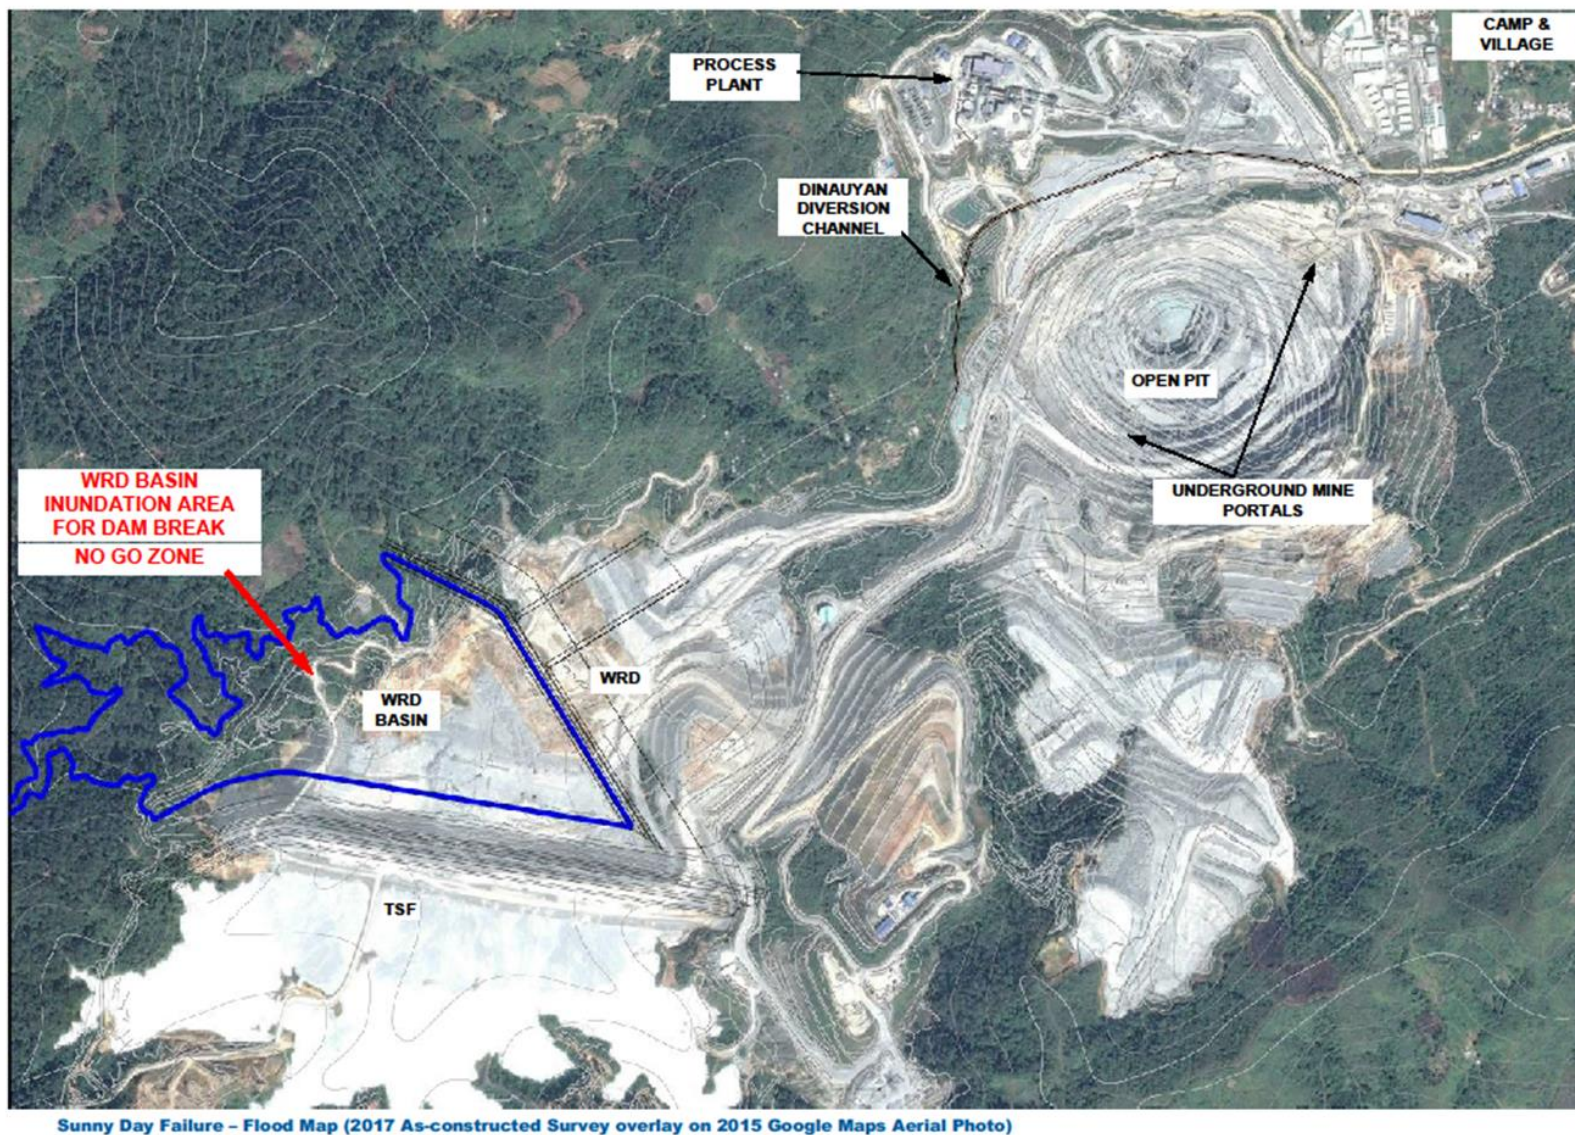
Figure 4-6: Sunny Day Failure – Flood Map

The overall mine waste storage concept provides an integrated solution to store waste rock materials and tailings while initially diverting and eventually throttling Dinauyan River flows, to mitigate the risk of flooding the downstream mine pit.

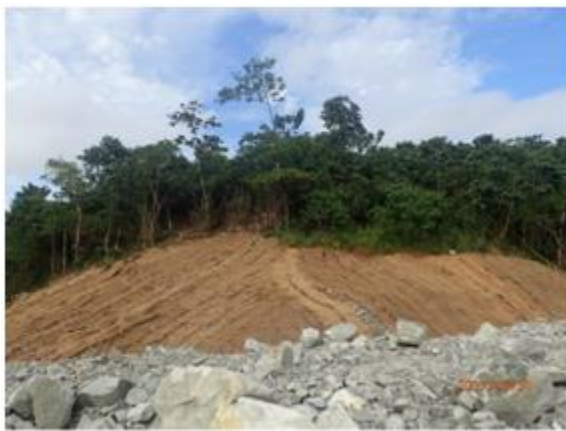
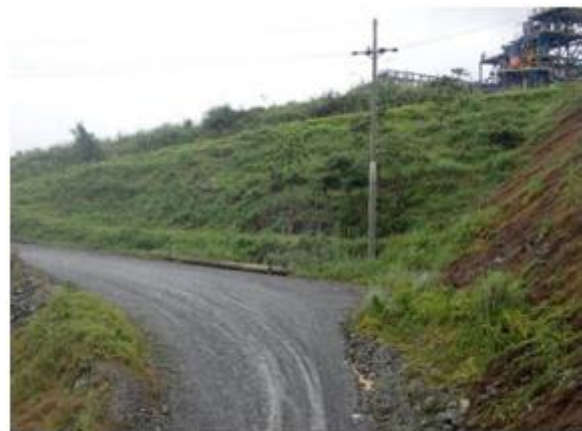
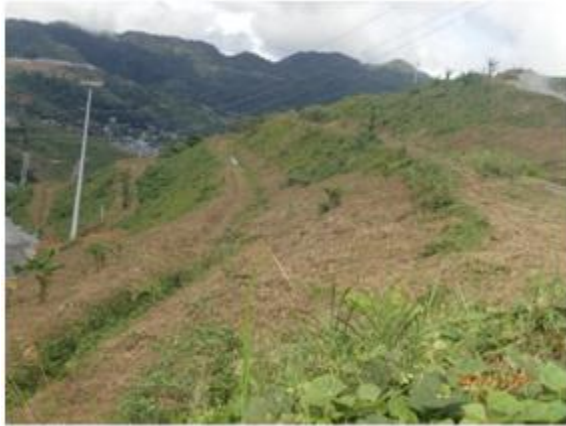
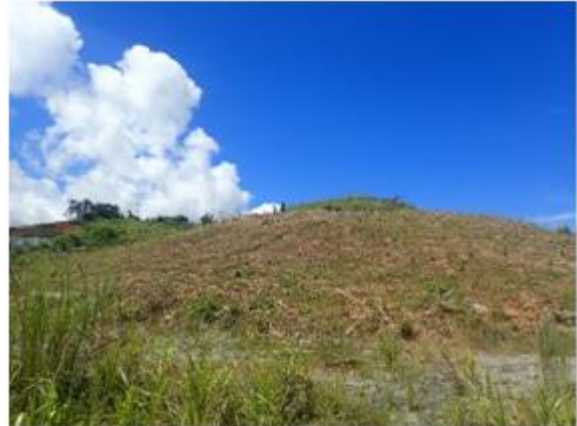
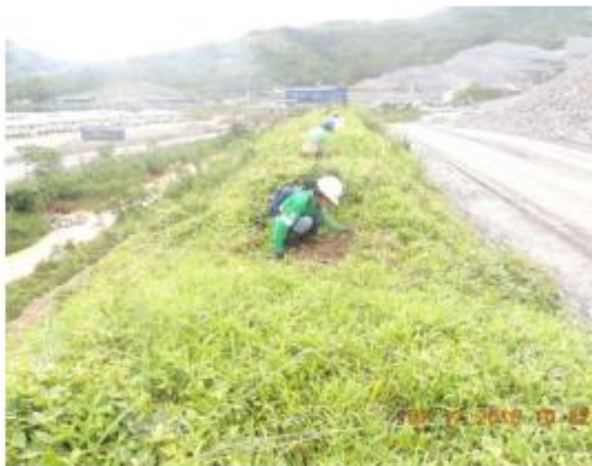
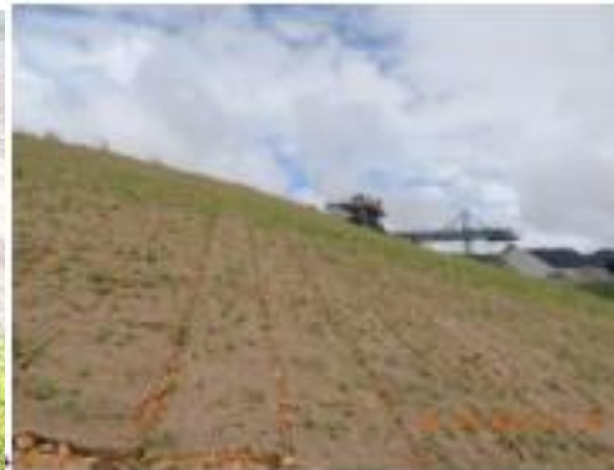
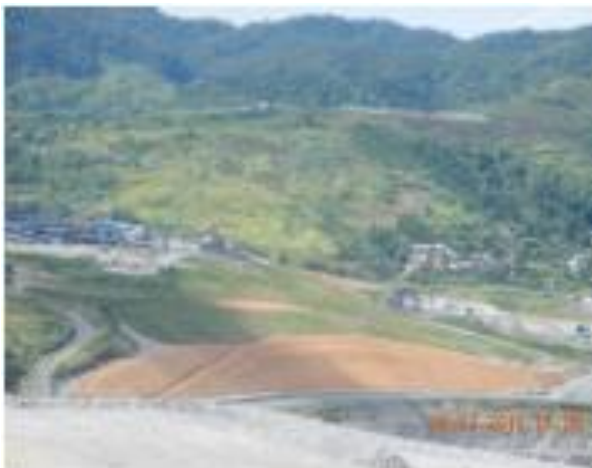
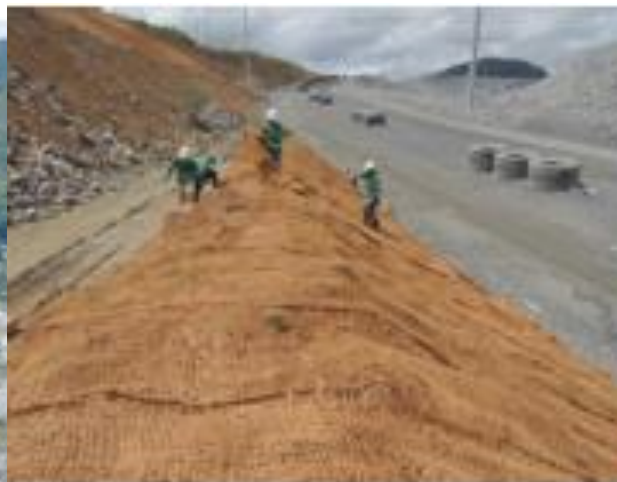
Erosion control blankets are temporary erosion controls that provide cover over exposed soils. It reduces raindrop impacts by providing cover. These controls are commonly use on earth embankments and slopes before and during revegetation phase. Currently, Didipio mine has used and will continue to use cocomats in combination with various revegetation techniques.

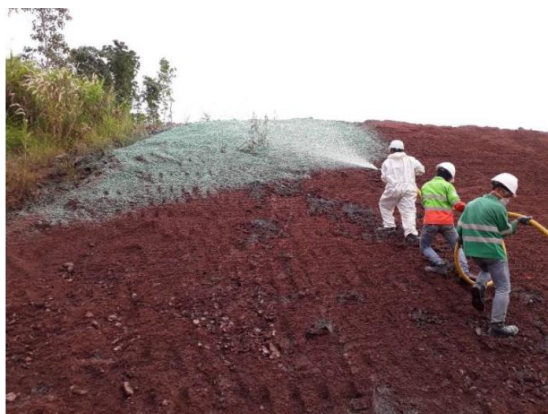
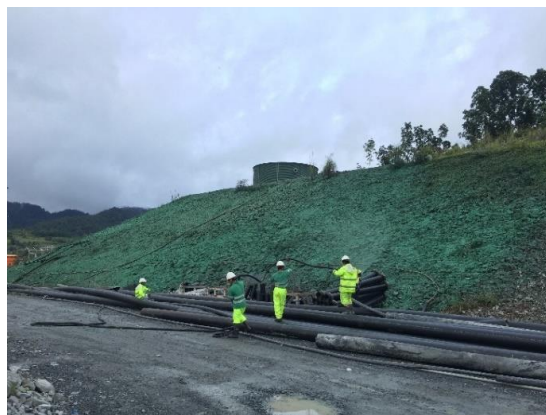
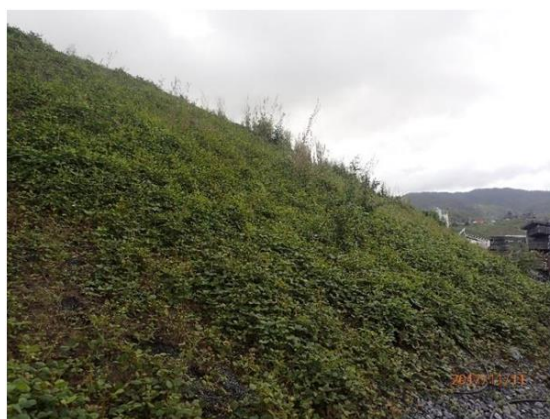
Hydroseeding was adopted by OGPI to address the problem of soil erosion control and progressive rehabilitation especially for those areas with insufficient soil and rock phases area.

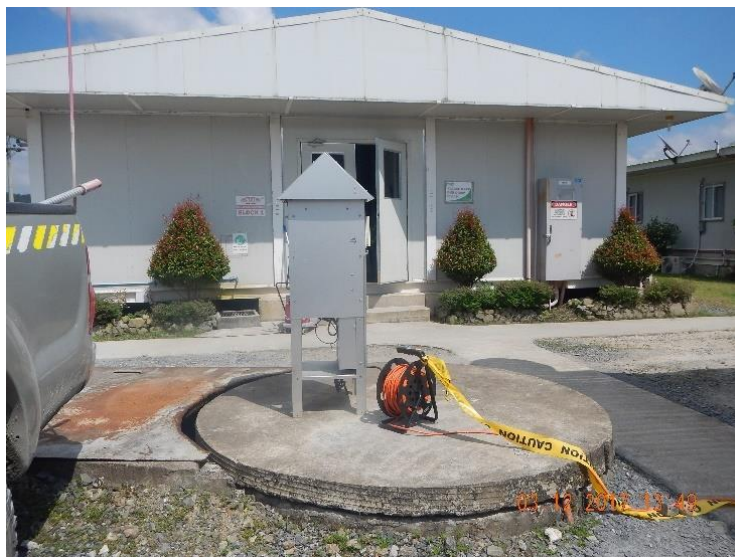
Locations of air quality monitoring are shown in Figure 6-103. The air quality monitoring program of OGPI focused on ambient air quality monitoring to determine impact of project operation to nearby residents. Air quality monitoring equipment, high volume sampler, is used to monitor total suspended particulates (TSP). Photo of the high-volume sampler is shown in Photo 6-19.

Photo 6-19: High-volume sampler for Total Suspended Particulates (TSP)

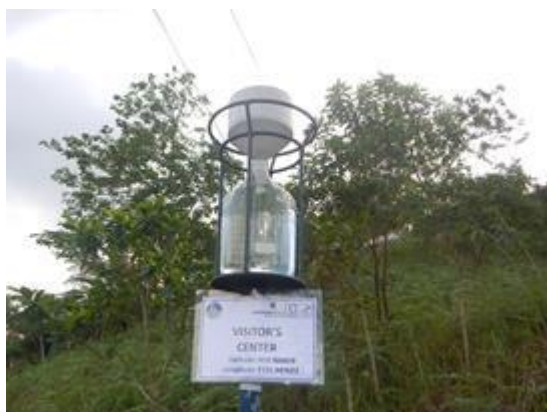
Monitoring stations close to dust sources are monitored using dust deposition gauges which is analysed monthly. A dust deposition gauge is stationary dust collecting equipment for particulate matter that rapidly settles from the air. Deposited dust is assessed as insoluble solids as defined by Standards Australia, 2003, AS/NZS 3580.10.1:2003: Methods for Sampling and Analysis of Ambient Air - Determination of Particulates - Deposited

Matter - Gravimetric Method. The standard has a maximum limit of total deposited dust level of no more than $4\text{g}/\text{m}^2/\text{month}$. An example of dust gauge is shown in Photo 6-20.

Photo 6-20: Dust Deposition Gauge (DDG)

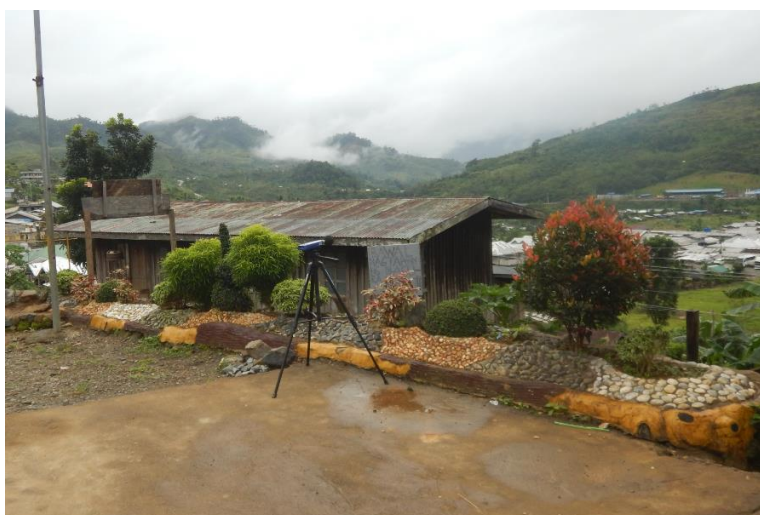
Portable noise monitoring equipment is used to take noise level measurements at different stations. Photo of the monitoring activity is presented in Photo 6-21 and Photo 6-22.

Photo 6-21: Ambient Noise Monitoring Activity

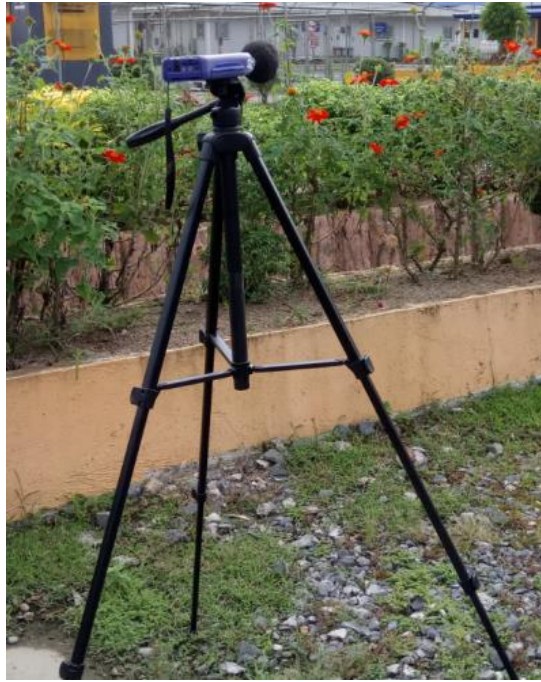
Photo 6-22: Noise level meter
