ENVIRONMENTAL PERFORMANCE REPORT AND MANAGEMENT PLAN (EPRMP)

**EXPANSION OF THE SILICA QUARRY OF THE HEIRS OF
ARTURO ZAYCO (HAZ) UNDER MINERAL PRODUCTION
SHARING AGREEMENT NO. 218-2005-VII**

OCTOBER 2019

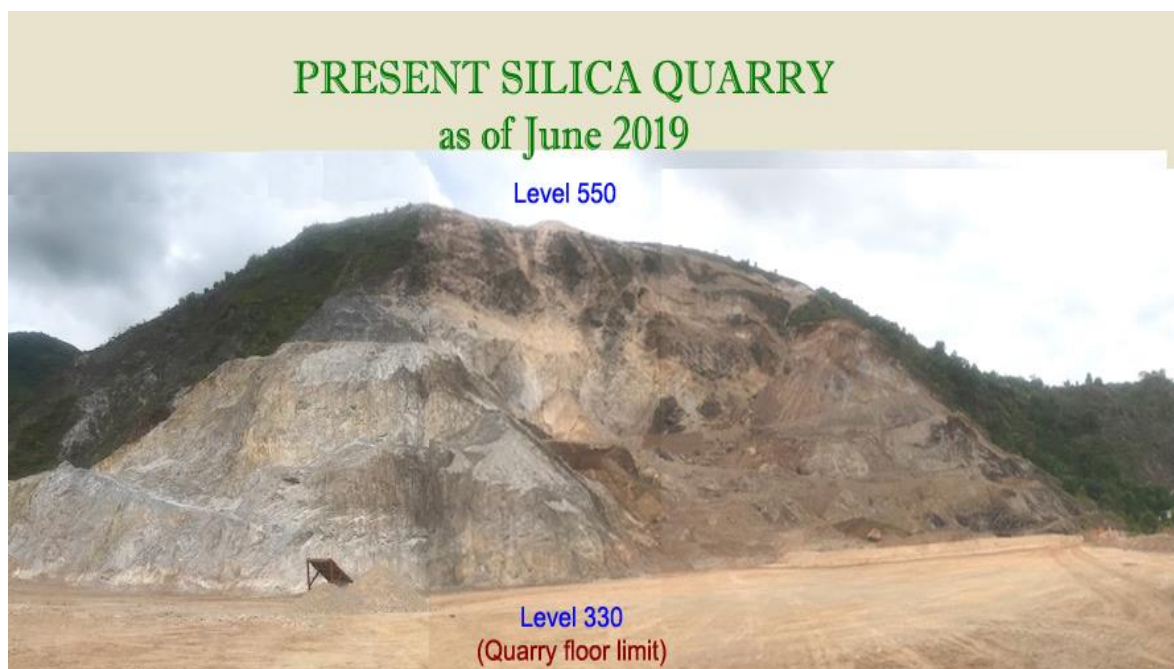
Figure 2-8. Latest Quarry Area

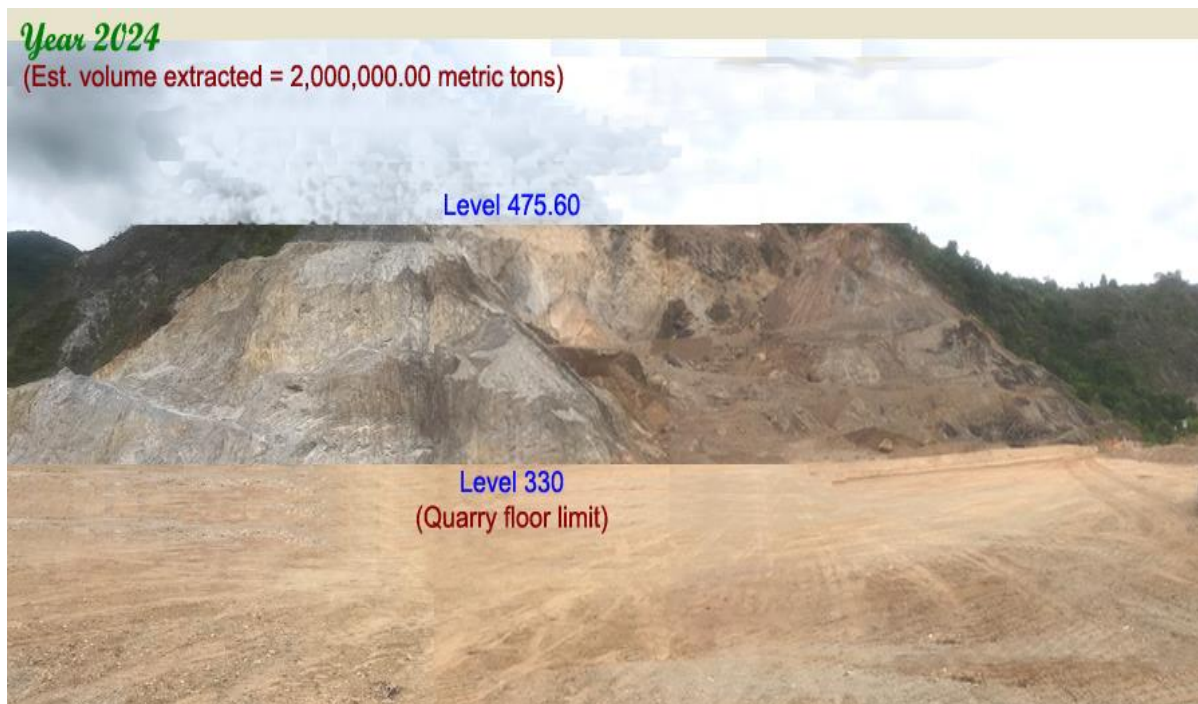
Figure 2-10. Silica Quarry as of Year 2024

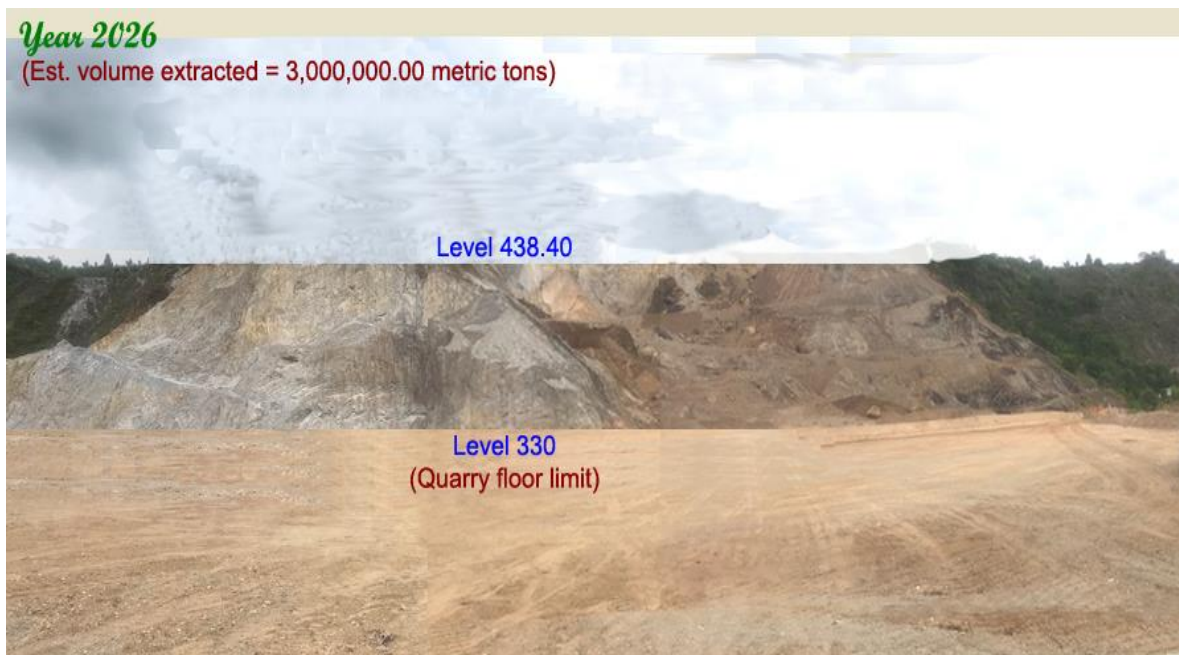
Figure 2-11. Silica Quarry as of Year 2026

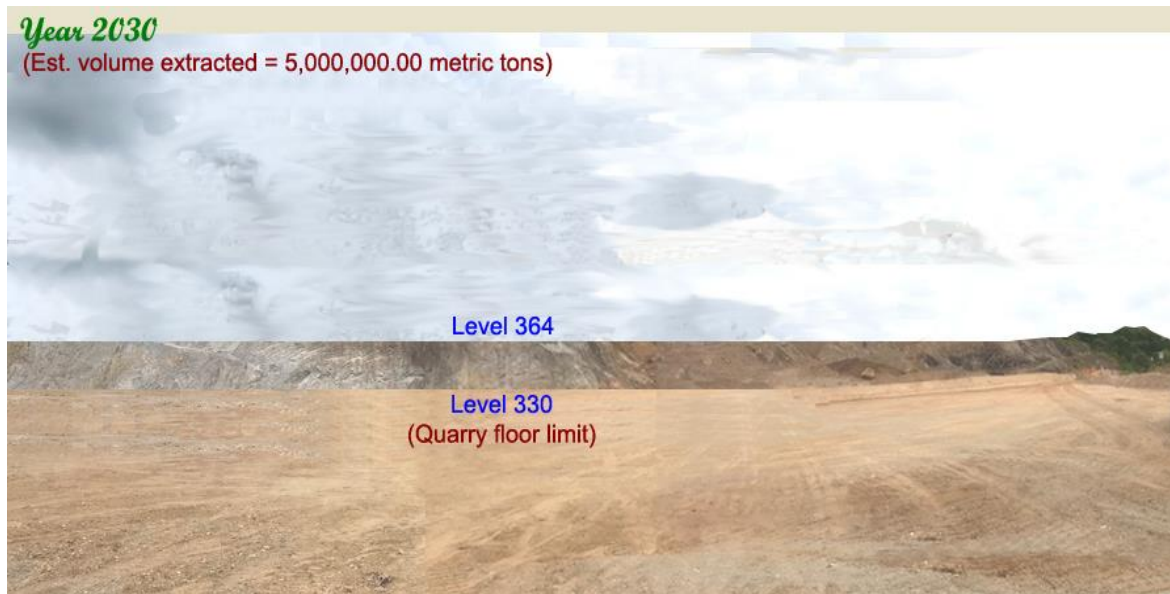
Figure 2-13. Silica Quarry as of Year 2030

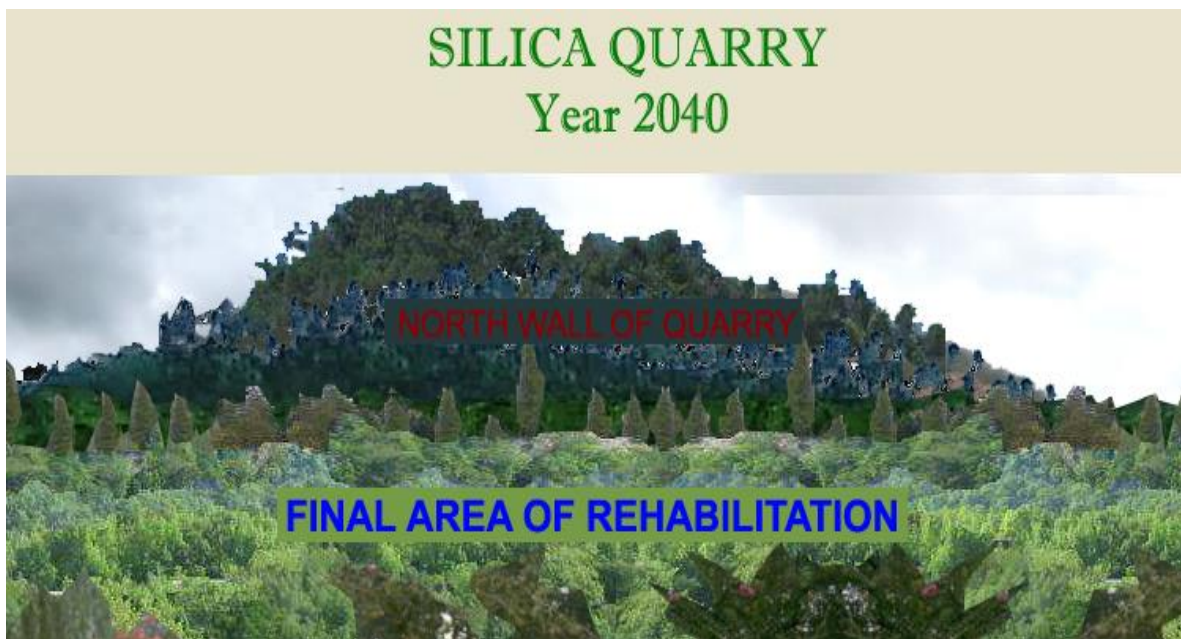
Figure 2-14. Silica Quarry as of Year 2040

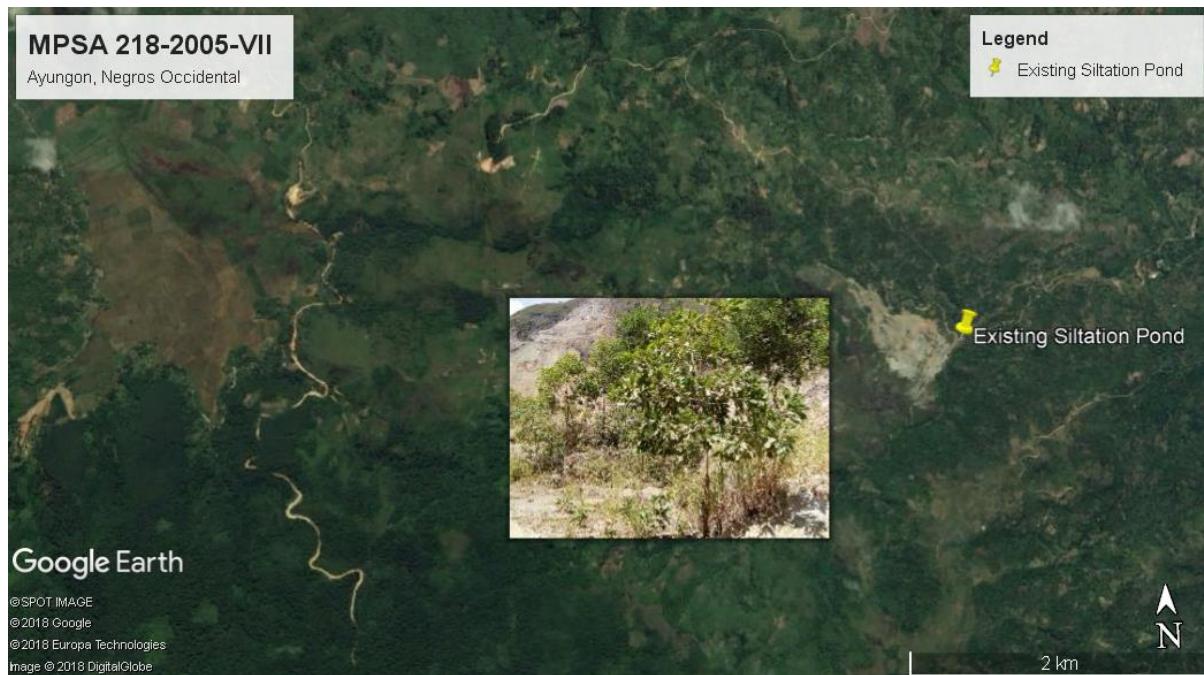
Figure 2-26. Existing Siltation Pond

The table below shows the geographical locations of silt traps and siltation ponds and the map of the location of the siltation ponds can be seen in Figure 2-26.

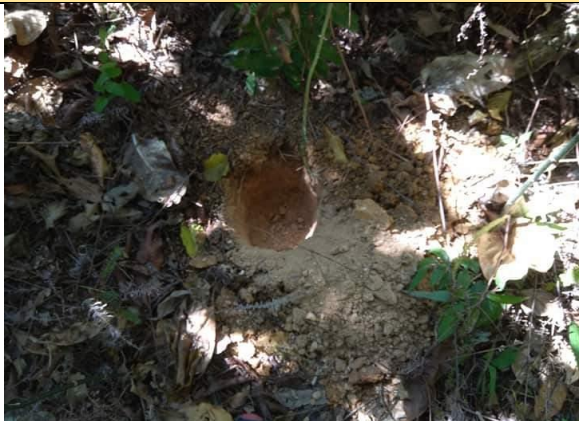
Sampling station	Geographic coordinates	Description	Photograph
S1	09°51'36.7" N 123°04'24.6" E	Covered with grass and shrubs.

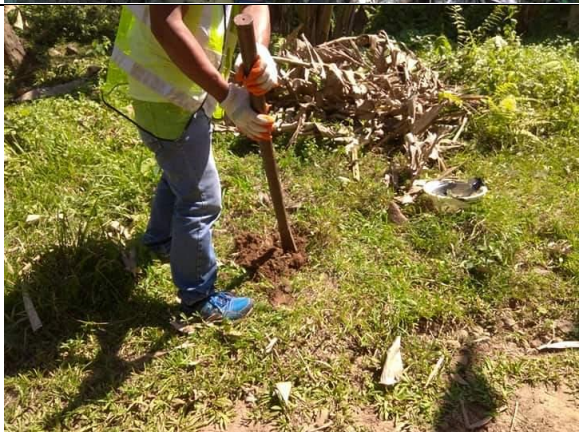
S2	09°51'17.1" N 123°04'56.8" E	Mixed plantation of coconut and banana

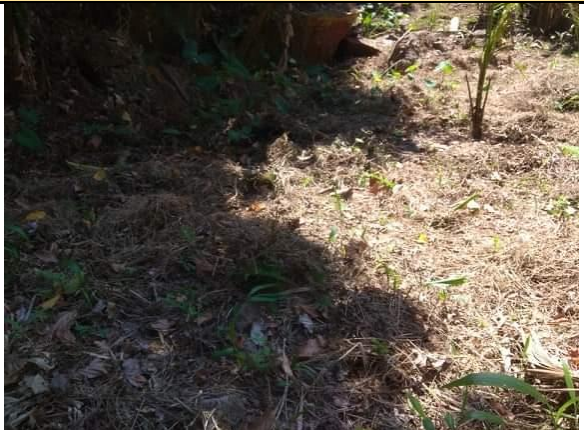
Sampling station	Geographic coordinates	Description	Photograph
S3	09°50'59.9" N 123°04'41.6" E	Banana plantation with some grass and shrubs

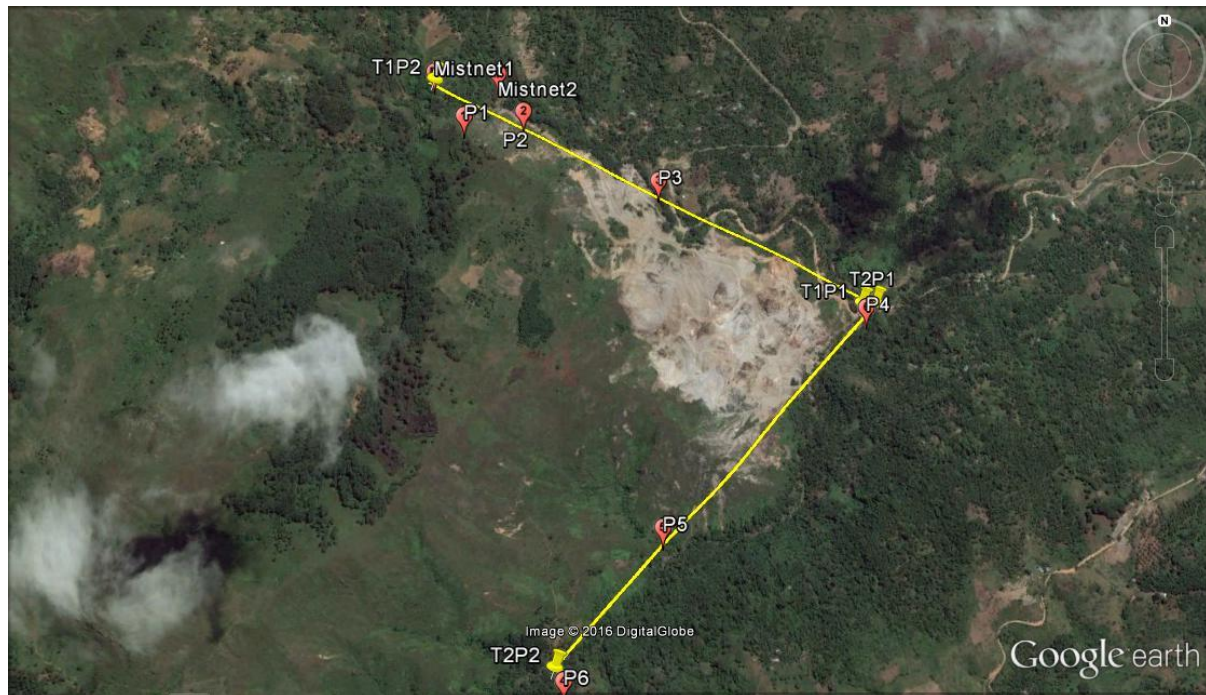
Figure 2-28. Flora Survey Plots (TP1-6) and Fauna Transects and Sampling Points (T1P1-T1P2; P1-P2) within the Silica Quarry Project Site

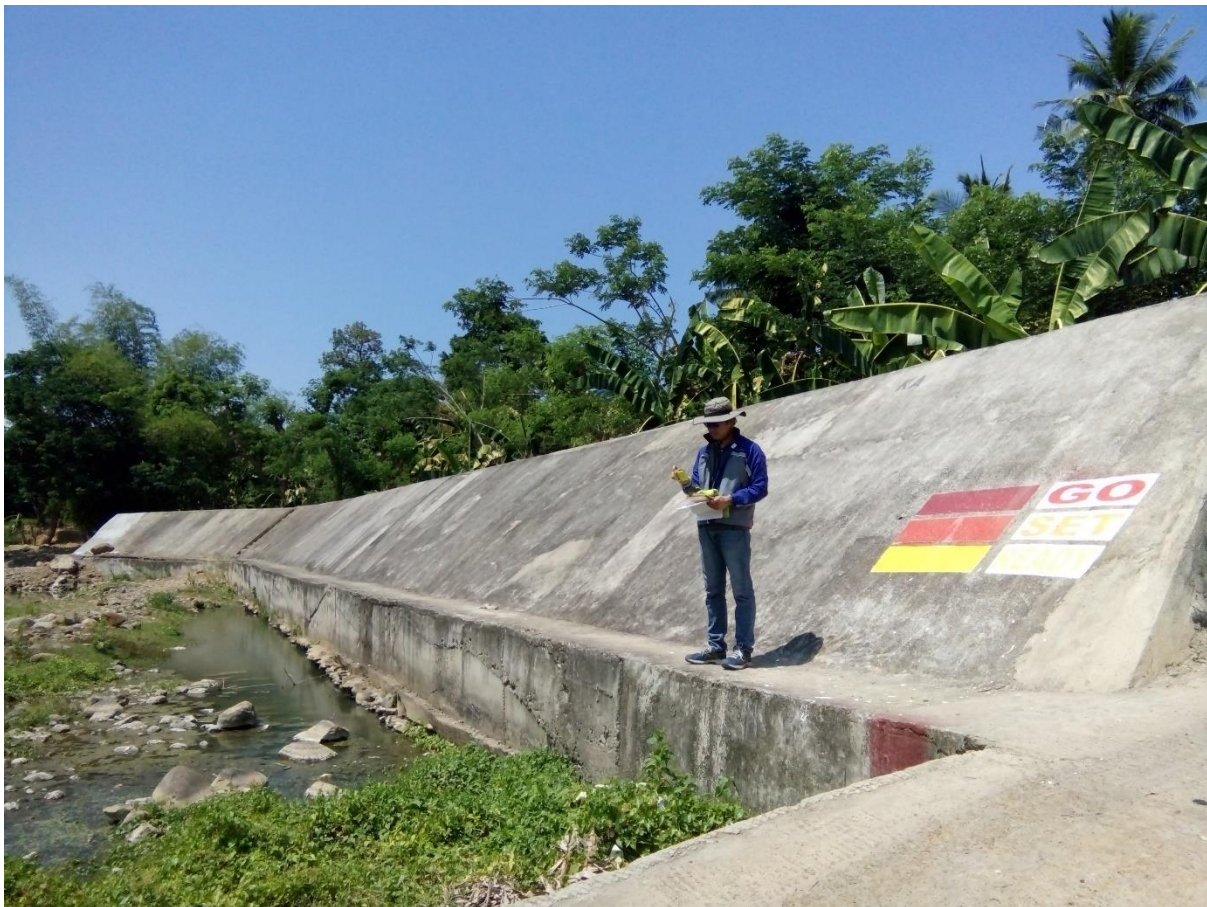
The photograph below exhibits the minimum discharge rate of the Maaslum River. Water depth is relatively shallow with sand, silt and clay deposits accumulating at the creek beds. Increase in sediment deposition along creek and stream channels will cause reduction in the stream volumetric flow. As with the reduction in water depth, reduction in the volumetric flow will also adversely affect the aquatic habitat. There will be a decrease in oxygen supply, decrease in the area of aquatic habitat, and consequently an increase in aquatic resource competition.

Figure 2-52. Water level manual monitoring in the Maaslum watershed

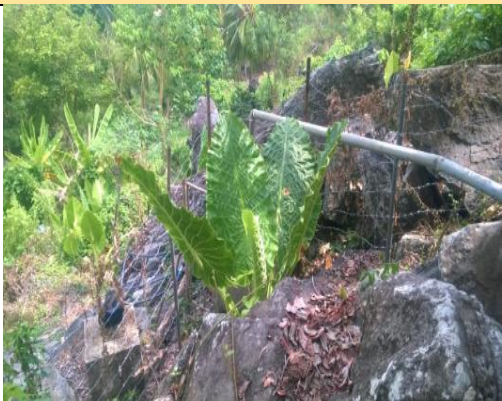
Spring at Sitio Binatkan	<p>The sampling station (GW-01) is located 325m. Currently, the spring is being utilized by the local water district and has installed water pipes.</p> <p>There is a small portion or opening at the source where water sampling was done. The vicinity of the spring is concretized.</p>	<p>The water sample in this station is clear (in terms of color) with some suspended particles.</p> <p>There are some patches of settlements below the sampling station.</p> <p>Vegetation is still present in the area and the source of water is concretized.</p>	<p>9° 51.199' N 123° 05.334' E</p> <p>325 masl</p>
GW-02

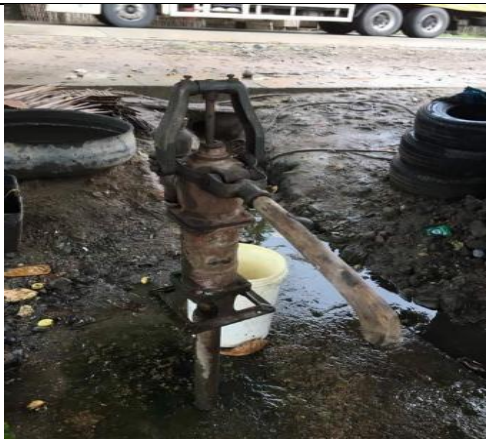
Beside Municipal Road	<p>GW-02 is located beside the municipal road and is owned by the vulcanizing shop owner beside it. It is being used for drinking and other domestic use. The pump well was said to have been established since the 1970s.</p>	<p>Similar observation in the area. No changes observed in the vicinity.</p>	<p>9° 50.940' N 123° 08.306' E</p>
