Figure 1- Location Map

1.3 Project Rationale²

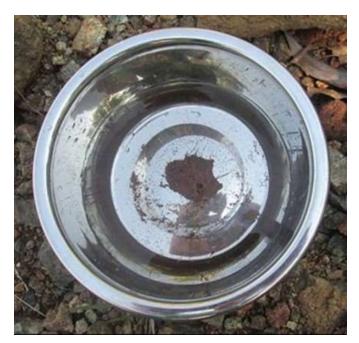
Figure 31 - Start of Slake Test, P7 SS1

All of the six soil sampling locations were field tested for their soil aggregate slaking property and, for brevity slaking test for P7 SS1 is illustrated in **Figure 31** for the start of the slake test and at the end of the test (**Figure 32**) after approx. 10 minutes.

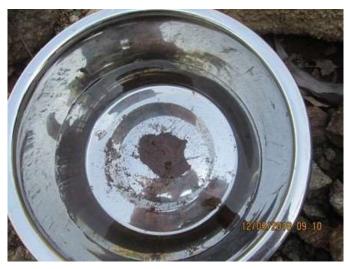
Figure 32 - End of Slake Test, P7 SS1

Soil response to rapid wetting is observed for a period of 10 minutes. The result shows that the soil can be classified as Class 4 or very stable (Figure 32). There is no slumping of particles after 10 minutes of submergence in water. The whole fragment remains intact with no evidence of swelling or disintegration of particles.

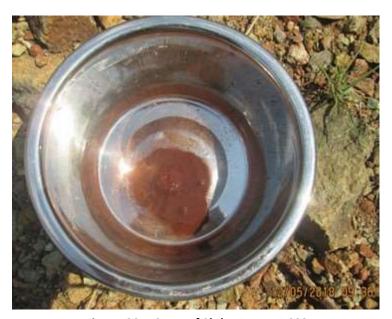
Figure 33 - Start of Slake Test, P7 SS2

is observed rapid air bubble evolution. A period of 10 minutes of water submergence is allowed before observance of any slaking property. Figure **34** showed after 10 minutes of water immersion, there was a total slumping of particles of the whole fragment. The surface soil found in Parcel 7 SS2 is therefore classified as Class 1 very unstable.

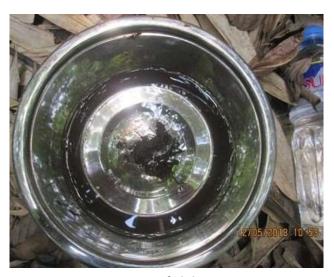
Figure 35 - Start of Slake Test P2 SS3

The Slake test procedure is repeated in the Top end portion of Parcel 2. (**Figure 35**). A period of 10 minutes of water submergence is allowed before observance of any slaking property of the soil. **Figure 36** shows that the soil of Parcel 2 on the Top end portion is very stable (Class 4). There was no slumping of sub-crust.

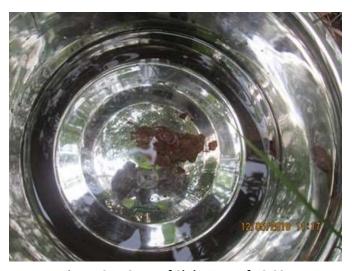
Figure 37 - Start of Slake Test of P2 SS4

Reaching the middle portion of Parcel 2 a separate slake test were made and is presented **Figure 37 and Figure 38.** After 10 minutes of water submergence a slight slumping of the crust was observed. This portion of Parcel 2 can be classified as Class 3 or moderately Stable.

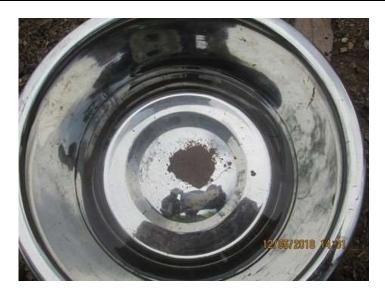
Figure 39 - Start of Slake Test P8 SS5

Slake test for Parcel 8 SS5 is presented in **Figure 39** and **Figure 40**. There was an immediate slight slumping of the sub crust observed of the soil fragment within 5 -10 seconds after water submergence (**Figure 39**). After 10 minutes there was no further crust collapse observed. The soil of Parcel 8 can be classified as Class 3 or moderately stable. Slumping of sub-crust but most of the crust is intact.

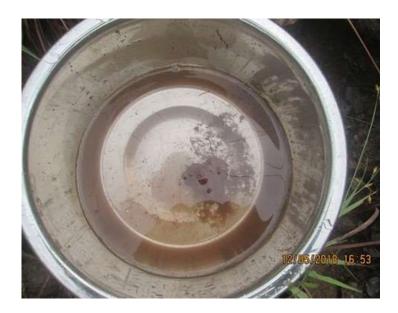
Figure 41 - Start of Slake Test P2 SS6

Shown in **Figure 41** and **Figure 42** is the slake test conducted in the end portion of Parcel 2. Upon water immersion of the soil fragment a slight slumping was observed, numerous air bubbles emerged (**Figure 41**). After 10 minutes, there was no further slumping observed the sub crust remains intact. In this case, the end portion of Parel 2 can be classified as Class 3

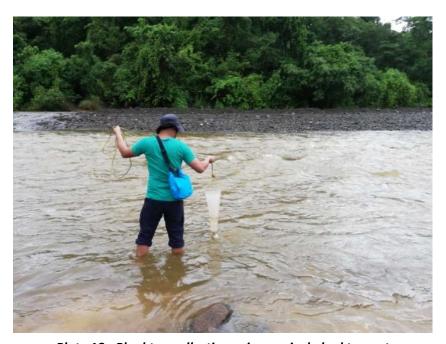
Plate 18 - Plankton collection using conical plankton net

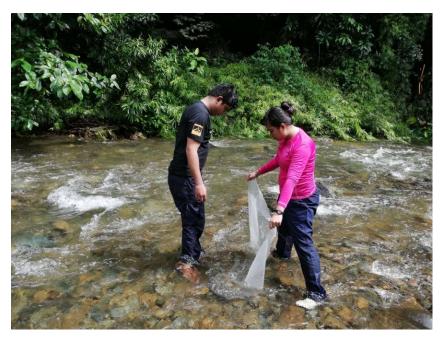
Plate 19 - Benthic macroinvertebrates collection using rectangular kick net

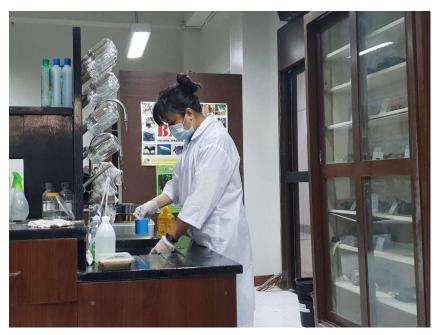
Plate 20 - Processing and filtering of plankton samples

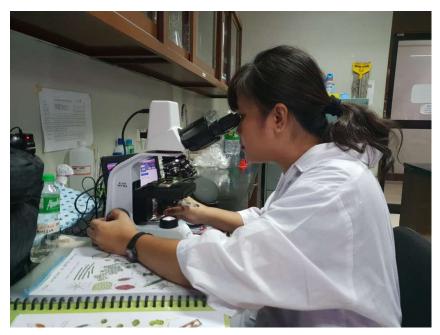
Plate 21 - Identification and quantification of plankton using compound microscope

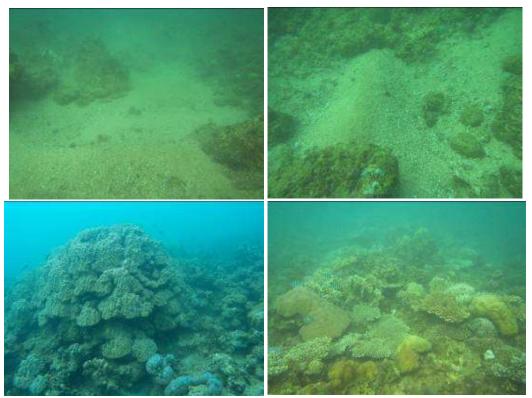
Plate 29 - Degraded reef flat observed in many manta tow stations with sandy substrate (upper photos); robust massive, branching and encrusting corals seen inside the MPAs.

only two stations hosted the fair coral cover of 25% live hard coral cover (LHC), both inside the Sinabacan MPA, while the rest of the stations only had 5 to 10% live corals, most of which are vividly stressed. The corals occur in sporadic reef flats in Barangay Uacon to Sinabacan. Thereafter, the entire manta tow belt in the next three Barangays revealed sandy substrate, except in the Batong Lakay MPA which was located about 300 meters offshore in Barangay Sinabacan. Coral damage is vividly the result of destructive fishing practices and coral bleaching, among others, the use of explosives in fishing and the use of sodium cyanide to catch live fish. Of the forty-seven (47) manta tow benthic observations, twenty (20) stations in the reef flats were dominated by dead corals with algae, ranging from 10 to 90% of the benthic substrate. Sargassum sp and Padina sp covered the dead corals and settlement of new recruit appear to be unlikely (Figure 88; Plate 29). Across the tow stations, live hard coral cover was averaged at only 2%, while dead coral with algae was recorded at 18% (Figure 86).

In the Sinabacan MPA, however, live corals were robust, with old massive corals growing amidst an array of tabulate and branching corals. More importantly, coral recruits were present, indicating the presence of a source of planulae in the area. Schools of surgeonfishes and fusiliers were observed even in degraded patches.

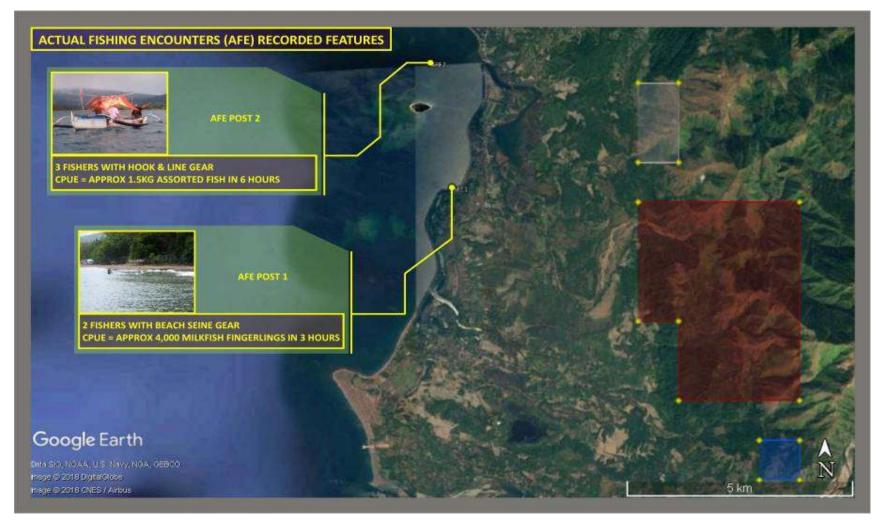
Figure 98 - Highlights of documented actual fishing operations during marine ecology baseline assessment in the coastal impact area of the proposed ChinaMin Nickel Project in Candelaria, Zambales; June 2018

The highlights of findings from actual fishing documentation are shown in Figure 98.

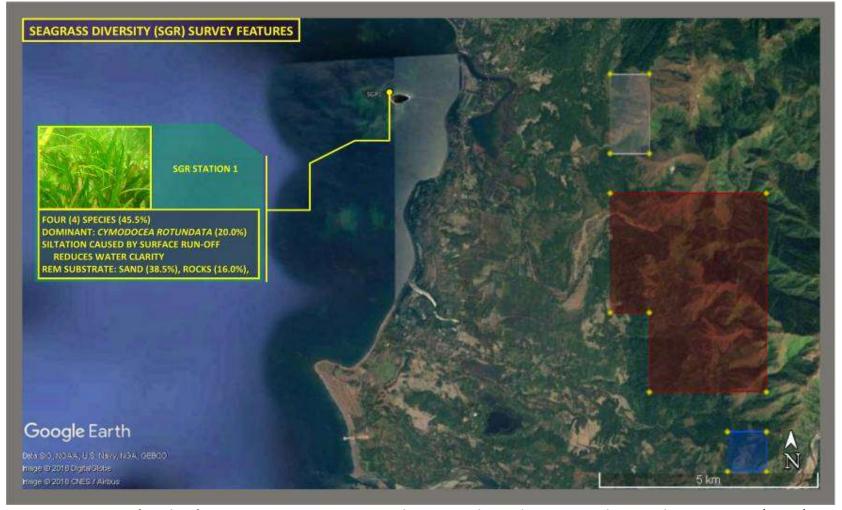
Figure 100 - Summary of results of seagrass assessment in one sampling station during the Marine Ecology Baseline Assessment (MEBA) survey proximal to Isla de Potipot, Barangay Uacon, in Candelaria, Zambales; June 6, 2018; (Observers: Victor L. Pantaleon and Ronald T. Pocon; map prepared by Jose Rene Villegas).

Results of the assessment, summarized in **Table 57** and shown in Figure 27, show four (4) segarass species dominated by *Cymodecea rotundata* (ribbon seagrass) — a species which was not mentioned in the 2009 report of the BFAR, and *Thalassia hempricii* (sickle seagrass), covering 20% and 21% of the total seagrass meadow surveyed, respectively. The two other seagrass species are *Syringodium isoetifolium* (tube seagrass) and *Halophila ovalis* (spoon seagrass), accounting for 4% of the seagrass community combined (**Figure 99**; **Plate 32**). The later species, *H. ovalis*, was also not encountered in the previous report for the ICRM Plan. The seagrass were growing intermittently, as sand and rocks were prominent, covering more than half of the transect area (54.5%). Apart from 2 specimens of the ball sea urchin (*Tripnuestes gratilla*) and a carapace of the spider shell (*Lambis sp*) encountered in the seagrass transect, no significant community of macro-invertebrates or holothurians were seen in the seagrass meadow.

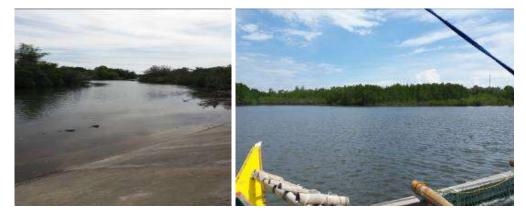
Plate 33 - Mangroves in the Malabon River with flood control revetment in the foreground (left); and in Uacon Lake (right).

Transect 3 yielded a total of thirty (30) trees in the transect, owing to the thin strip of mangroves in the banks of the Malabon River. Moreover, concrete flood control revetments have caused drying up of some portions of the mangroves fringing the river. The area surveyed has old growth of *Avicennia alba* with 208 centimeters Diameter at Breast Height (DBH) and *Sonneratia alba* with 58 centimeters DBH. There is abundant growth of *Agallocha excoecaria* in the area due to its sandy-mud substratum. However, propagules of *Rhizophora sp.* though abundant in the area may not be able to grow robustly due to the nature of the substrate and reduced inflow of seawater in some portions of the mangrove due to the establishment of concrete flood control structures.

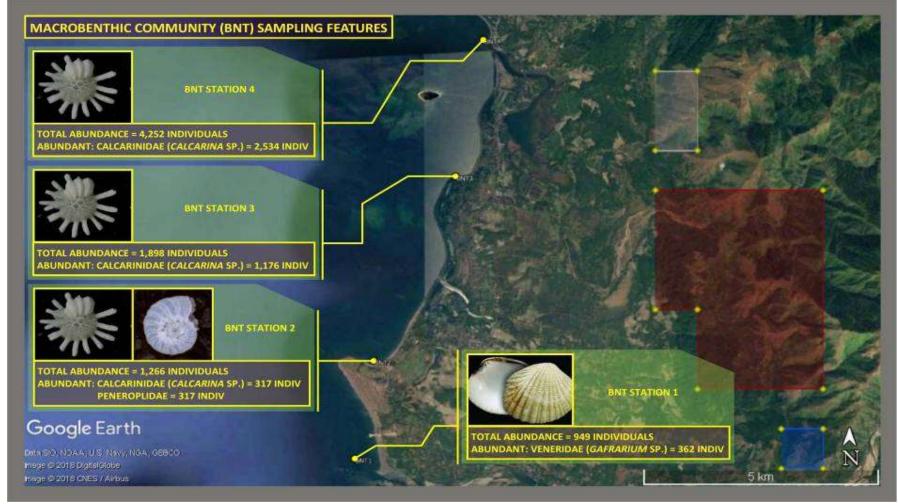
Figure 45. Summary of macrobenthos abundance and richness in four sampling stations across the coastline of Candelaria Municipality as Marine Ecology Baseline Assessment results for the WESTCHINAMIN MP, Candelaria, Zambales; 06 June 2018.

north of the survey area. However, based on the Wilhm criteria (1975), these diversity values are poor since this criteria classified diversity indices that are <3.0 as low and indicates low community stability. Importantly, there were no rare, endemic, or threatened organisms present, as the identified groups are common and cosmopolitan in distribution.

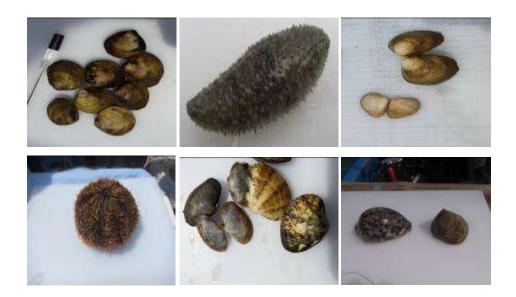
Plate14. Some commercially important macro-invertebrates catalogued during marine ecology baseline assessment in Candelaria, Zambales — Top Row: marsh clams (Polymesoda sp); sea cucumber (Stichopus chloronotus), another marsh clam (Polymesoda erosa). Bottom: Sea urchin (tripnuestes gratilla, venus clams (Tapes sp and Liconcha sp) and top shell (Trochus sp.) with tiger cowrie (Cyprea sp)

In the coral and seagrass stations surveyed, the presence of macro-invertebrate organisms was not encountered in significant distribution. A thriving community of marsh clams and venus shells were, however, encountered in the mangrove stations (Plate 14). A total of sixteen (16) species were catalogued, dominated by various bivalves (5 species) and gastropods (7 species. There were three species of echinoderms that included the lucrative sea cucumber and the ball sea urchins. Based on FAO's Species Identification Guide for Fishery Purposes (1998), eleven (11) species were noted to have a commercial importance and/or considered edible. Also, most of the species found were of significant interest to fisheries, forming a major part of the marine food chain and serving as diet to many species of fish and crustaceans in the reef ecosystem. Overall, this survey indicates a low biodiversity and population of the macro-invertebrates found in two major ecosystems i.e., coral reefs and mangrove area (Figure 44).

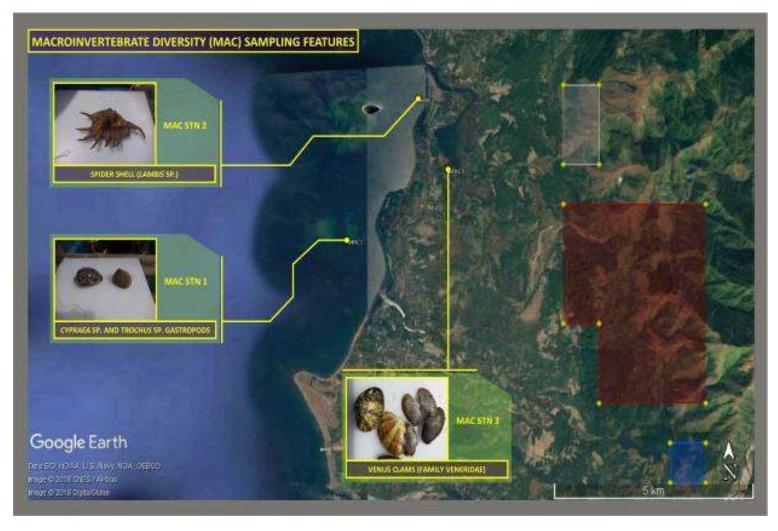
Figure 115 - Macro-invertebrates of commercial importance catalogued in three sampling stations during during marine ecology baseline assessment in the coastal impact area of the proposed ChinaMin Nickel Mining Project in Candelaria, Zambales; 06 June 2018; (map prepared by Jose Rene Villegas).
