ENVIRONMENTAL IMPACT STATEMENT

EAGLE CEMENT CORPORATION

Plant Site: Brgy. Akle, San Ildefonso, Bulacan, Philippines

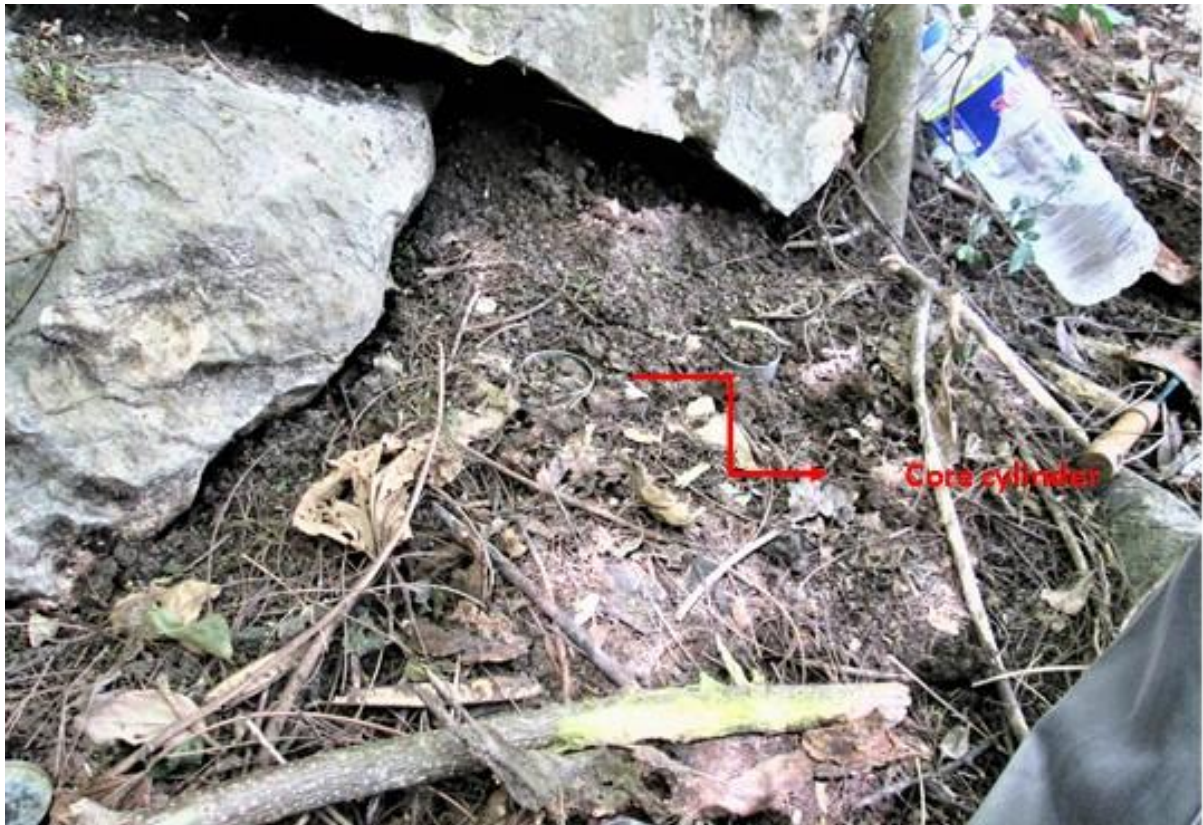
Figure 22 - Soil sampling for Bulk Density Using Stainless steel cores

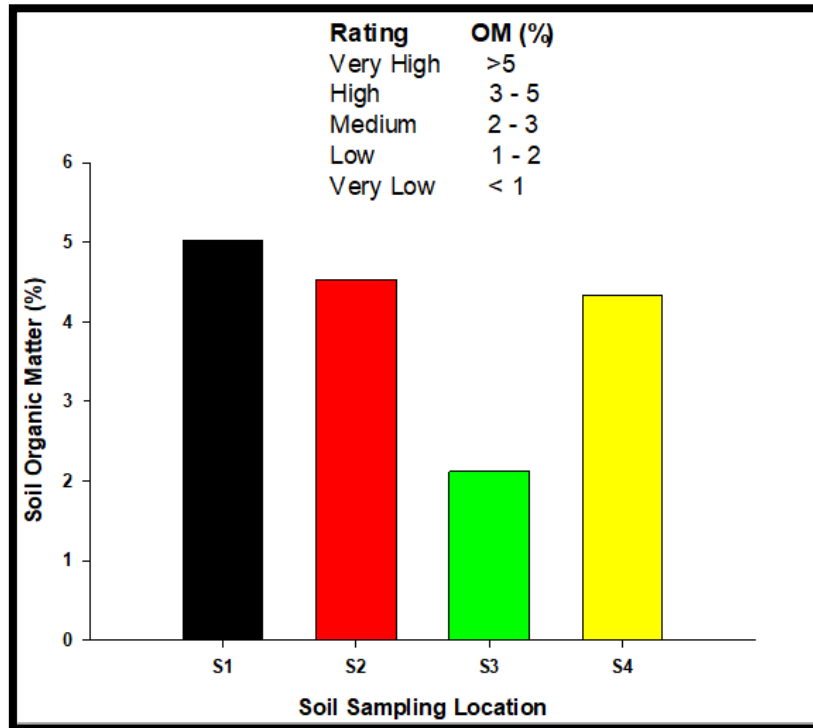
Figure 26 - Soil Organic Matter Content of the Soil Sampling Locations

Soil Organic Matter (SOM) content influences the physical and chemical properties of soils. It helps to improve the soil structure, conserve soil moisture and enhance the existence of useful micro-organisms resulting to high Cation Exchange Capacity (CEC), increased Water Holding Capacity (WHC) and improves soil consistence and infiltration rates of clayey soils.

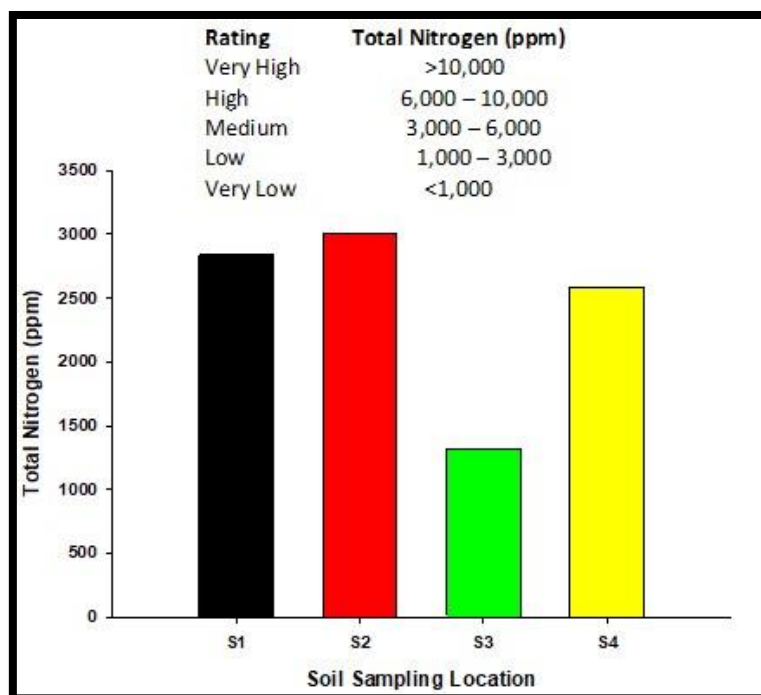
Figure 27 - Total Nitrogen Content of the Soil Sampling Locations

One of the essential elements needed by plants for growth and development is nitrogen (N). Being one of the major components of the chlorophyll it provides green color of the leaves and determines the size and the protein content of the produce. However, essential plant nutrient N is the most unstable in soils and can be easily lost through various transformations (e.g. volatilization, nitrification).

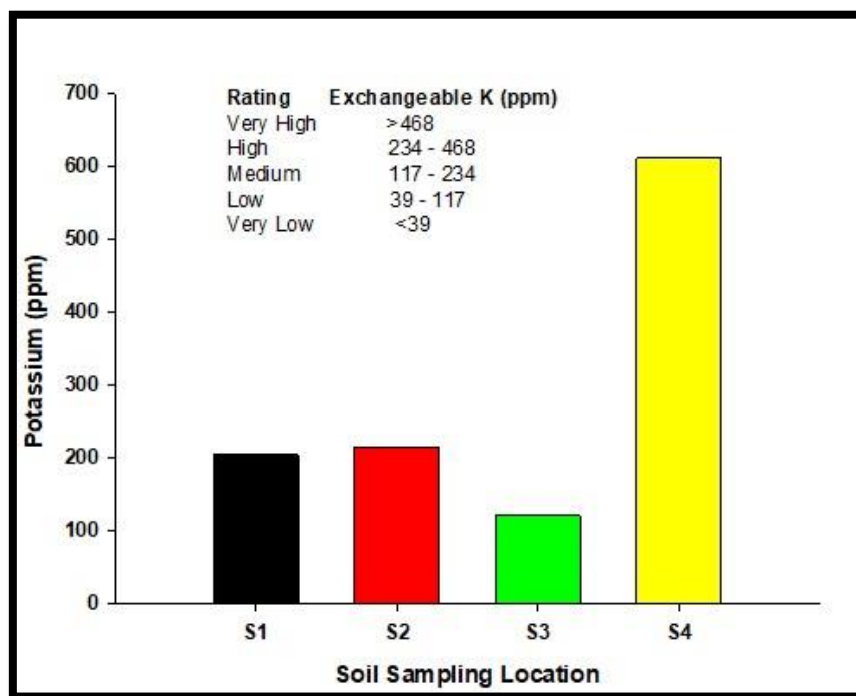
Figure 29 - Surface Soil Potassium Content of the Soil Sampling Locations

Available potassium (K) are usually found in an adequate supply in calcareous soils. This is due to native high levels of exchangeable K (Brady and Weil, 1999). However, when the soil is experiencing an aquatic moisture regime (i.e. more than 2000 mm rainfall a year) K deficiency may occur as K is highly soluble with water and is easily lost thru leaching and runoff. Over all, the soil of the Eagle Cement quarry area has an adequate K in its immediate soil surface.

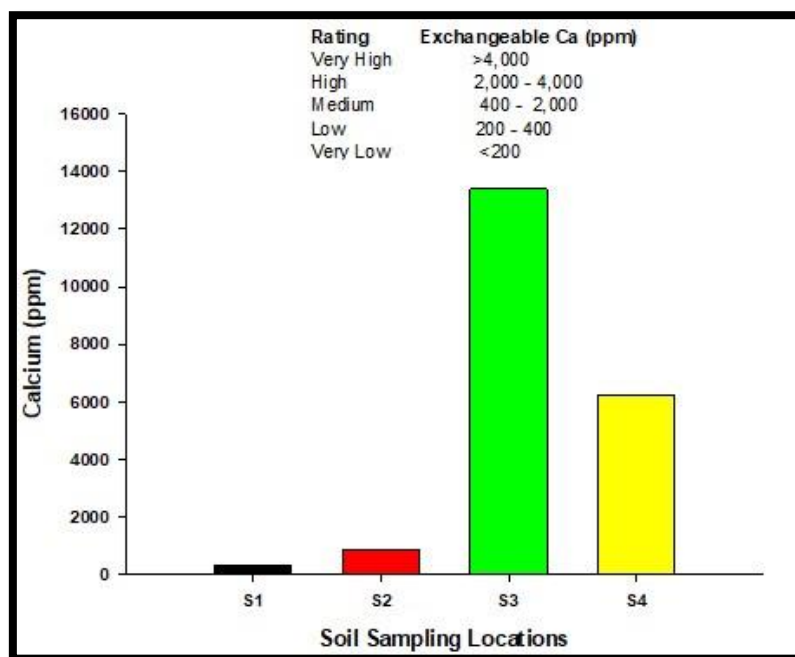
Figure 30 - Soil Surface Calcium Content of the Soil Sampling Locations

The native Ca content of the soil in the area (i.e. being a calcareous soil and the constant low elevation dust formation every heavy vehicle passing along the limestone quarry haul road area specially during dry road surface soil conditions inevitably have increased the Ca content of the topsoil.

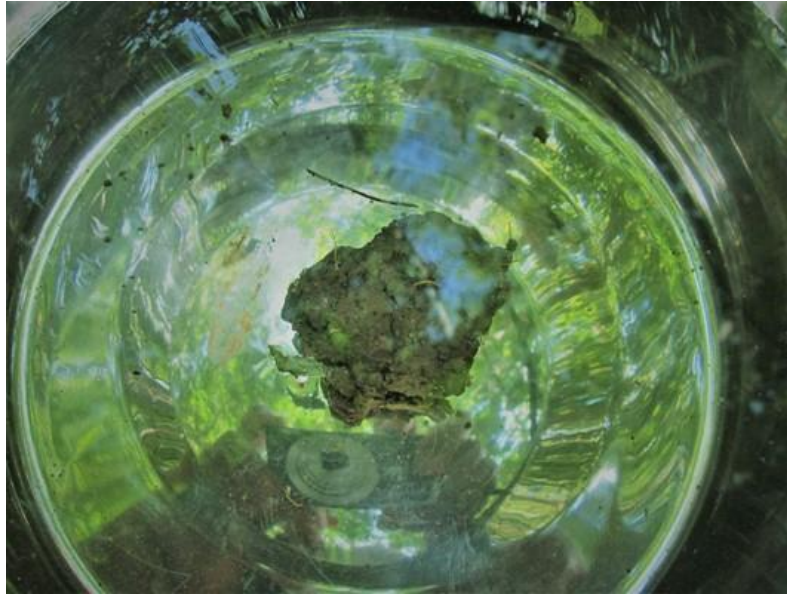
Figure 43 - Start of Slake Test, Soil Sampling Location, S2

The start of slake test for S2 is shown in **Figure 43**. The soil fragment (at least 2 cm x 2 cm in size) was taken at the immediate soil surface of the soil sampling location. No rapid escape of air bubbles from the aggregate sample was observed.

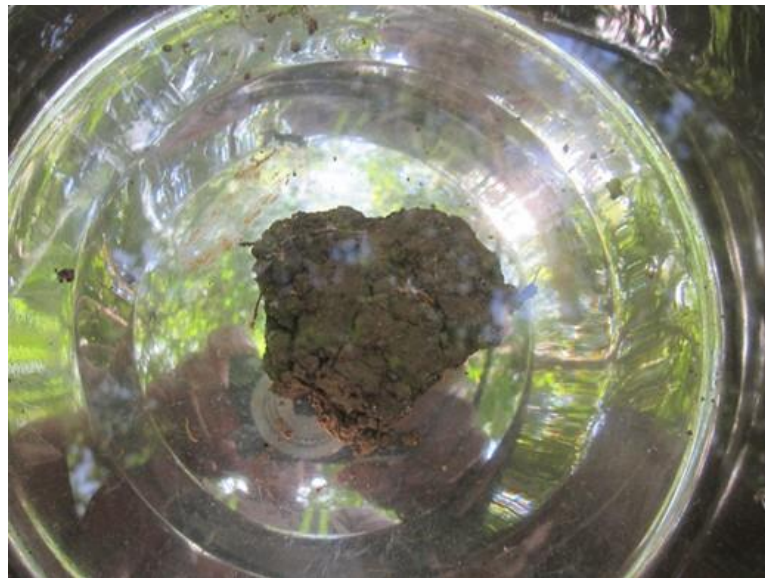
Figure 44 - Minutes After Slake Test, Soil Sampling Location, S2

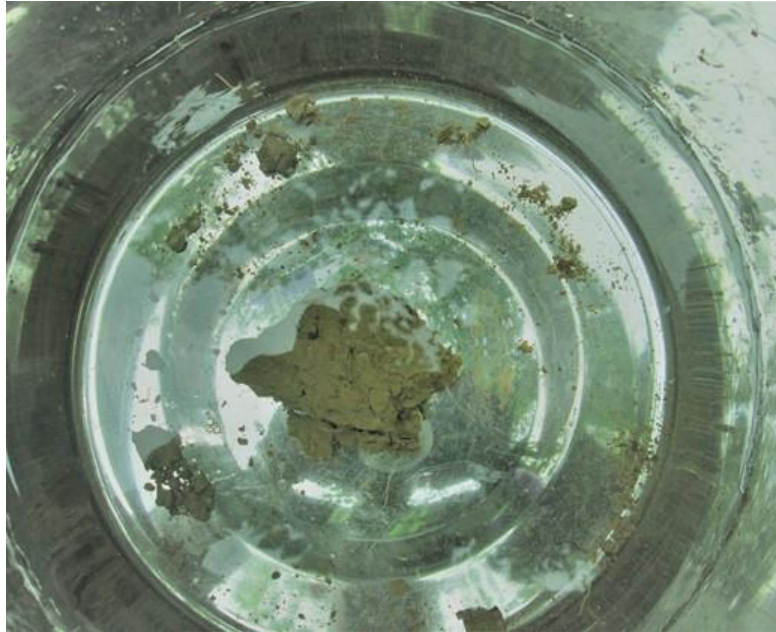
Figure 45 - Start of Slake Test, Soil Sampling Location, S3

Similarly, the aggregate sample was carefully immersed with the distilled water using a stainless steel pan and the slaking property was observed within 10 minutes. The result shows that the soil remain intact, no slumping was observed. This soil is then classified as class 4 or Stable.

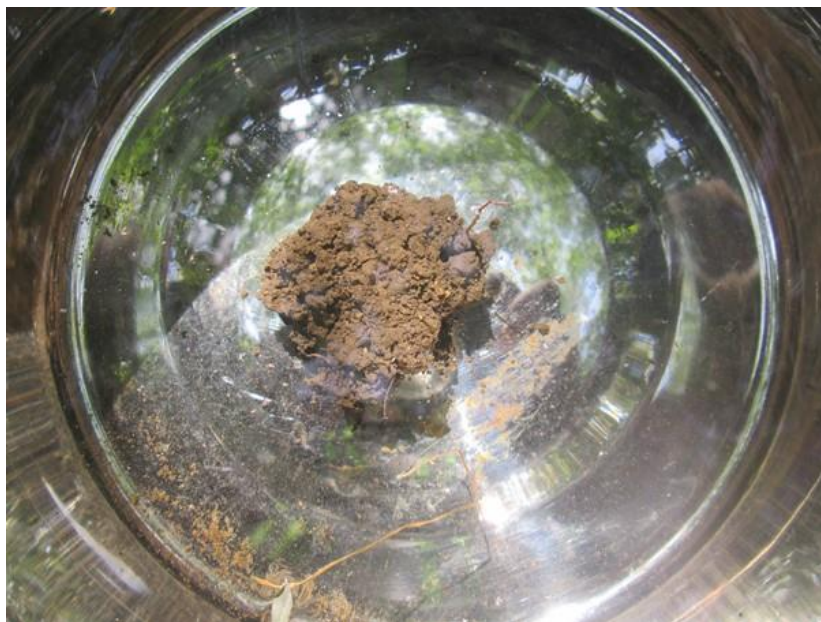
Figure 48 - Minutes After Slake Test, Soil Sampling Location, S4
